# HAZARD ALERT

Damaged Water Main

April 2016

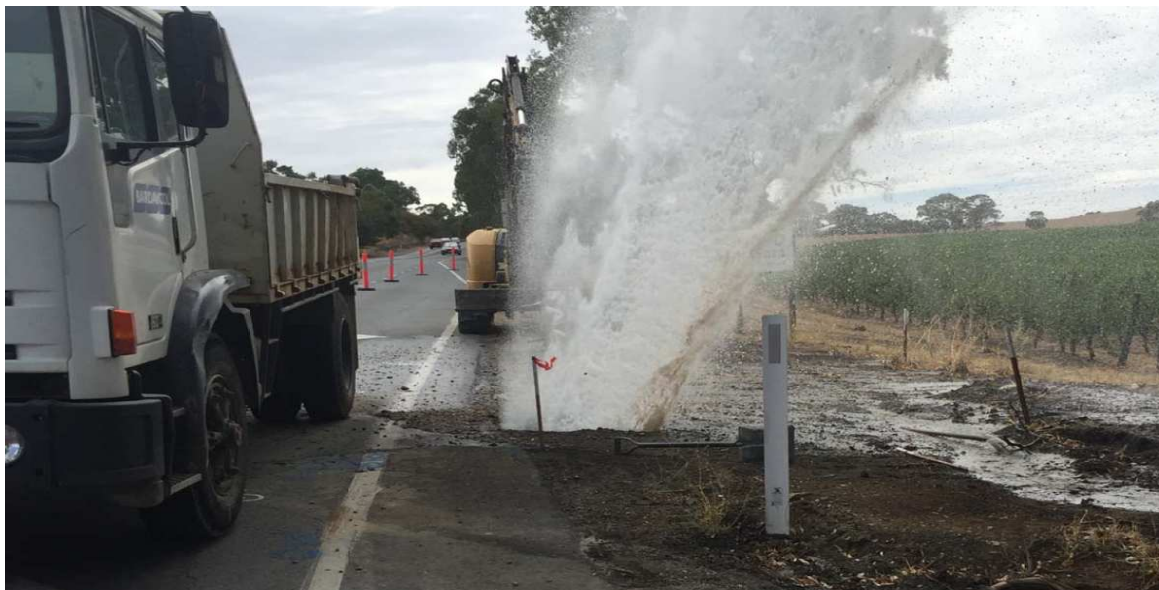
A contractor was drilling a footing for a light pole and hit a 450 AC water pipe on a main road.

The lighting infrastructure was designed over the existing water main and did not align with indicative survey and service locator markings.

- Review SWMS.
- Identify and risk assess the hazards when you arrive at a site.
- Prior to commencing work, call Dial Before You Dig 1100 or [www.1100.com.au](http://www.1100.com.au) to check the current service plans for the area.
- Ensure contractors understand and use their SWMS correctly.
- Discuss and highlight site specific hazards at toolbox meetings.
