SMITH BAY WHARF

DRAFT ENVIRONMENTAL IMPACT STATEMENT

APPENDIX P – TRAFFIC AND TRANSPORT

FORESTRY ACCESS ROUTE ASSESSMENT

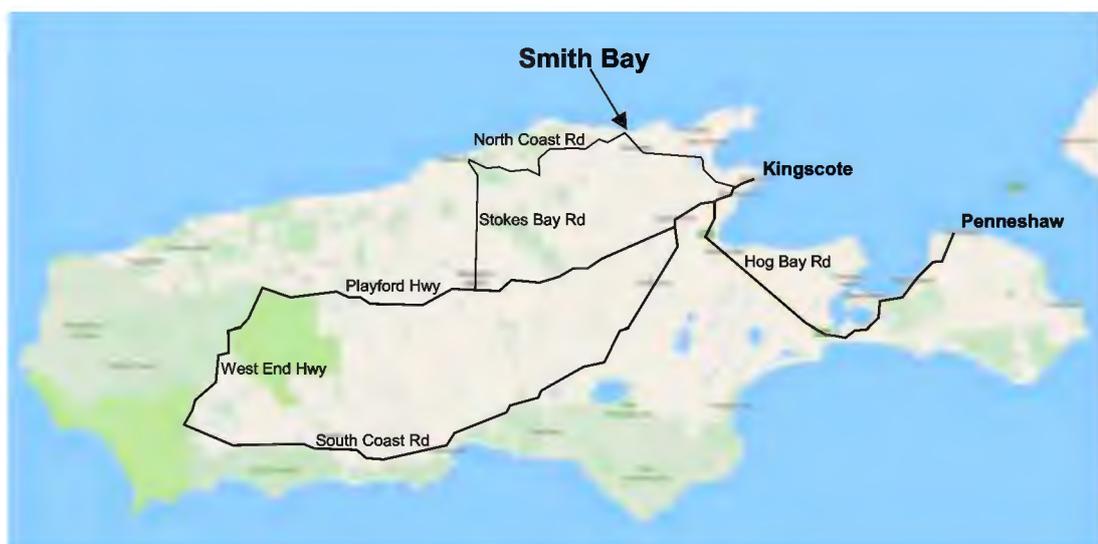
Figure 1. Smith Bay Locality Plan

KIPT is currently planning to construct a new multi-user deep-water wharf at Smith Bay on the island's north coast to handle the shipping of harvested timber. The wharf will include a storage area for a total of 30 kilotons of timber plus other non-forestry cargoes. Usage of the new wharf will locate forestry haulage vehicles further from the more heavily trafficked roads leading to Kingscote and Penneshaw. The location of Smith Bay is illustrated in Figure 1.

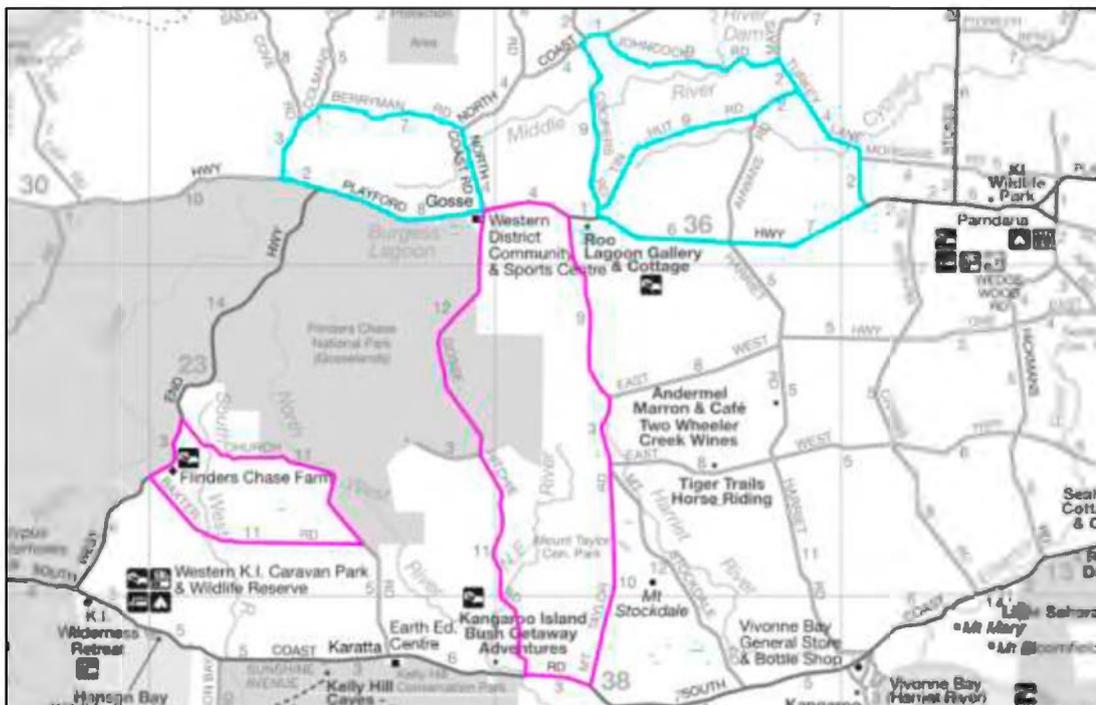
Figure 2. One-Way Haulage Route Opportunities

A number of the local roads used to access plantations have connections to other local roads and the collector road network. In order to minimise or remove the risk of obstructions caused by oncoming vehicles a one-way system could be implemented for haulage vehicles, by which they would enter the plantation from one direction and leave from the other. As well as removing oncoming heavy vehicle traffic, the system would also reduce journey times, as vehicles would not be required to wait at junctions for the road to clear, as would be the case with the above options. Plantation vehicles may still encounter private vehicles under the one-way system, but the number of encounters is expected to be minimal.

Figure 2 illustrates a number of potential one-way routes on the assessed roadways. The one-way system could operate in either direction. Opportunities for additional one-way routes should be investigated prior to the commencement of haulage on each road.

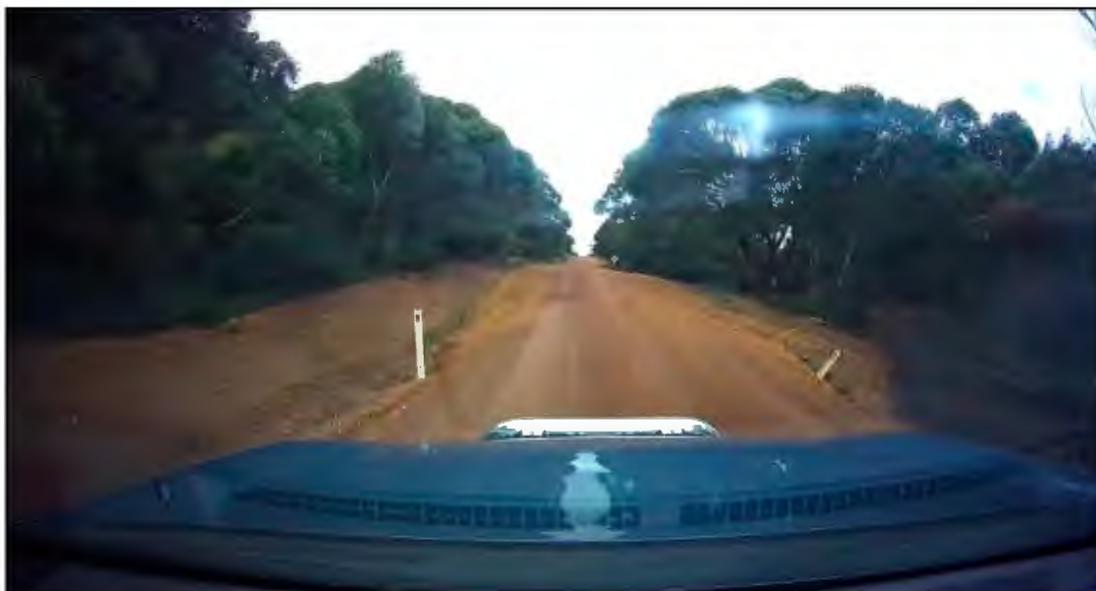
Figure 4. Steep Batter Slope

RRD 2.6. Steep fill batter on southern side of roadway, as shown below (left of frame).

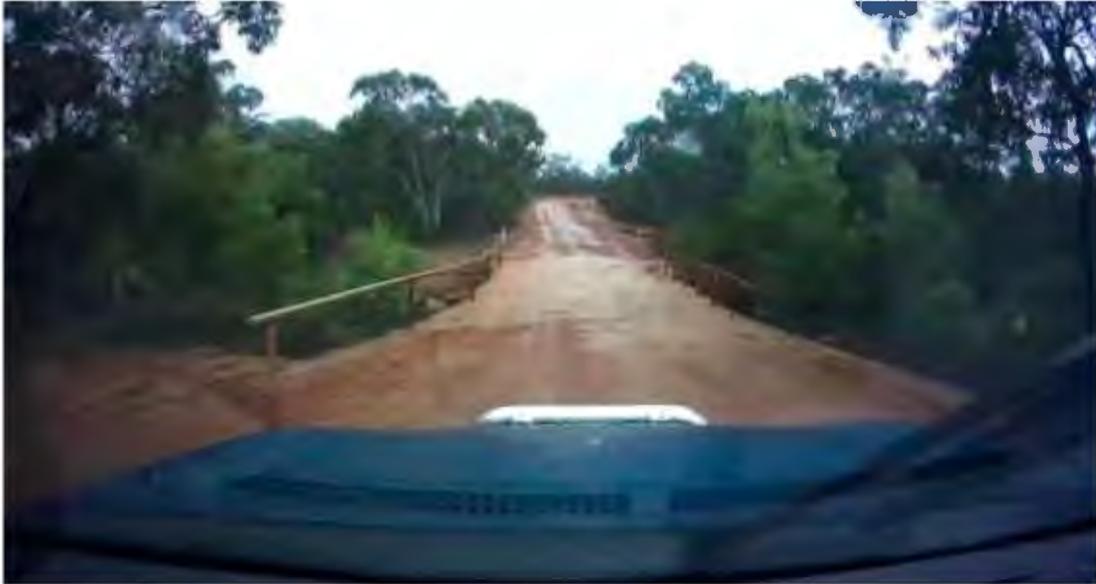
Figure 5. Middle River Bridge Crossing

RRD 10.8. Middle River Bridge Crossing. Light railing on both sides. No width markers on either approach.

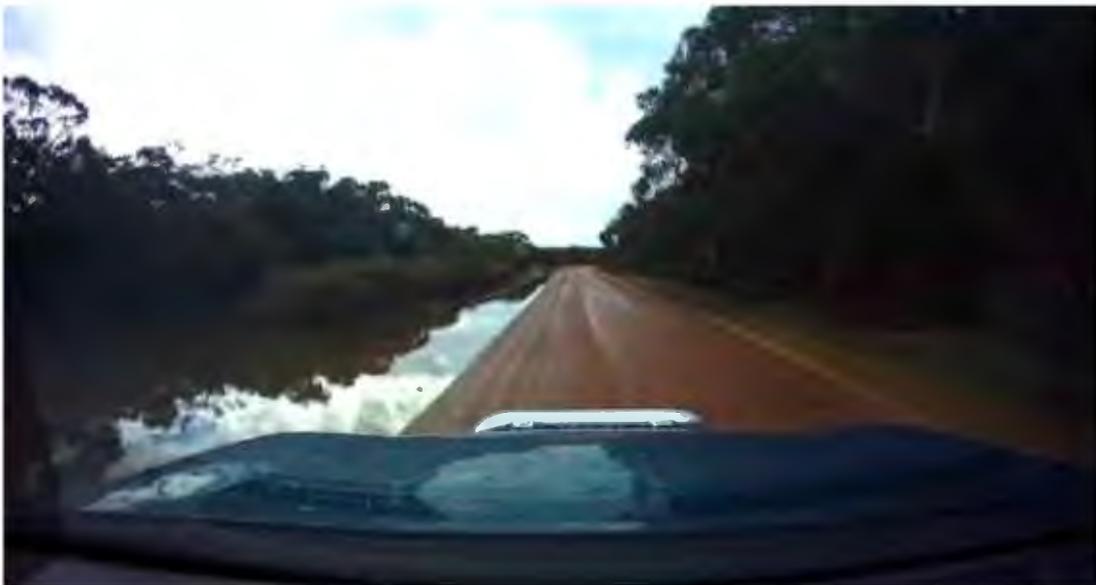
Figure 6. Flooding Extending onto Roadway

RRD 16.4 – 16.8. Flooding on southern side of road, extending into carriageway.

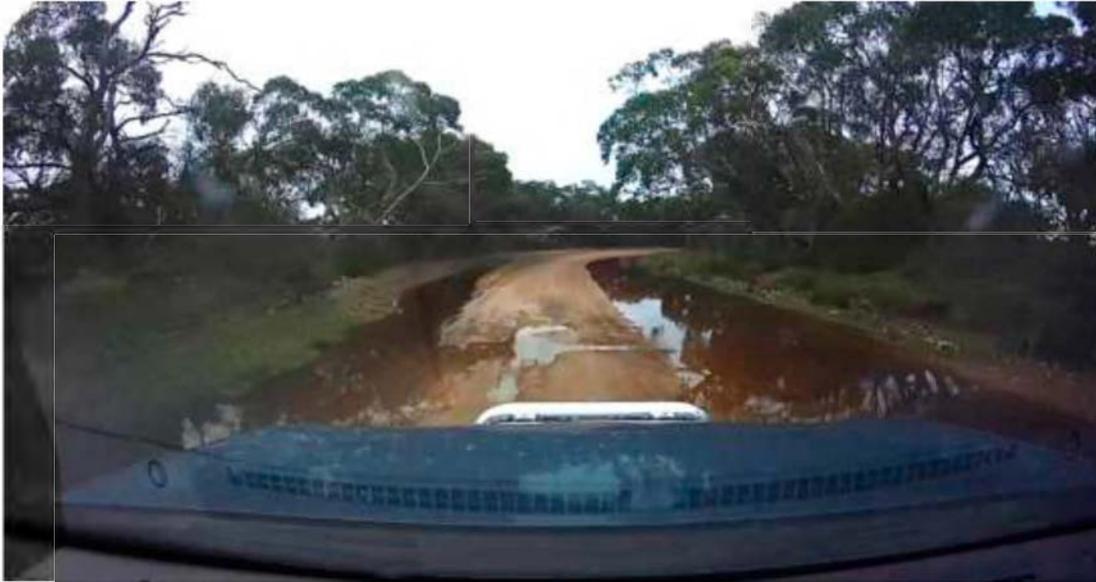
Figure 7. Flooding Extending onto Roadway through Curve

RRD 3.1. Flooding on both sides of the road, extending through the curve.

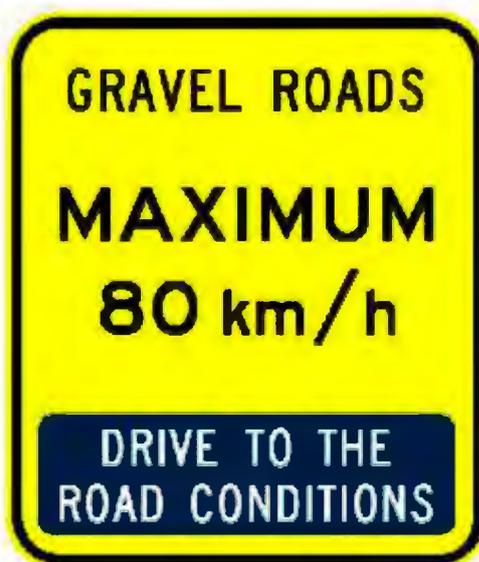
Figure 8. Gravel Roads - Maximum 80 km/h W1-SA101 Sign

DPTI Operational Instruction 4.10: Maximum 80 km/h Advisory Sign on Unsealed Roads, states that on unsealed roads with varying width, alignment and surface condition, a maximum speed of 80km/h may be appropriate. In such cases Gravel Roads - Maximum 80 km/h W1-SA101 advisory signage, as illustrated below, may be used to encourage lower speeds and assist in improving safety. The sign is an advisory sign only and is not a regulatory speed limit sign.

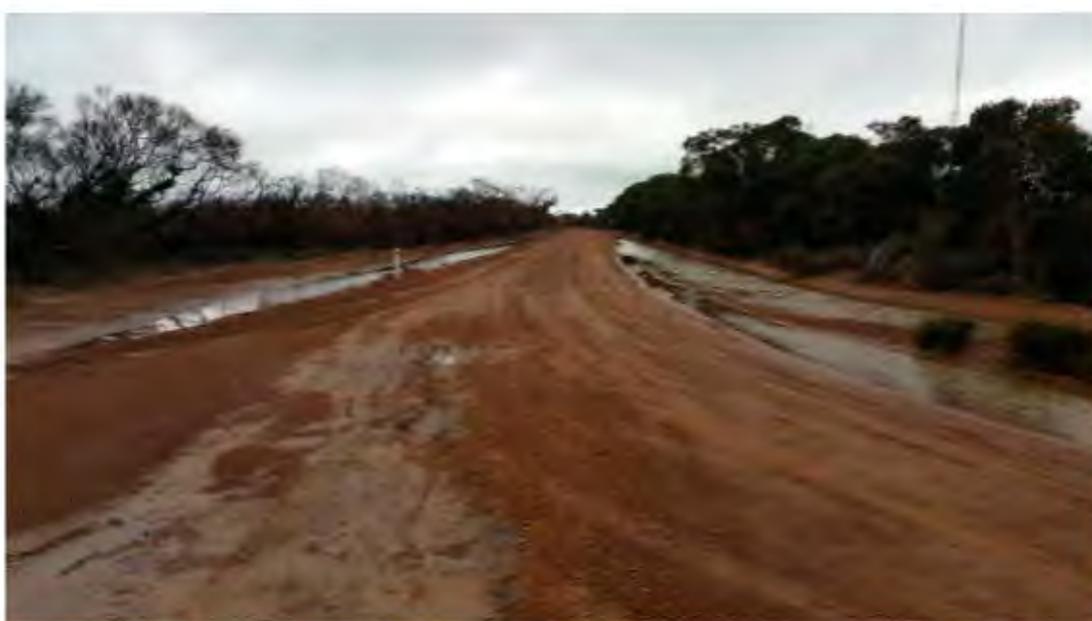
Figure 9. Jump Off Road Flooding at Junction

Flooding on both corners and on Playford Highway opposite the junction.

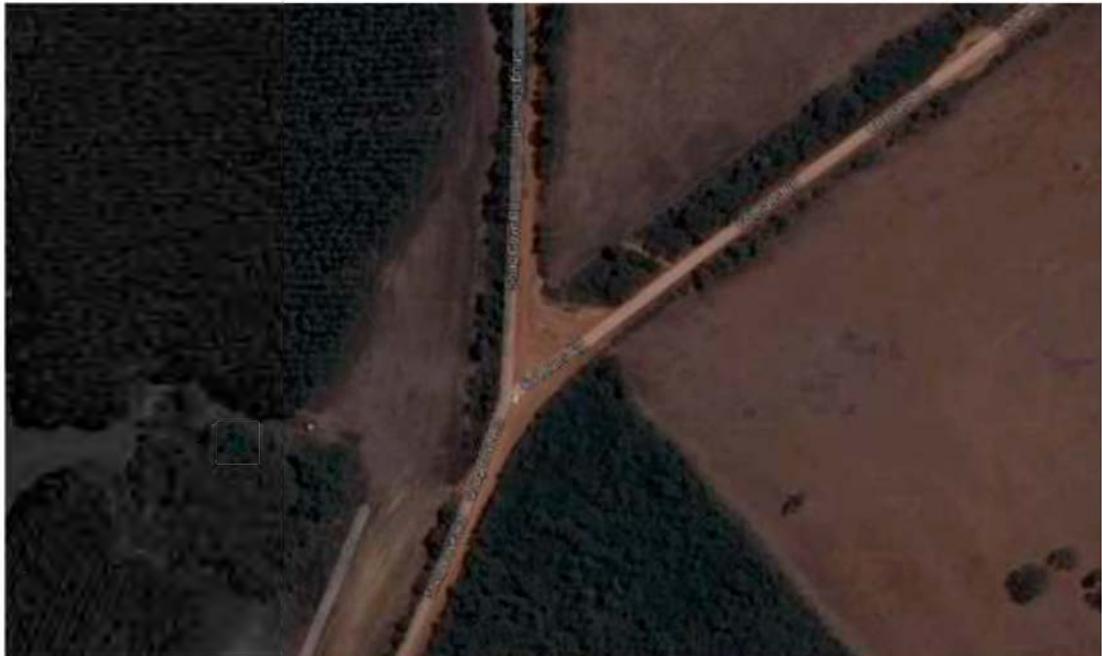
Figure 10. Snug Cove Road / Colmans Road Junction Alignment

The Snug Cove Road northern approach is the minor junction arm; however, the junction arrangement means that priority is ambiguous. Priority is indicated with Give Way R1-2 signage.

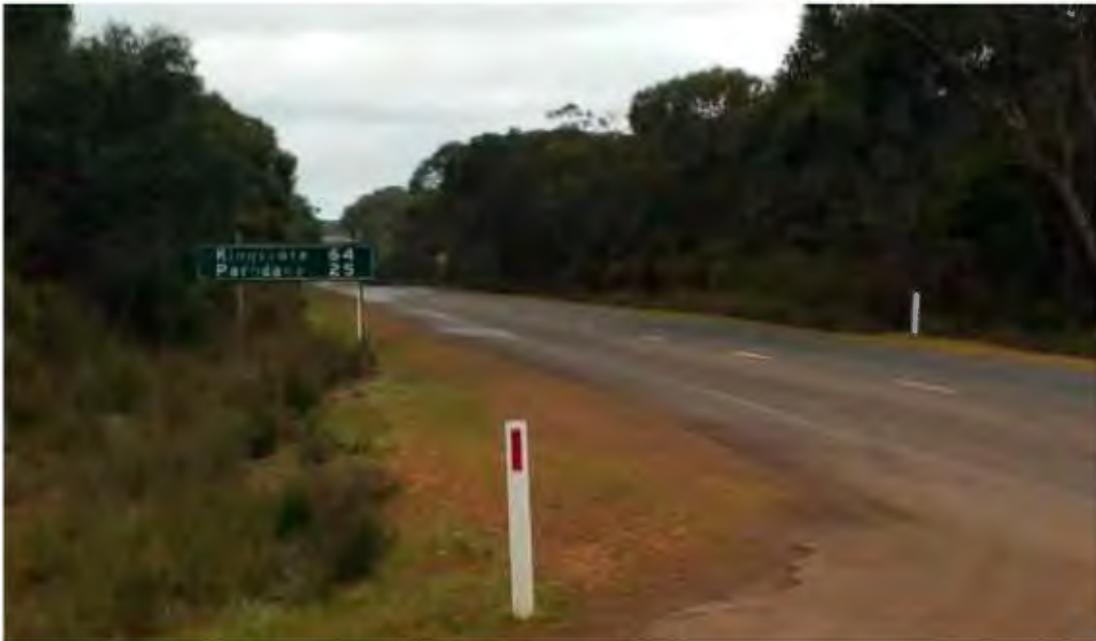
Figure 11. Sightlines Obscured by Sign

Sight distance to the east on Playford Highway for vehicles at the North Coast Road junction is compromised by the location of a road sign. It is recommended that the sign is relocated to improve sightlines.

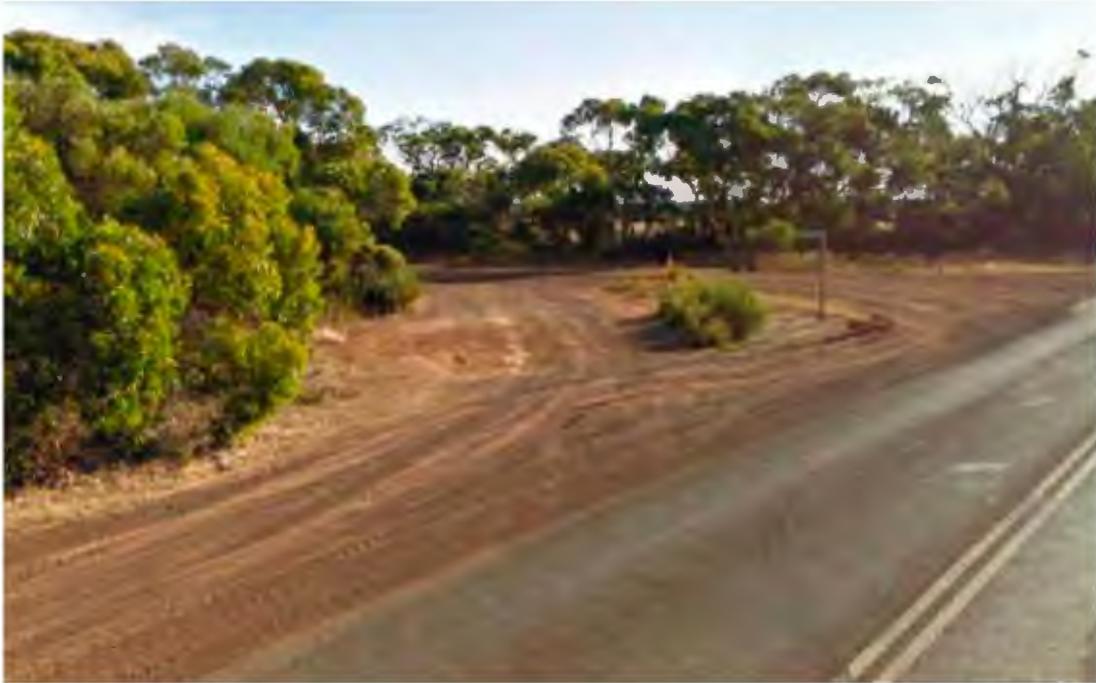
Figure 12. Informal Left Turn Arrangement, Playford Highway Western Approach

Vehicles cutting the corner when turning left from Playford Highway onto Timber Creek Road has resulted in the creation of an informal channelised left turn arrangement, with a vegetated area between the informal left turn and the formal Timber Creek Road approach. The arrangement may cause confusion among drivers, increasing the likelihood of collisions.

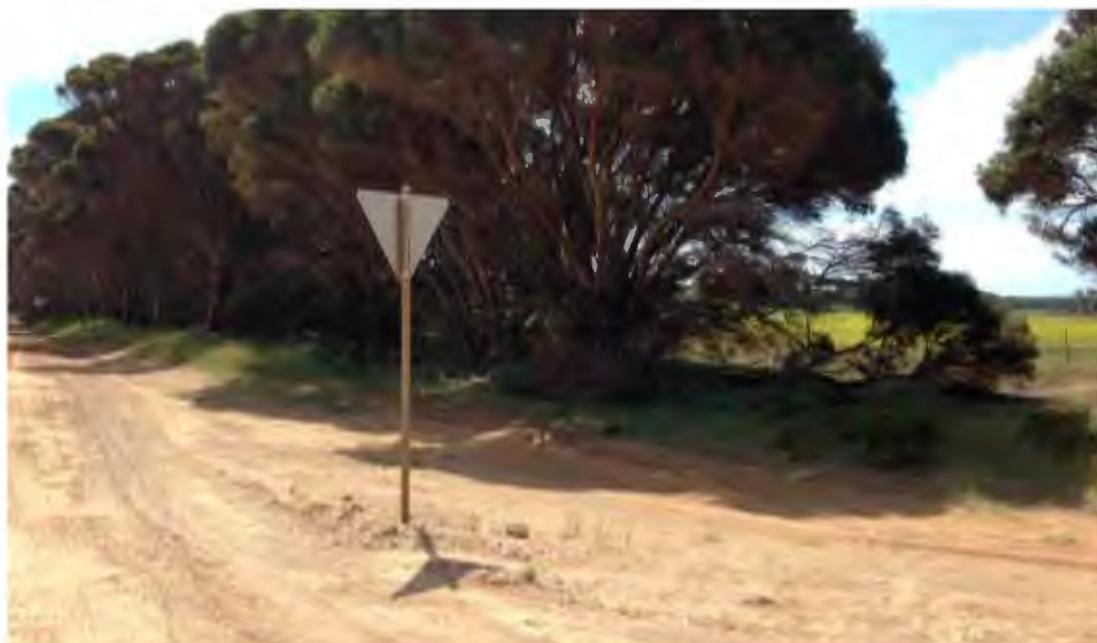
Figure 13. Path of Travel Both Sides of Sign, Gap Road Approach

Vehicles cutting the corner when turning left from Gap Road onto Gum Creek Road has resulted in the creation of an informal channelised left turn arrangement, with vehicles passing either side of the Give Way sign on Gap Road. The arrangement creates a hazard and may increase the likelihood of collisions.

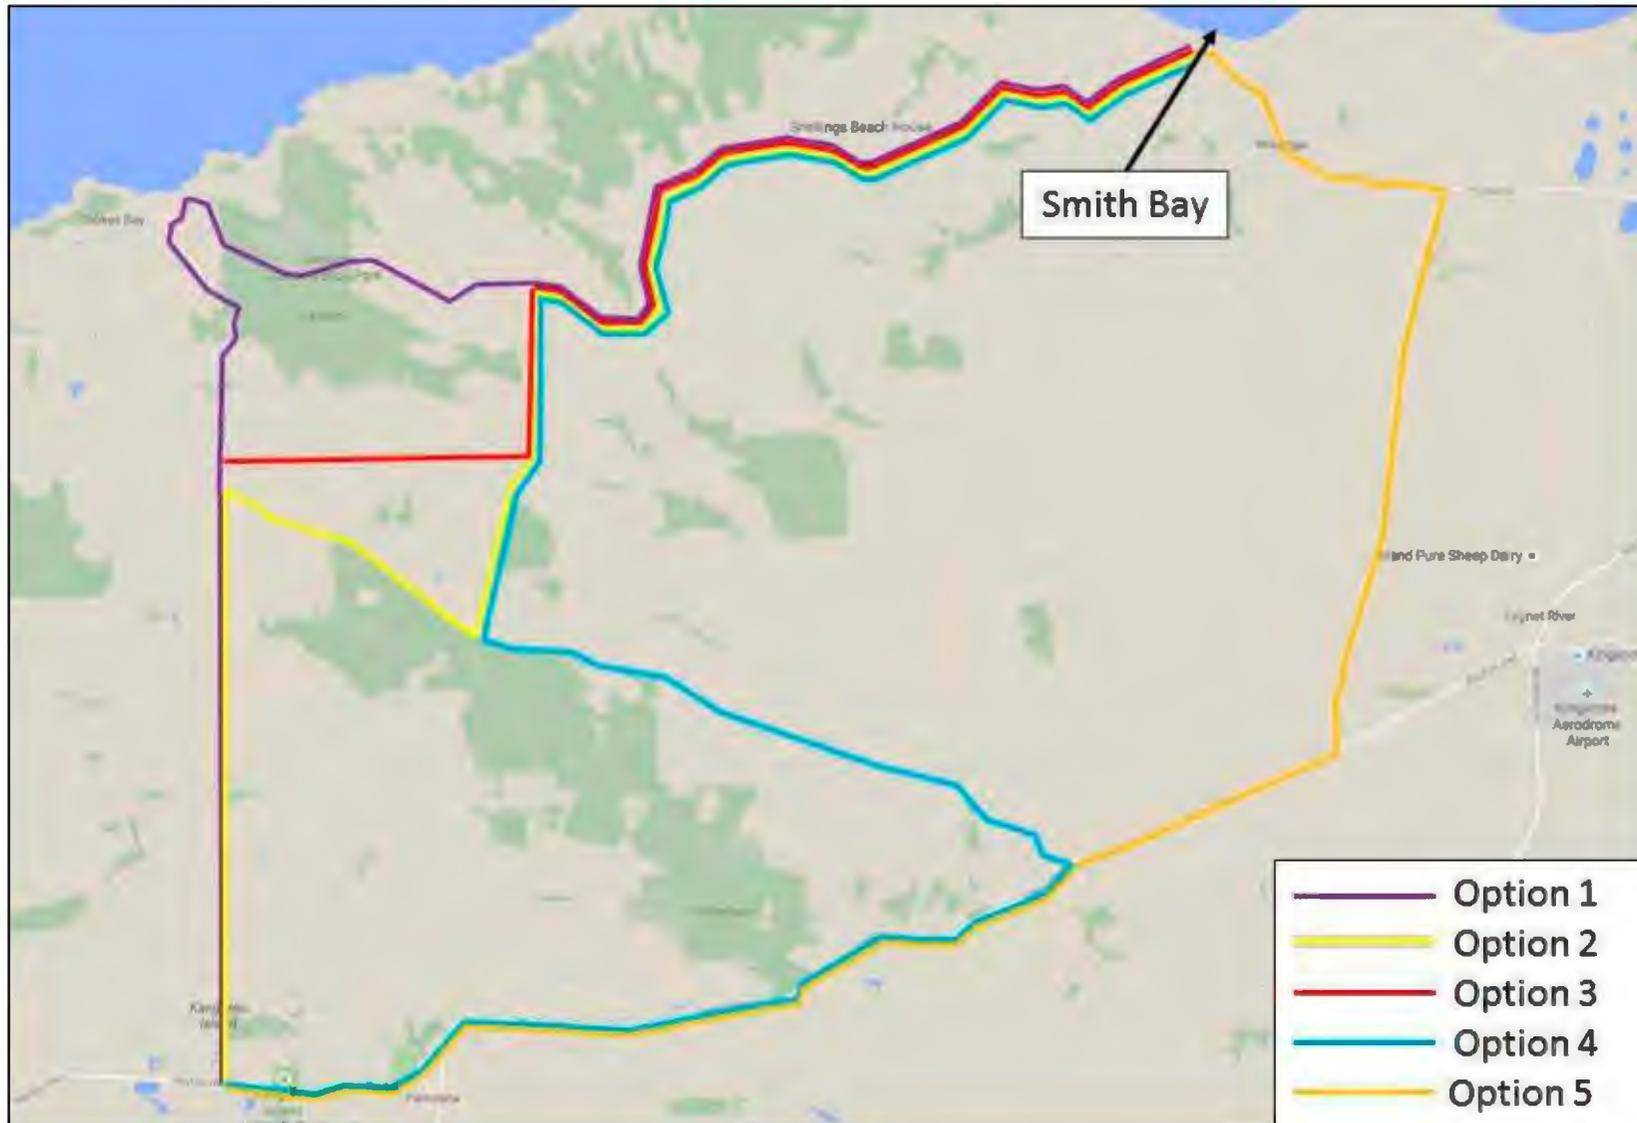
Figure 14. Smith Bay Access Route Options

Figure 14 highlights each of the assessed routes, while the advantages and disadvantages of each route are detailed in Table 7.

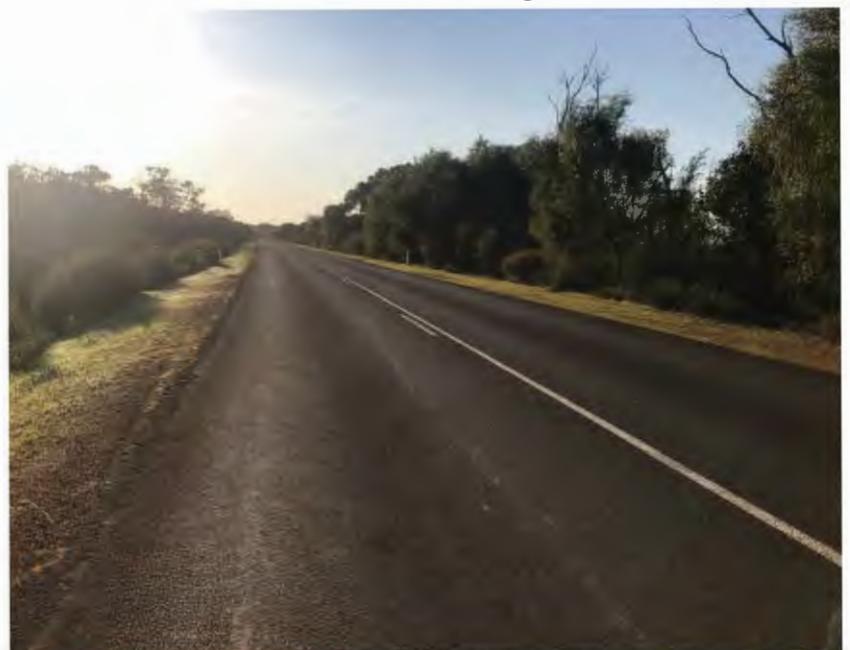
Based on the assessment, seal has been scored at 3 with pavement at 4. Playford Highway from Ahwans Road to Rowland Hill Highway is

Playford Highway A 1 – typical clearances

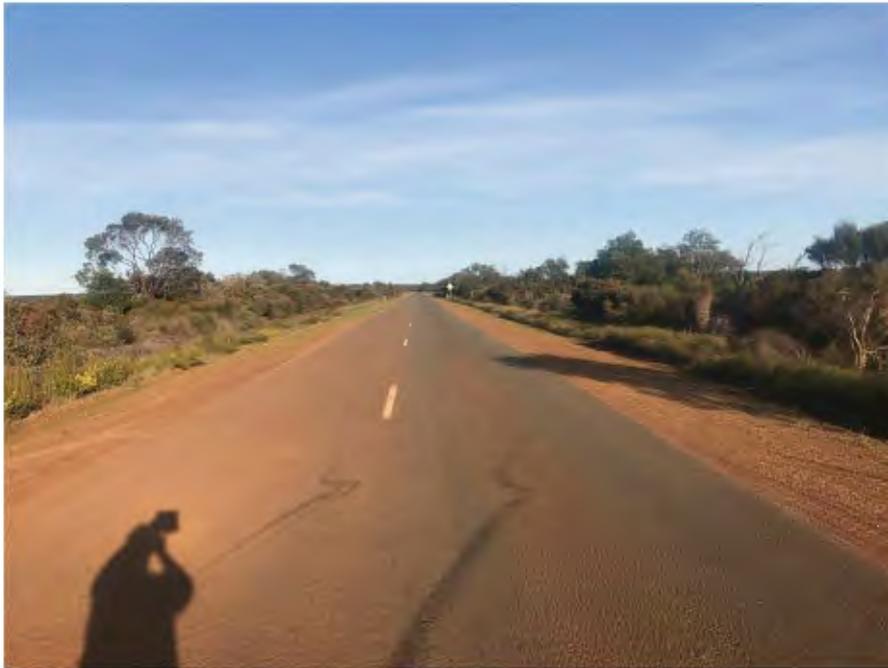
The shoulders are unsealed and range from 1.0 – 2.0m along the assessed length with clearance back at least 2m which has resulted in

Playford Highway A 1 - typical condition and clearances

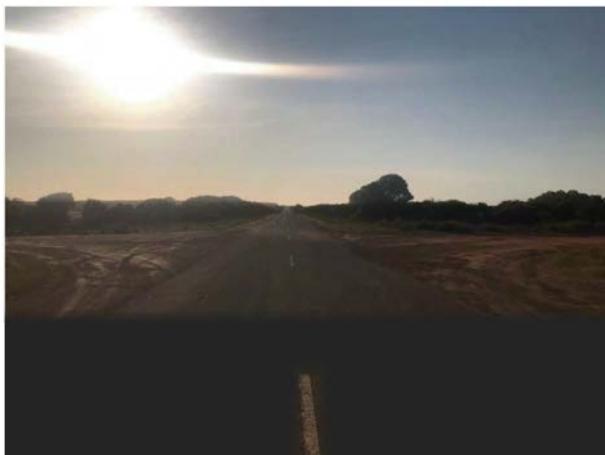
Playford Highway A 2 - Harriet Road intersection

- Gosse Ritchie Road & North Coast Road (110km speed zone) which provides adequate Safe Intersection Site Distance (SIDS).
- Mt Taylor Road (110km speed zone) which provides adequate SIDS.
- Coopers Road (110km speed zone) which provides adequate SIDS.
- Harriet Road & Ahwans Road (110km speed zone) which provides adequate SIDS. Harriet Road services the Marron Farm which generates tourist traffic.
- Turkey Lane (110km speed zone) which provides adequate SIDS.
- McHughes Road (110km speed zone) which provides adequate SIDS.

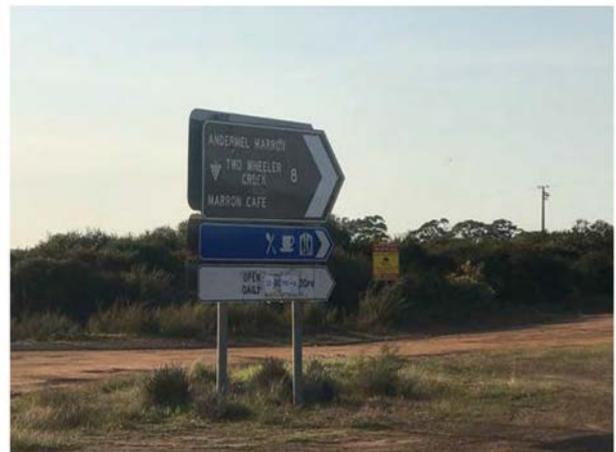
The intersection that is non right of way will require widening to cater for heavy vehicle swept path and some vegetation removal, to enable the vehicle to turn without encroaching on the outgoing lane. It should be noted that SA Water main runs along the southern side of Playford

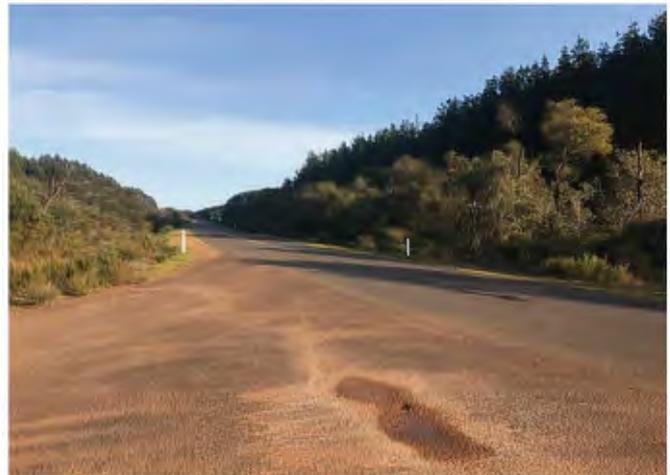
Playford Highway A 3 - Mt Taylor Road intersection (looking west)

Playford Highway has a traffic count of 140 vpd⁸ and Regionally Significant Tourist and Access Routes in the S&HLGA 2020 Transport Plan. There are no reported crashes along the assessed length of Playford Highway. The speed environment is 110km for the assessed length of Playford Highway with overtaking provisions along the assessed length.

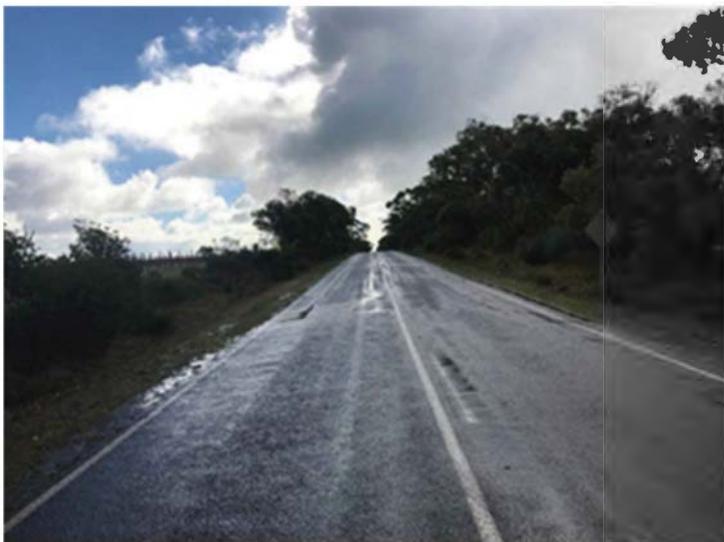
The shoulders are unsealed and range from 0.5 – 1.0 along the assessed length with clearance back at least 2m. There are several sections along the assessed length that have w-beam crash barriers installed that provides for a total width of 8m including unsealed shoulders which has resulted in a score of 4 overall in the assessment criteria.

Stokes Bay Road 1 - typical condition

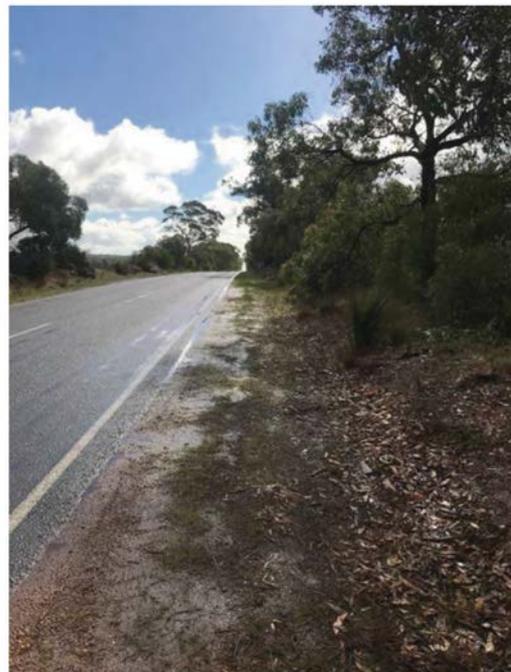
The Roadside vegetation is currently 2 – 3 m back from the carriageway along the majority of the assessed length of road. Pruning maintenance is required along the majority of the assessed length (approximately 9.5km) to get the vegetation back 2m behind the white marker posts. Height clearance is good (3 – 4 m clearance) with vegetation being scored at 4 overall in the assessment criteria.

Stokes Bay Road 3- roadside vegetation

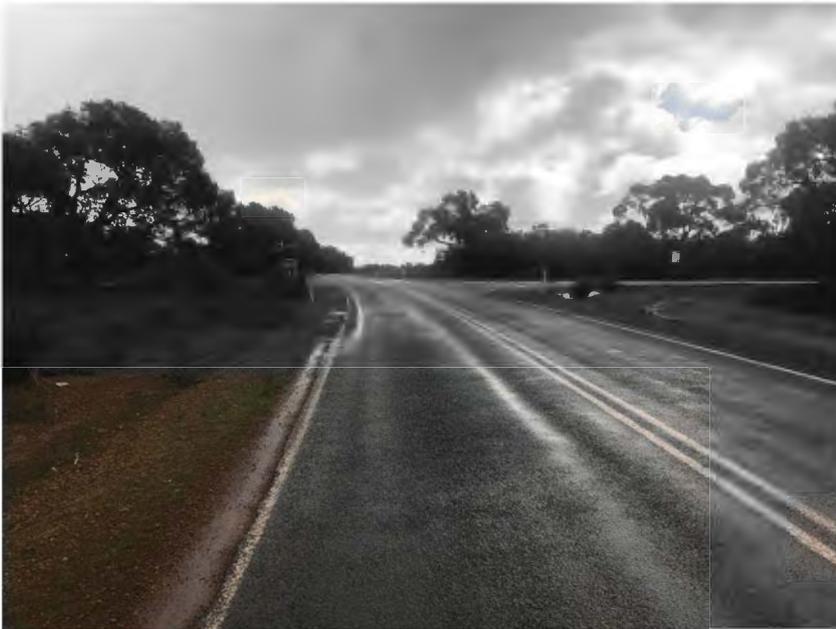
Stokes Bay Road 4 - intersection with Weatheralls & Morgans Roads

- Weatheralls & Morgans Roads (staggered intersection) which provides adequate Safe Intersection Site Distance (SIDS).
- Pioneer Bend Road which provides adequate SIDS.

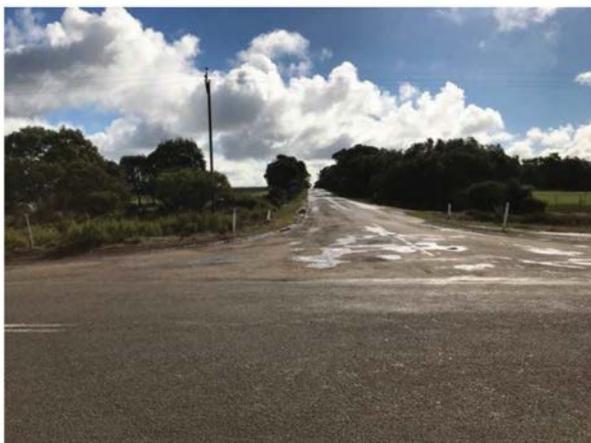
cater for heavy vehicle swept path and some vegetation removal, particularly at the intersection of Playford Highway and Stokes Bay Road where a deceleration lane on Playford Highway to enable the vehicle to turn without encroaching on the outgoing lane. Note that there is a power pole on the western side of the intersection of Playford Highway which needs to be considered when designing an upgrade.

Stokes Bay Road 5 - intersection with Playford Highway

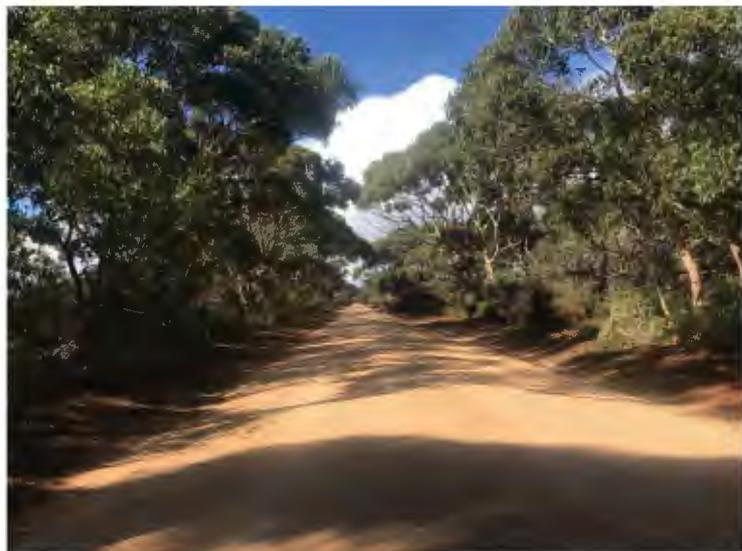
Unsealed road 7m that is in very good condition. The shoulders are generally 0.5m along the assessed length with clearance back at least 2m up to 3m. There is one section along the assessed length that has w-

Bark Hut Road 1 - typical condition

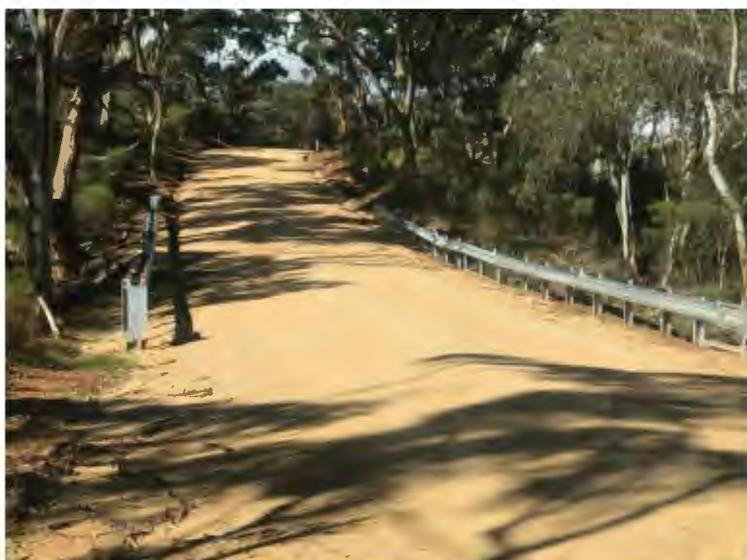
Geometry of the assessed length has good cross fall at 6% with gradual vertical grades however there are some sections where the batter slopes are steeper than 1 in 3 which has resulted in an overall score of 4 in the assessment criteria.

Bark Hut Road 2 - bridge crossing

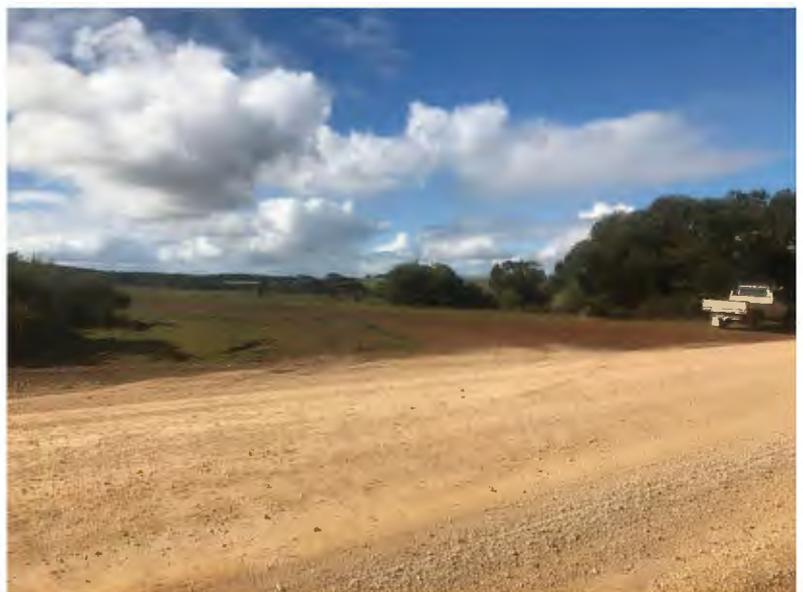
Bark Hut Road 3 - intersection with McBrides

- Stokes Bay Road & Bark Hut Road which is a right hand turn from Stokes Bay Road onto Bark Hut Road when heading towards Smith Bay.
- Bark Hut Road & McBrides Road which is a right hand turn when heading away from Smith Bay.

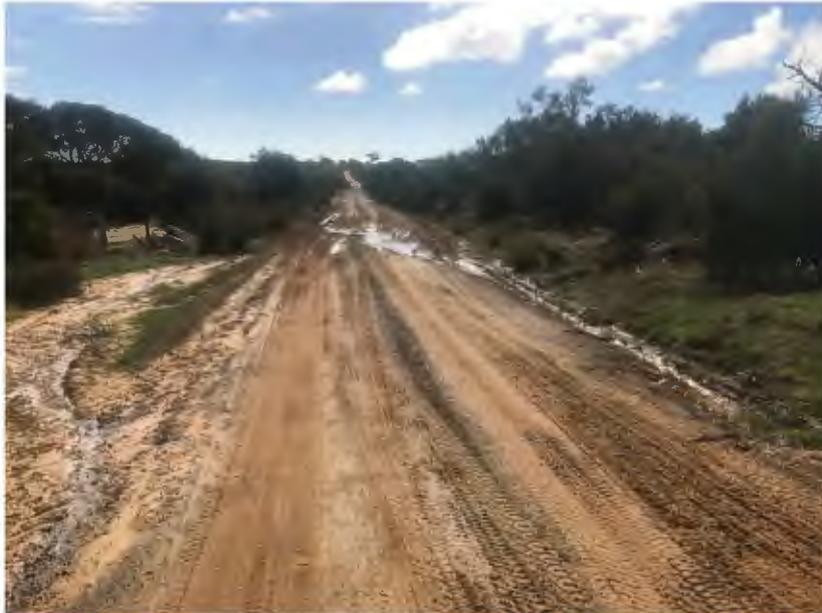
An unsealed, low classification road in poor condition. It is known that McBrides Road is often closed to non local traffic during winter due to hazardous conditions as it is not an all weather road. The carriageway width varies from 5.5m down to 3.6m and as such has been scored a

McBrides Road 1 - typical condition (poor)

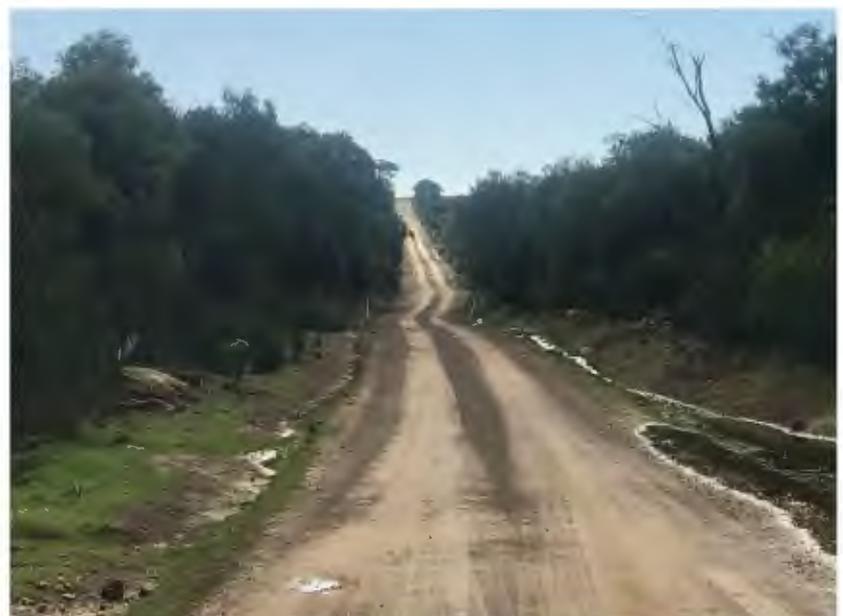
The cross drains along the assessed length of McBrides Road are under capacity and in poor condition. There are multiple creek/water way crossings that would require the road to be raised/built up

McBrides Road 2 - insufficient drainage

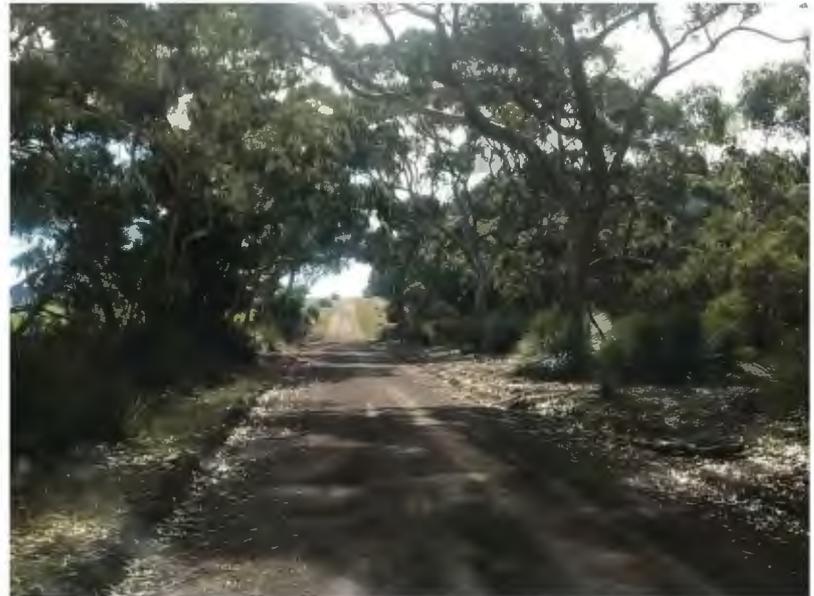
The Roadside vegetation currently abuts some of the narrow carriageway, with vegetation removal required if the road is upgraded. Based on the assessment, Vegetation has been scored as 2 in the assessment criteria.

McBrides Road 3 - roadside vegetation

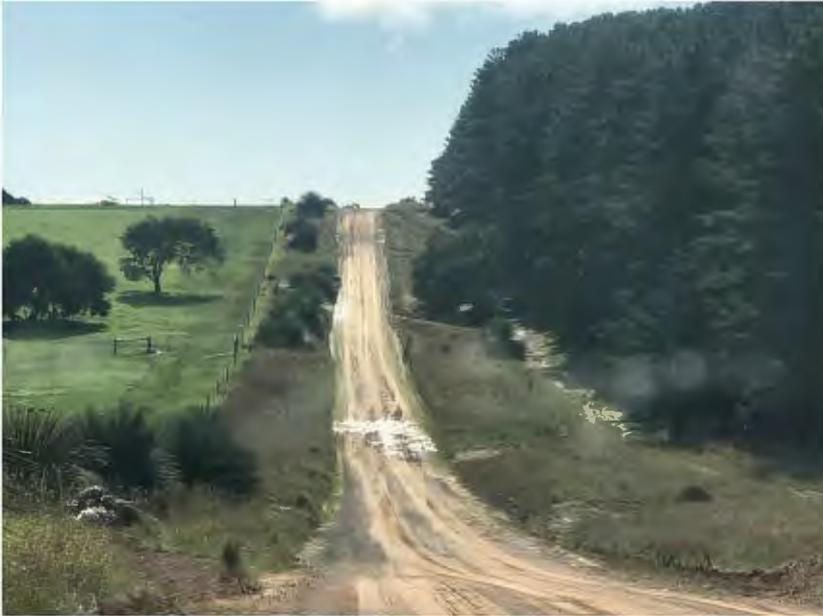
McBrides Road 4 - timber plantation

All agricultural land with paddock accesses only, no residential driveways. There is also a timber plantation approximately 1.6km from Bark Hut Road with a score of 5 in in the assessment criteria.

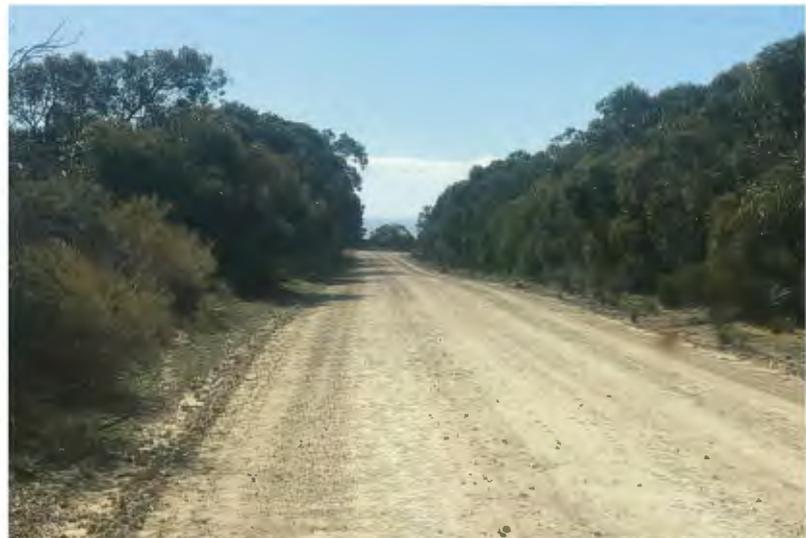
The surface and pavement condition have both been scored at a combined

North Coast Road 1 - typical condition

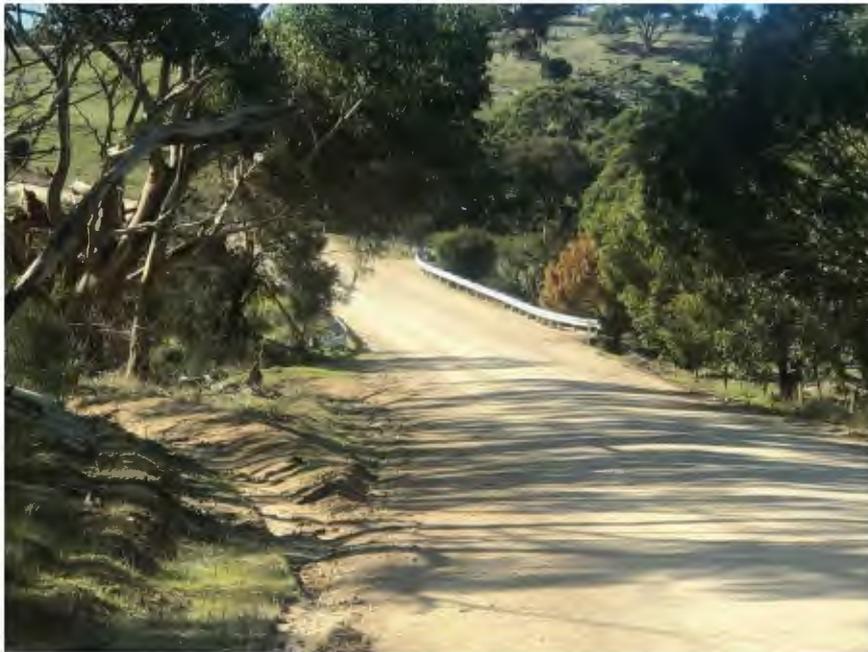
The cross drains along the assessed length of North Coast Road are in good condition, 1 - 2m clear of the carriage way and suitable capacity to capture and distribute water run of.

North Coast Road 2 – approaching bridge

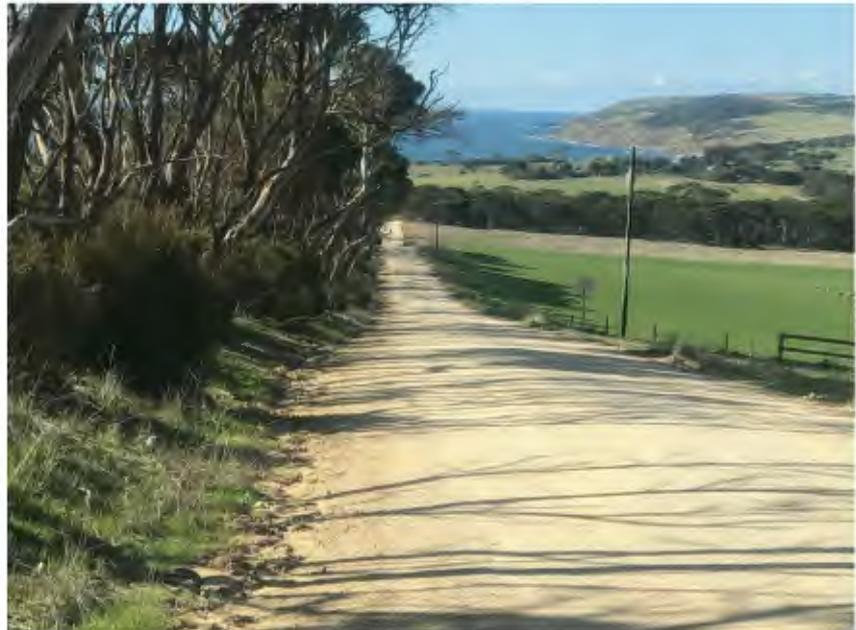
North Coast Road 3 - approach to Smith Bay access (vegetation removal required for intersection upgrade)

Both of the intersections that are non right of way will require widening to cater for heavy vehicle swept path and some vegetation removal, particularly at the

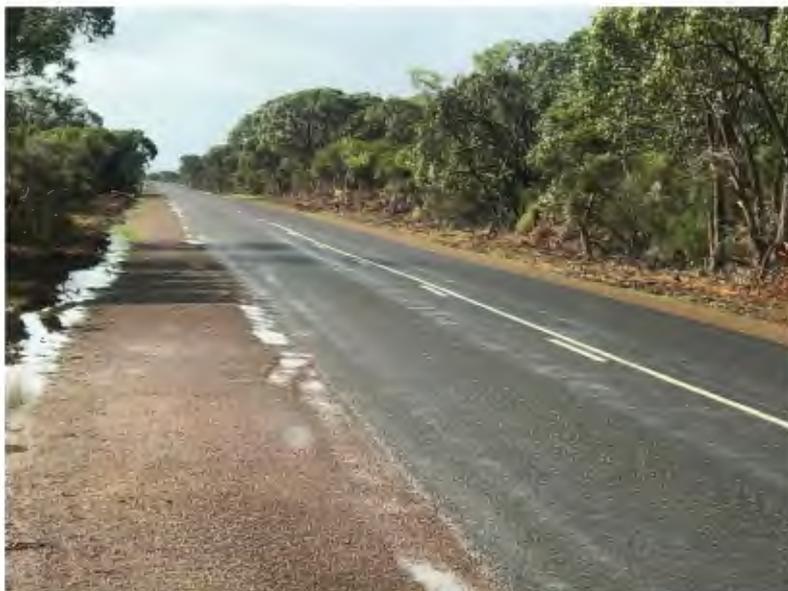
Playford Highway 2 – Council controlled section (west of Parndana)

Sealed road 6m wide from Stokes Bay Road intersection through to Parndana and 6.5m wide from Parndana through to Ropers Road and is in good condition. The carriageway does have some variation from the descent towards Bark Hut Road (travelling east) through to Ropers Road, going down to 6m east of the intersection with Bark Hut Road and as such has been scored a 4 overall in the assessment criteria.

The shoulders are unsealed and range from 1.0 – 2.0m along the assessed length with clearance back at least 2m. East of Parndana the shoulders are sealed 0.5 for the first 10km east of Parndana which then reduces to no edge lines with edge breaks evident along sections of the assessed length which has resulted in a score of 4 in the assessment criteria.

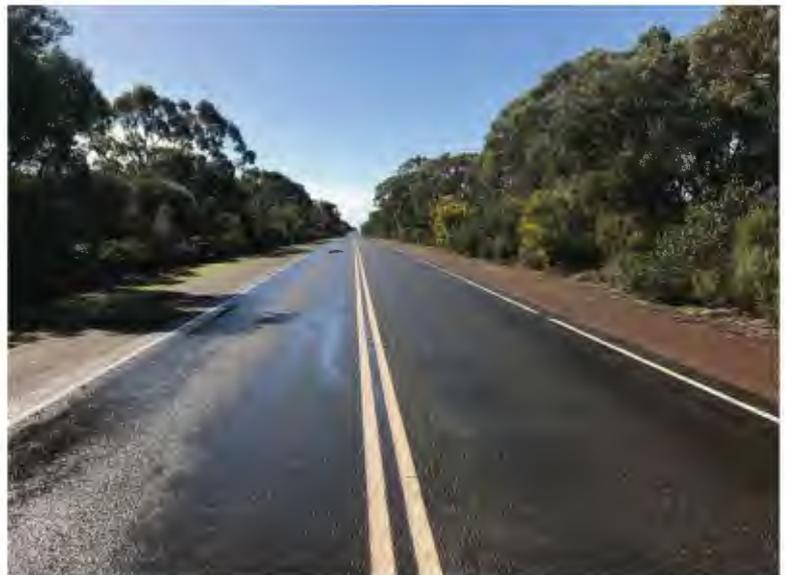
Geometry of the assessed length has good cross fall at an average of 3 – 4% however there is a steep descent (Kohinoor Hill) with a bend in the road that intersects with Bark Hut Road. Geometry has been scored 3 overall in the assessment, predominantly due to the steep section known as Kohinoor Hill.

Playford Highway 4 - evidence of seal delaminating

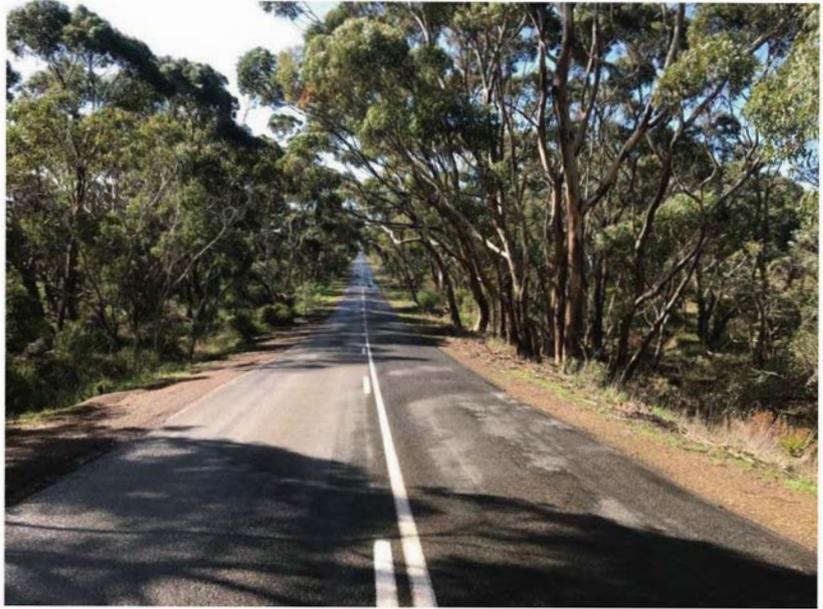
The cross drains along the assessed length of Playford Highway are in good condition, 2m clear of the carriage way and suitable capacity to capture and distribute water run of. The only area of concern is the length of road east of Bark Hut Road that can become inundated in very heavy, prolonged rain events. Based on that scenario, Drainage has been scored 4 overall in the assessment.

Playford Highway 5 – section east of Bark Hut Road intersection subject to inundation during prolonged, heavy rain events.
