SMITH BAY WHARF

DRAFT ENVIRONMENTAL IMPACT STATEMENT

APPENDIX P – TRAFFIC AND TRANSPORT

FORESTRY ACCESS ROUTE ASSESSMENT

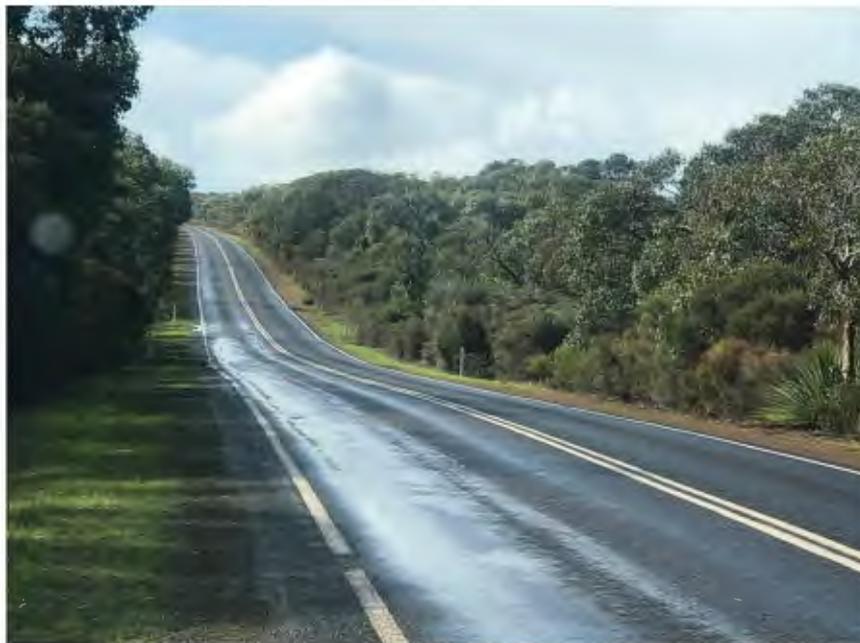
Playford Highway 6 - typical condition

The intersection that is non right of way will require widening to cater for heavy vehicle swept path and some vegetation removal, to enable the vehicle to turn without encroaching on the outgoing lane. It should be noted that SA Water main runs along the southern side of Playford Highway which will need to be considered when designing the intersection upgrade.

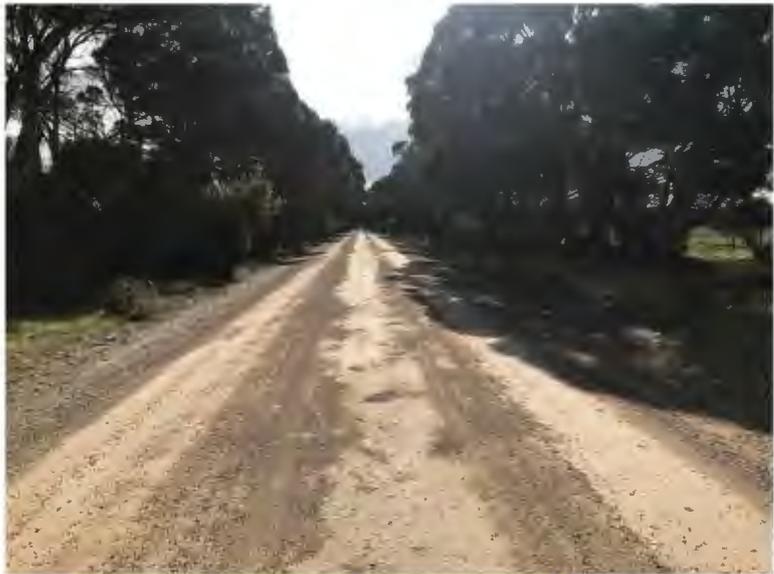
Ropers Road 1 – typical standard (200m off Playford Highway)

The cross drains along the assessed length of Ropers Road are under capacity and in fair to poor condition. The major issue identified is the length of road abutting the Cygnet River that is prone to annual flooding along that would need to be built up some 1.5 – 2m,

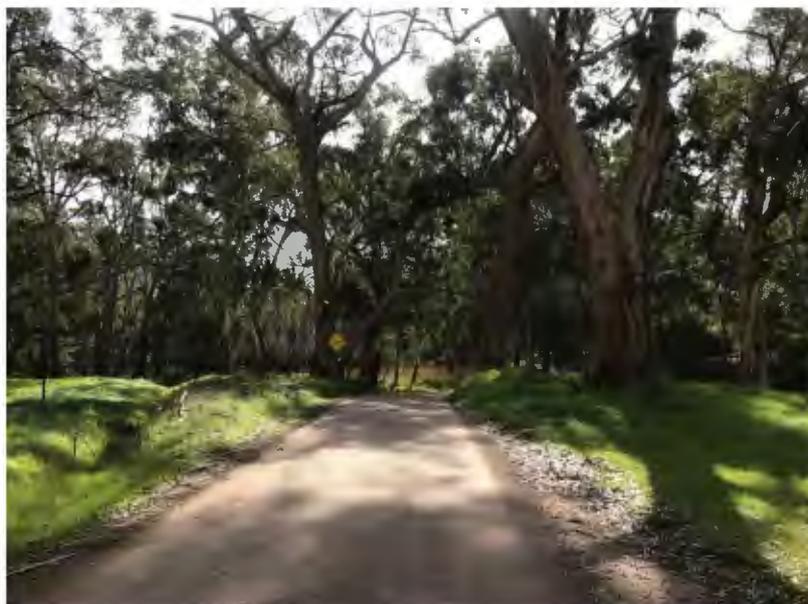
Ropers Road 2 - approaching floodway section that would require to be built up with substantial tree removal

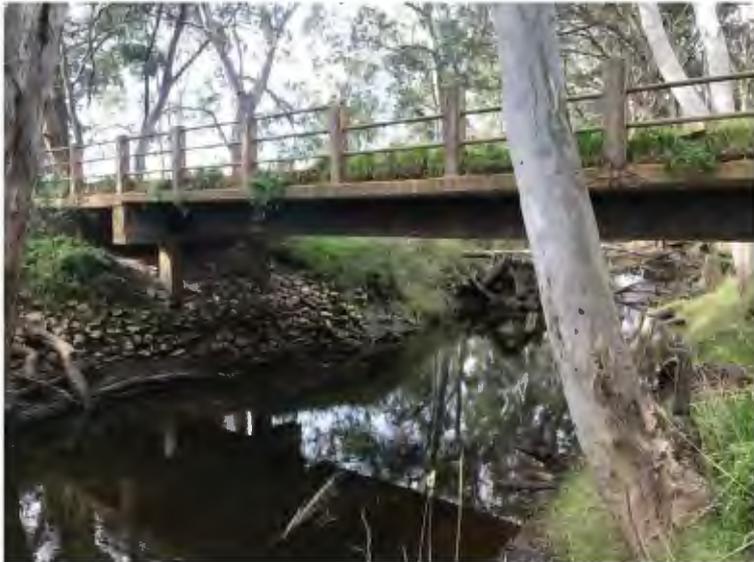
Ropers Road 3 - single lane bridge spanning Cygnet River

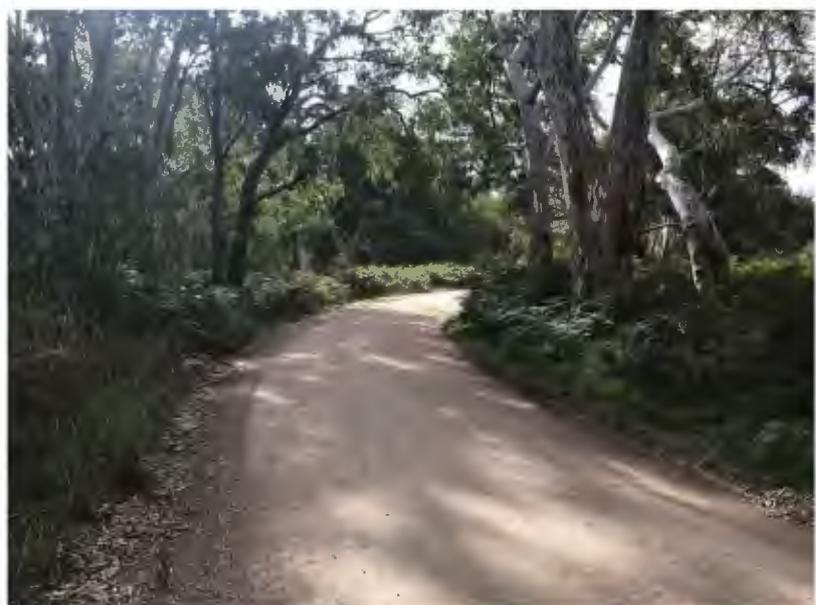
Ropers Road 4 - narrow section that would require significant tree removal

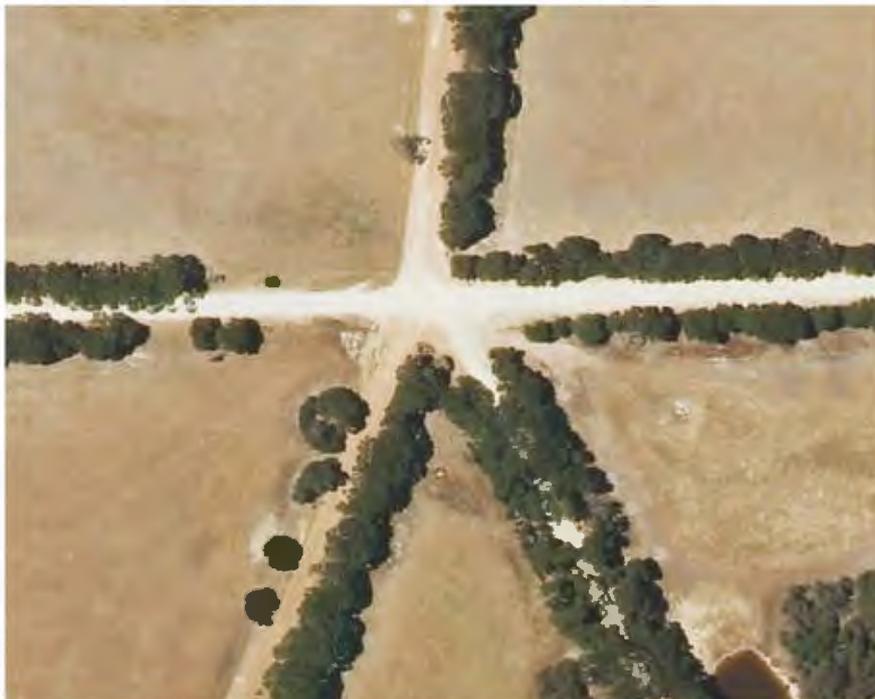
Both of the intersections that are non right of way will require upgrade

works. The 5 way intersection with Gum Creek Road will require re-alignment as Duck Lagoon Road is blind to vehicles travelling along Ropers Road. The intersection with Playford Highway is likely to require a deceleration lane to enable the vehicle to turn without encroaching on the outgoing lane.

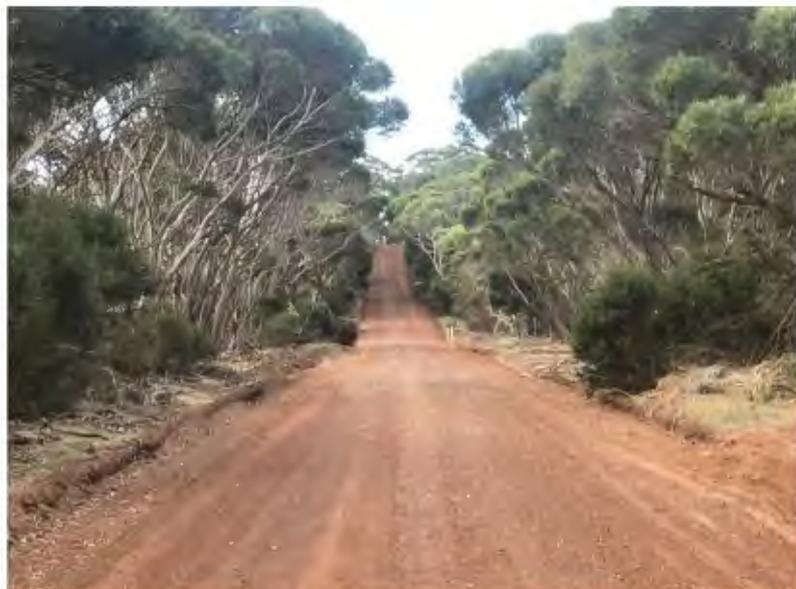
Gap Road 1 - typical condition

The surface and pavement condition have both been scored at 2 and 2.5 respectively in the assessment criteria. It is noted that Council have recent patched sections between Gum Creek and Springs Roads and that re-sheeting of that same section is programmed for 2017/18 Financial Year.

Geometry of the assessed length has poor cross fall at an average of 1 – 2 % with several sections that dip where waterways/creeks cross (see Drainage for further

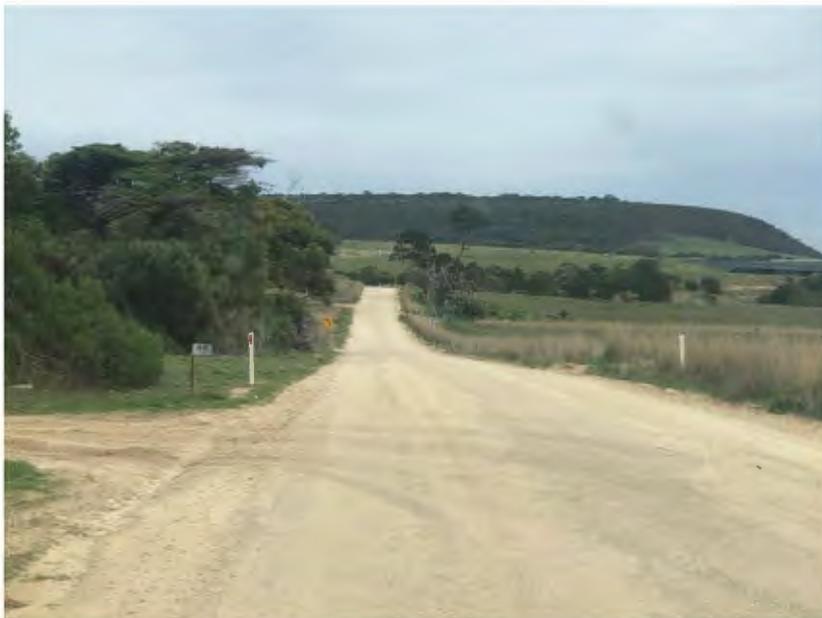
North Coast Road 4 - typical condition

An unsealed road 7m wide that is in good condition and has been scored 5 overall in the assessment criteria.

The shoulders around 0.5 along the assessed length with clearance back 2 - 3m. Vegetation pruning/maintenance will improve the line of sight for curves and bends in the road. As such a score of 5 has been assigned in the assessment criteria.

The surface and pavement condition have both been scored at a combined average of 4.5, reflecting minor maintenance requirements to some sections of the wearing surface.

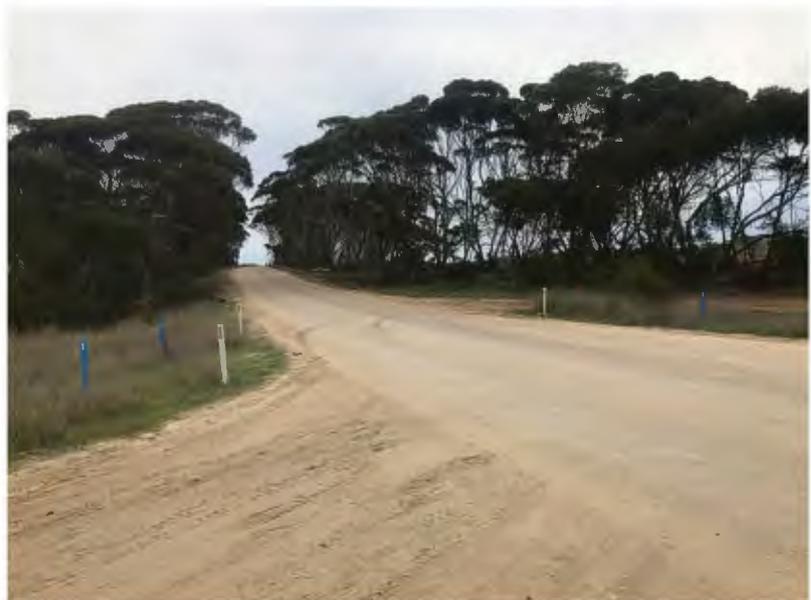
North Coast Road 5 - intersection with Gap Road

- North Coast Road and Smith Bay access road which is a right hand turn from North Coast Road onto the Smith Bay access road when heading towards Smith Bay.
- North Coast Road & Gap Road which is a right hand turn when heading away from Smith Bay.

The no other intersections along the assessed length of North Coast Road. Based on the assessment criteria, intersections have been scored as 4.

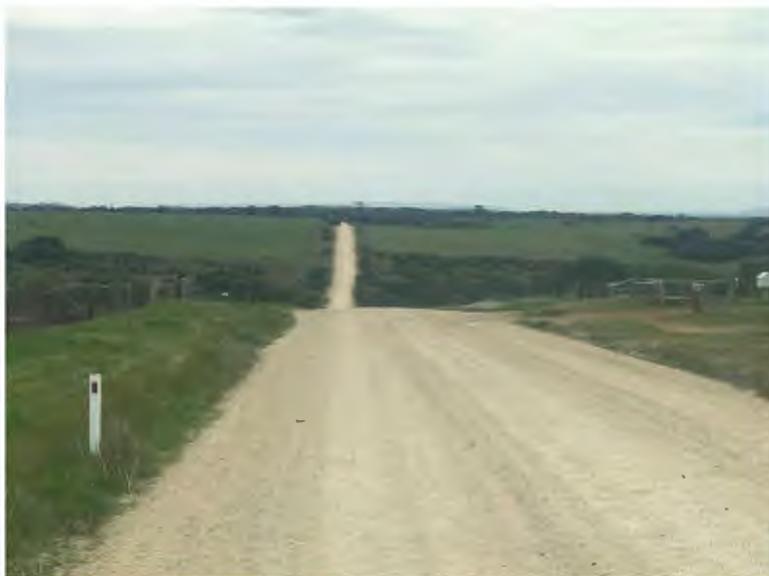
Springs Road 1 – at Woodlana looking east

Unsealed road 7m that is in very good condition. The shoulders are

generally 0.5m along the assessed length with clearance back at least 2m up to 3m which has resulted in a score of 5 overall in the assessment criteria.

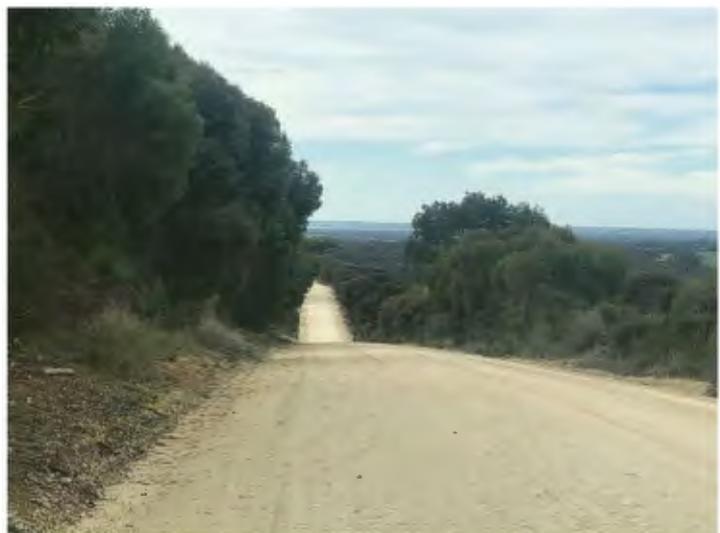
Spring Road 2 – vegetation that needs to be cut back

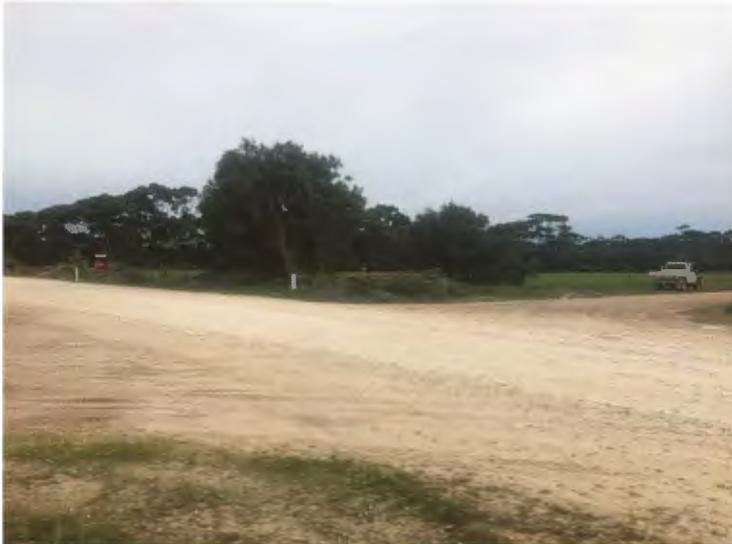
- Millers Road which is marginally short of adequate Safe Intersection Site Distance (SIDS). When heading towards Smith Bay, the approach to the Millers Road intersection is a relatively steep descent that has a couple of curves, limiting line of sight and the ability to pull up a heavy vehicle impacted.

Springs Road 4 – intersection with Rose Cottage Road

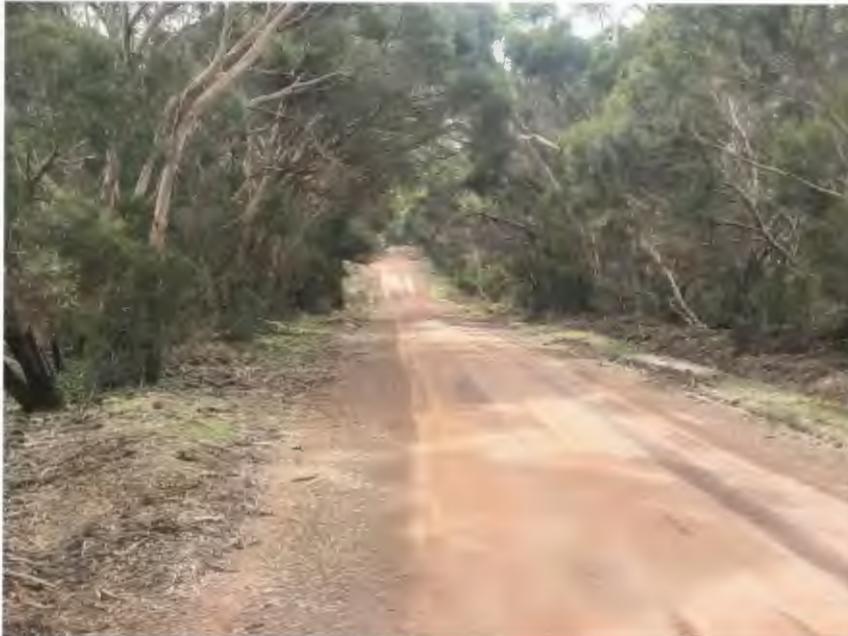
An unsealed, class road in fair to poor condition. The carriageway width varies from 6m down to 4.2m and as such has been scored a 2 overall in the assessment criteria.

The shoulders are predominantly non-existent along the assessed

Rose Cottage Road 1 – typical condition

length with clearance only 0.5 – 1m resulting in a score of 1 overall in the assessment criteria.

The surface and pavement condition have both been scored at 2 overall in the assessment criteria.

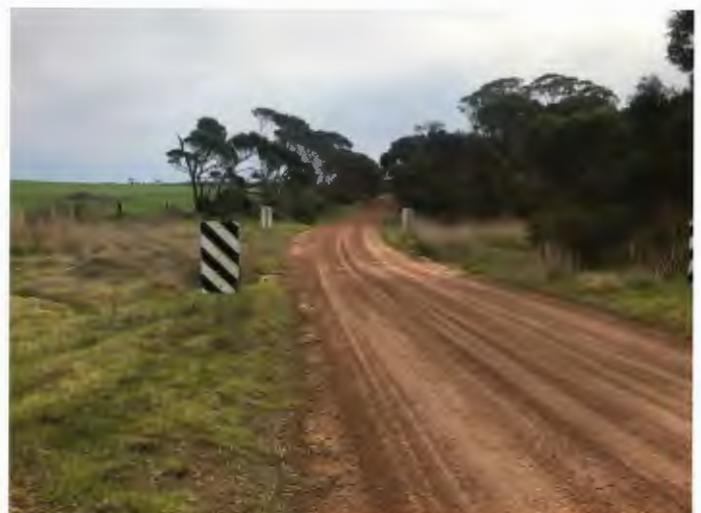
Rose Cottage Road 2 – existing FORD that would need to be upgraded

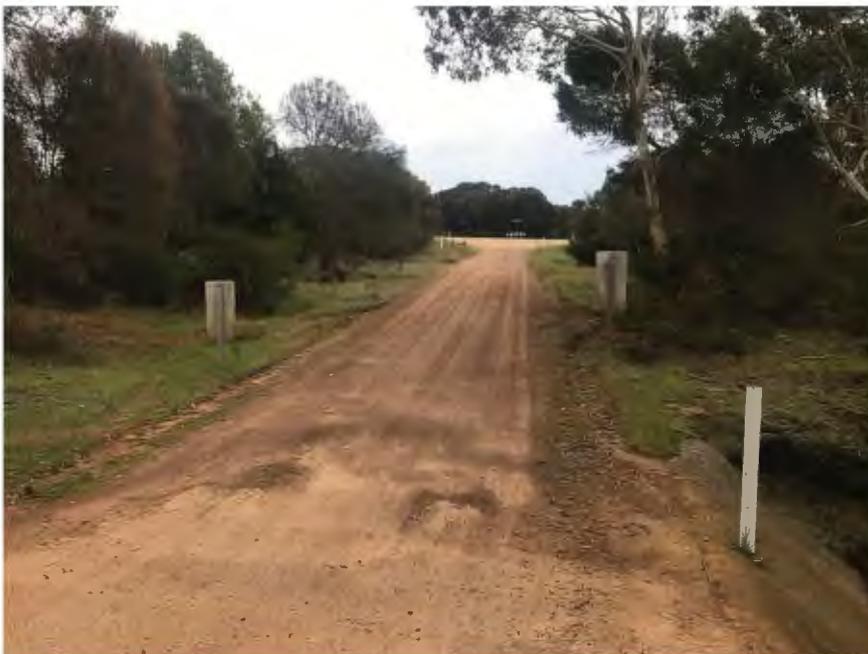
Rose Cottage Road 3 – approach to intersection with North Coast Road

meets with North Coast Road on a dip of a bend with insufficient line of sight. The intersection would need to be raised considerably but would still have limited line of sight onto North Coast Road. There is a creek crossing (FORD) 80 back from the intersection that would have to be raised and upgraded to enable laden heavy vehicles to pull up and stop safely at the intersection. The extent of works required for an intersection upgrade would impact on Glossy Black habitat and is not recommended.
