6 March 2009

## ENVIRONMENTAL SITE ASSESSMENT

# Sheep Hill Marine Port Facility Baseline Study

**Report Number:** 087661006 030 R Rev1

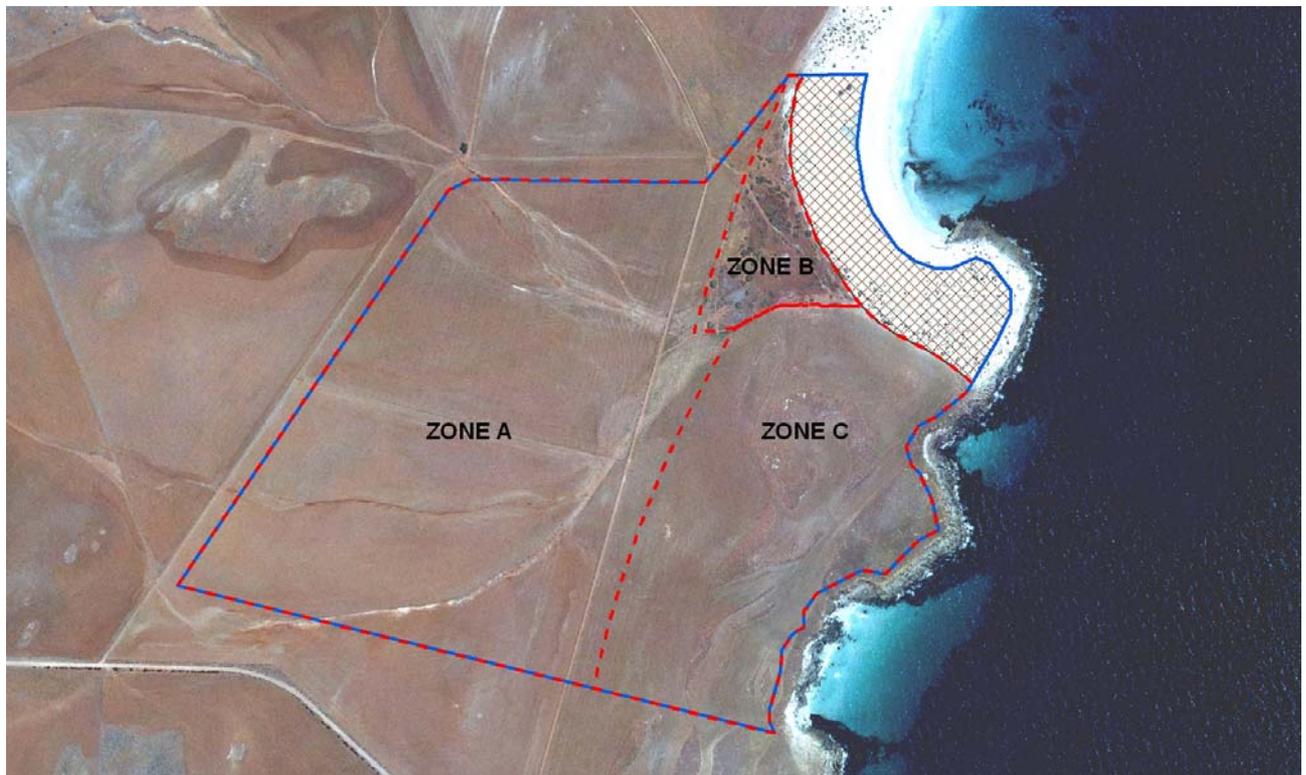
Based on our investigations, the port site may be separated into three zones, each with distinct geotechnical characteristics. The zones are shown in the figure below.

The boundaries between the zones cannot be interpreted accurately on the basis of the relatively few widely spaced test pits and boreholes placed during the investigation and hence the interzone boundaries shown on the Figure 3A must be regarded as approximate only.

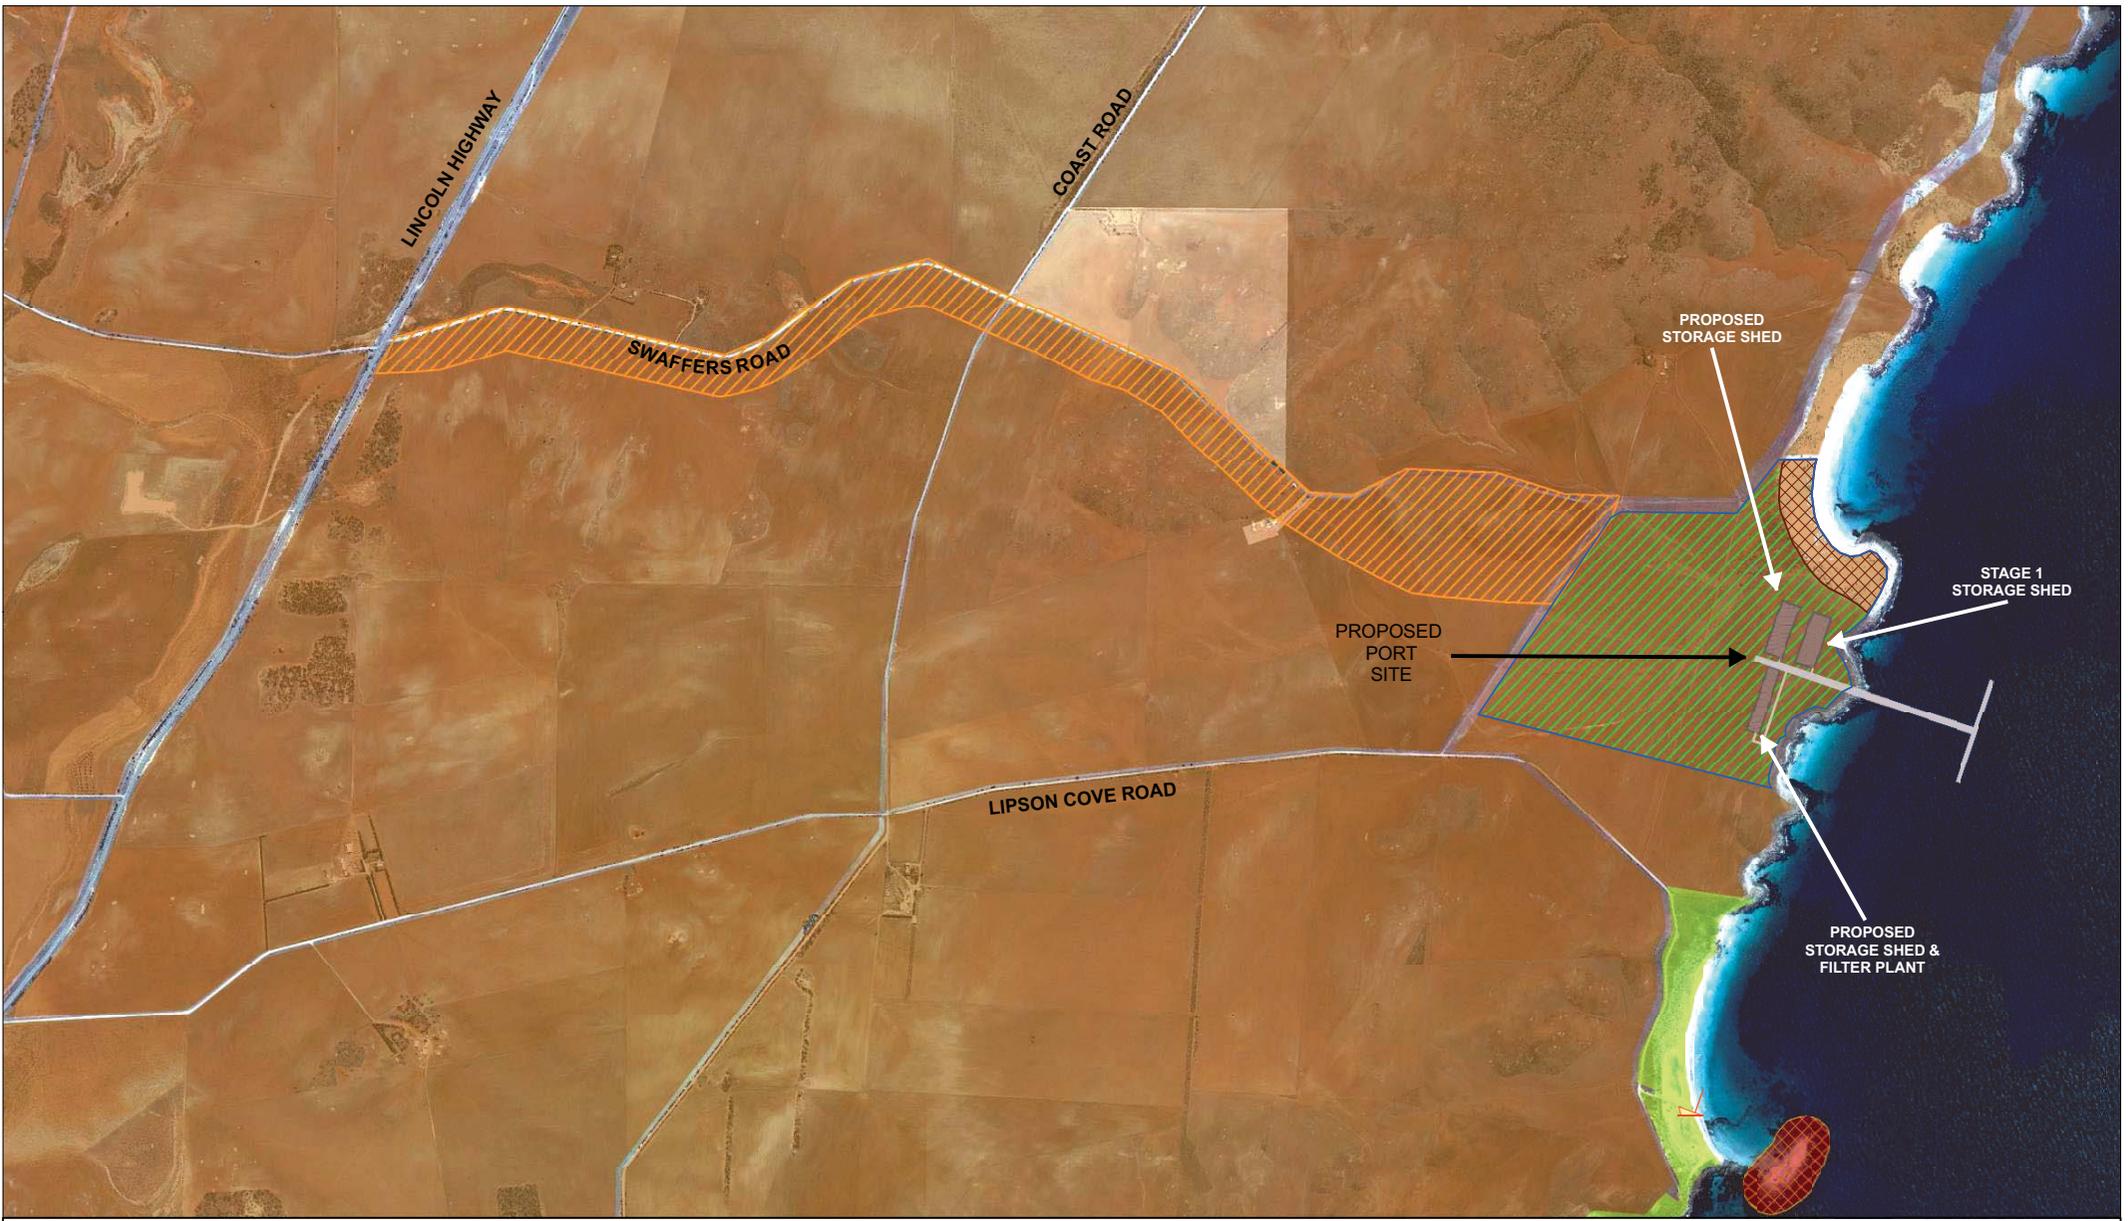
**FIGURE 4**

Concentrations reported by PIRSA in Table 2 indicated brackish to saline water regionally. The salinity, as measured by total dissolved solids (TDS, in mg/L) is presented in Figure 4. TDS ranges between the high hundreds (786 mg/L at GW05, 'freshwater') to brackish/saline water (maximum 19,500 mg/L at GW07). Considering the climate and expected low groundwater recharge, the presence of freshwater in GW05 was unexpected.

The pattern of salinity is 'normally' expected to follow the groundwater flow path in an unconfined aquifer. Salinity, in general, is expected to be low near recharge areas (where rain or surface water enters the aquifer). Salinity is expected to increase along the path. As Figure 4 indicates, salinity is low (< 1,000 mg/L) in GW05, moderate (1,000 mg/L to 10,000 mg/L) in GW01, GW02 and GW04; and high (>10,000 mg/L) in GW03, GW06, GW07 and GW08. This pattern generally follows the expectation: low salinity in GW05 and GW01; and high salinity in GW03, GW07 and GW08. The reported high salinity in GW06 is, however, a surprise as this bore is situated close to the ridge of the headland and therefore a low salinity was anticipated.

**Figure 4 – Interpreted Total Dissolved Solids in Groundwater**

The locations of these wells are shown in Figure 4. Well details are listed in Table 3.

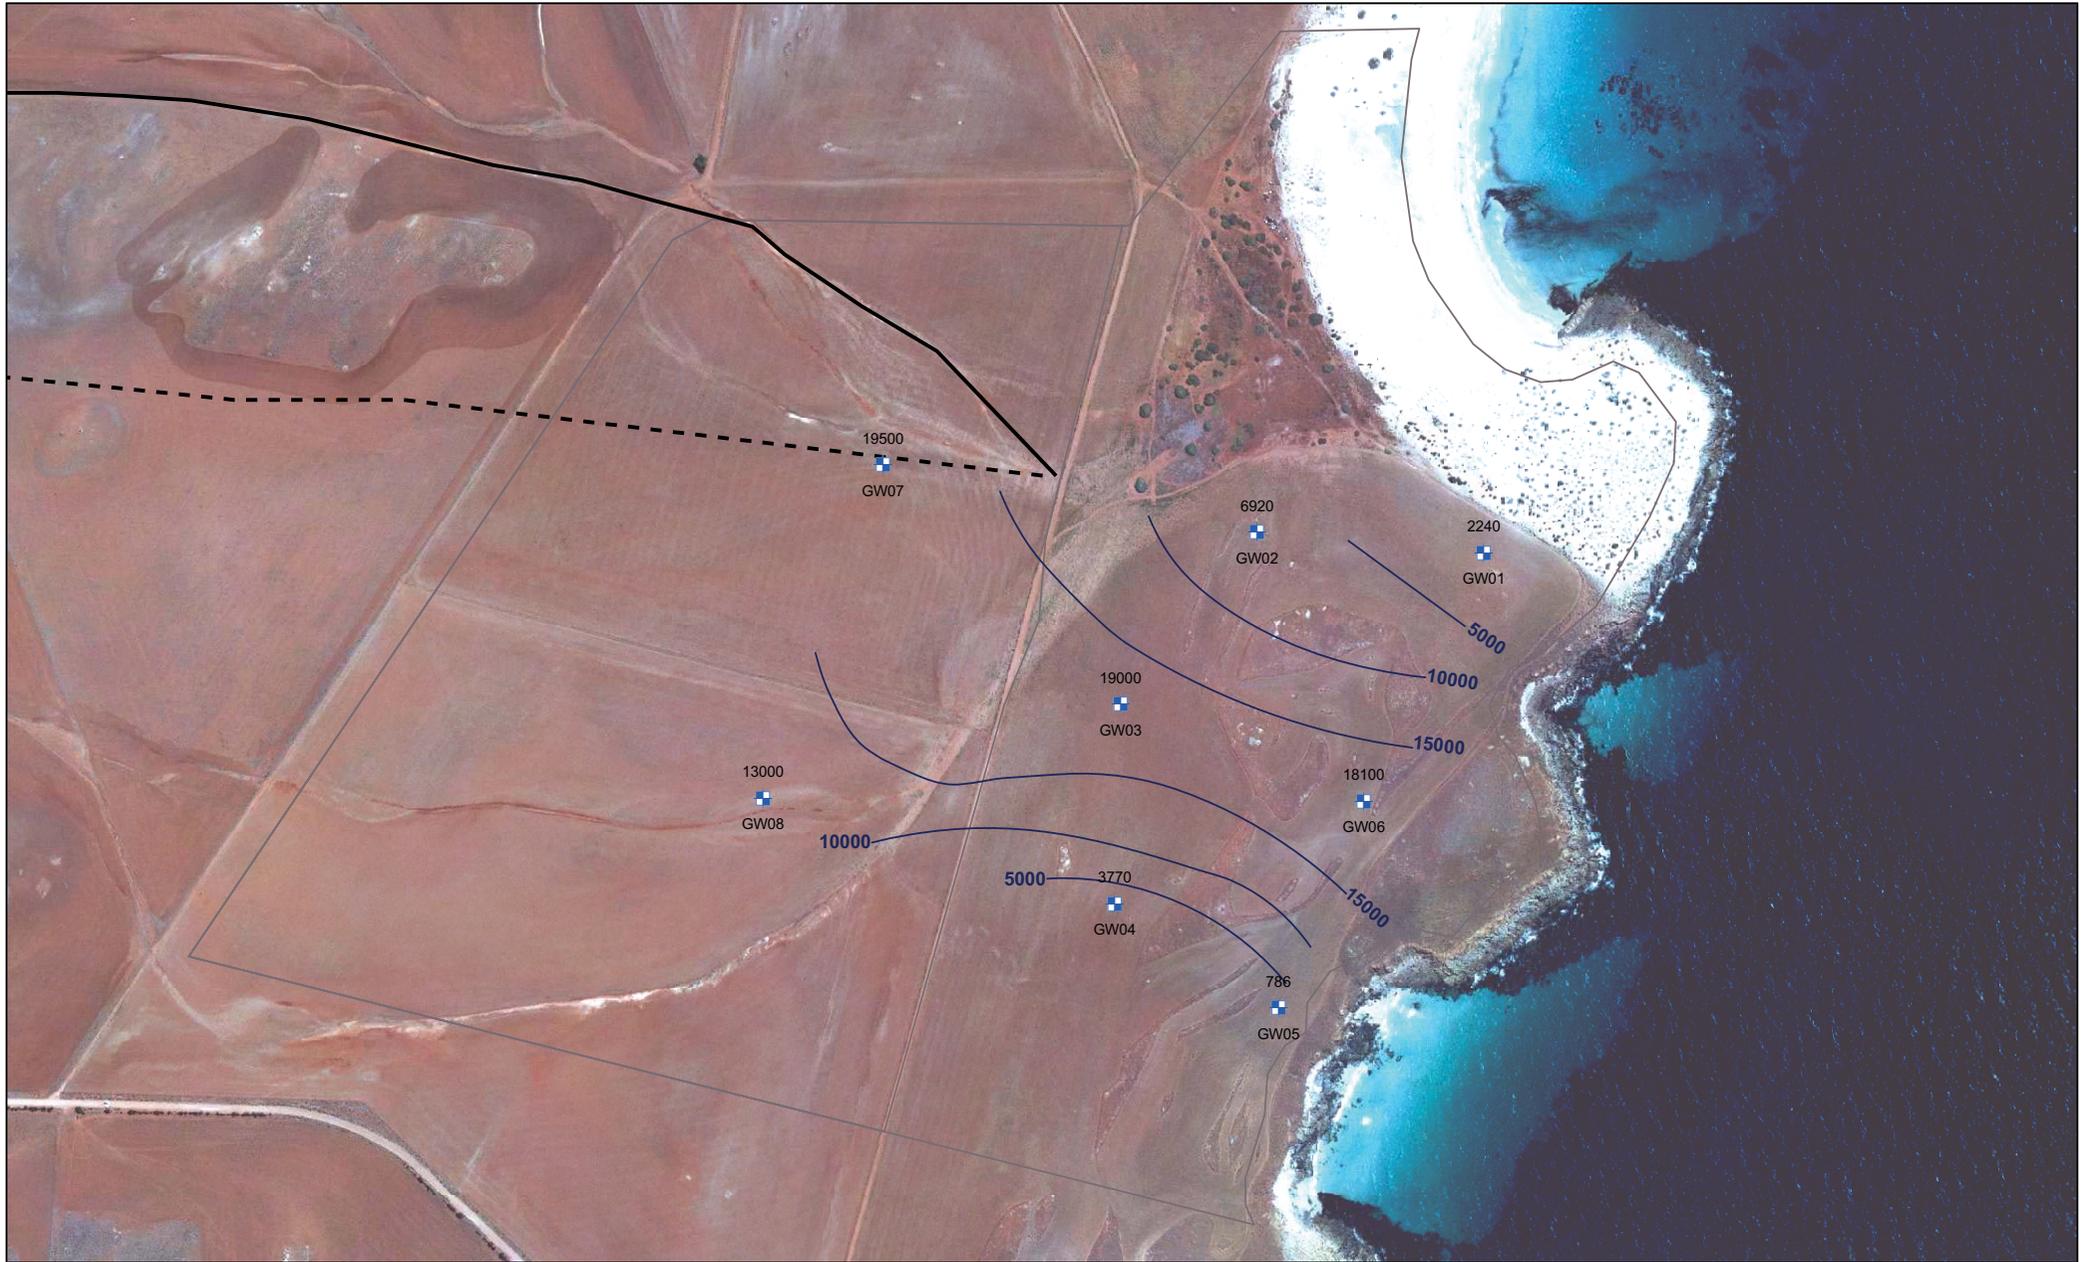
**INTERPRETED TOTAL DISSOLVED**  
**SOLIDS IN GROUNDWATER**

A single, multi-lithology (different rocks contain the groundwater) aquifer is inferred beneath the site. Groundwater is hosted in this aquifer just above mean sea level (<3 m AHD) in either fractured rocks (GW01 to GW06) or unconsolidated sediments (GW07 and GW08). The unconsolidated sediments above the fractured rocks (granite, gneiss or schist) are either a thin (few metres thick) veneer of extremely weathered rock or recent unconsolidated sediments (GW07 and GW08) approximately 10 m thick.

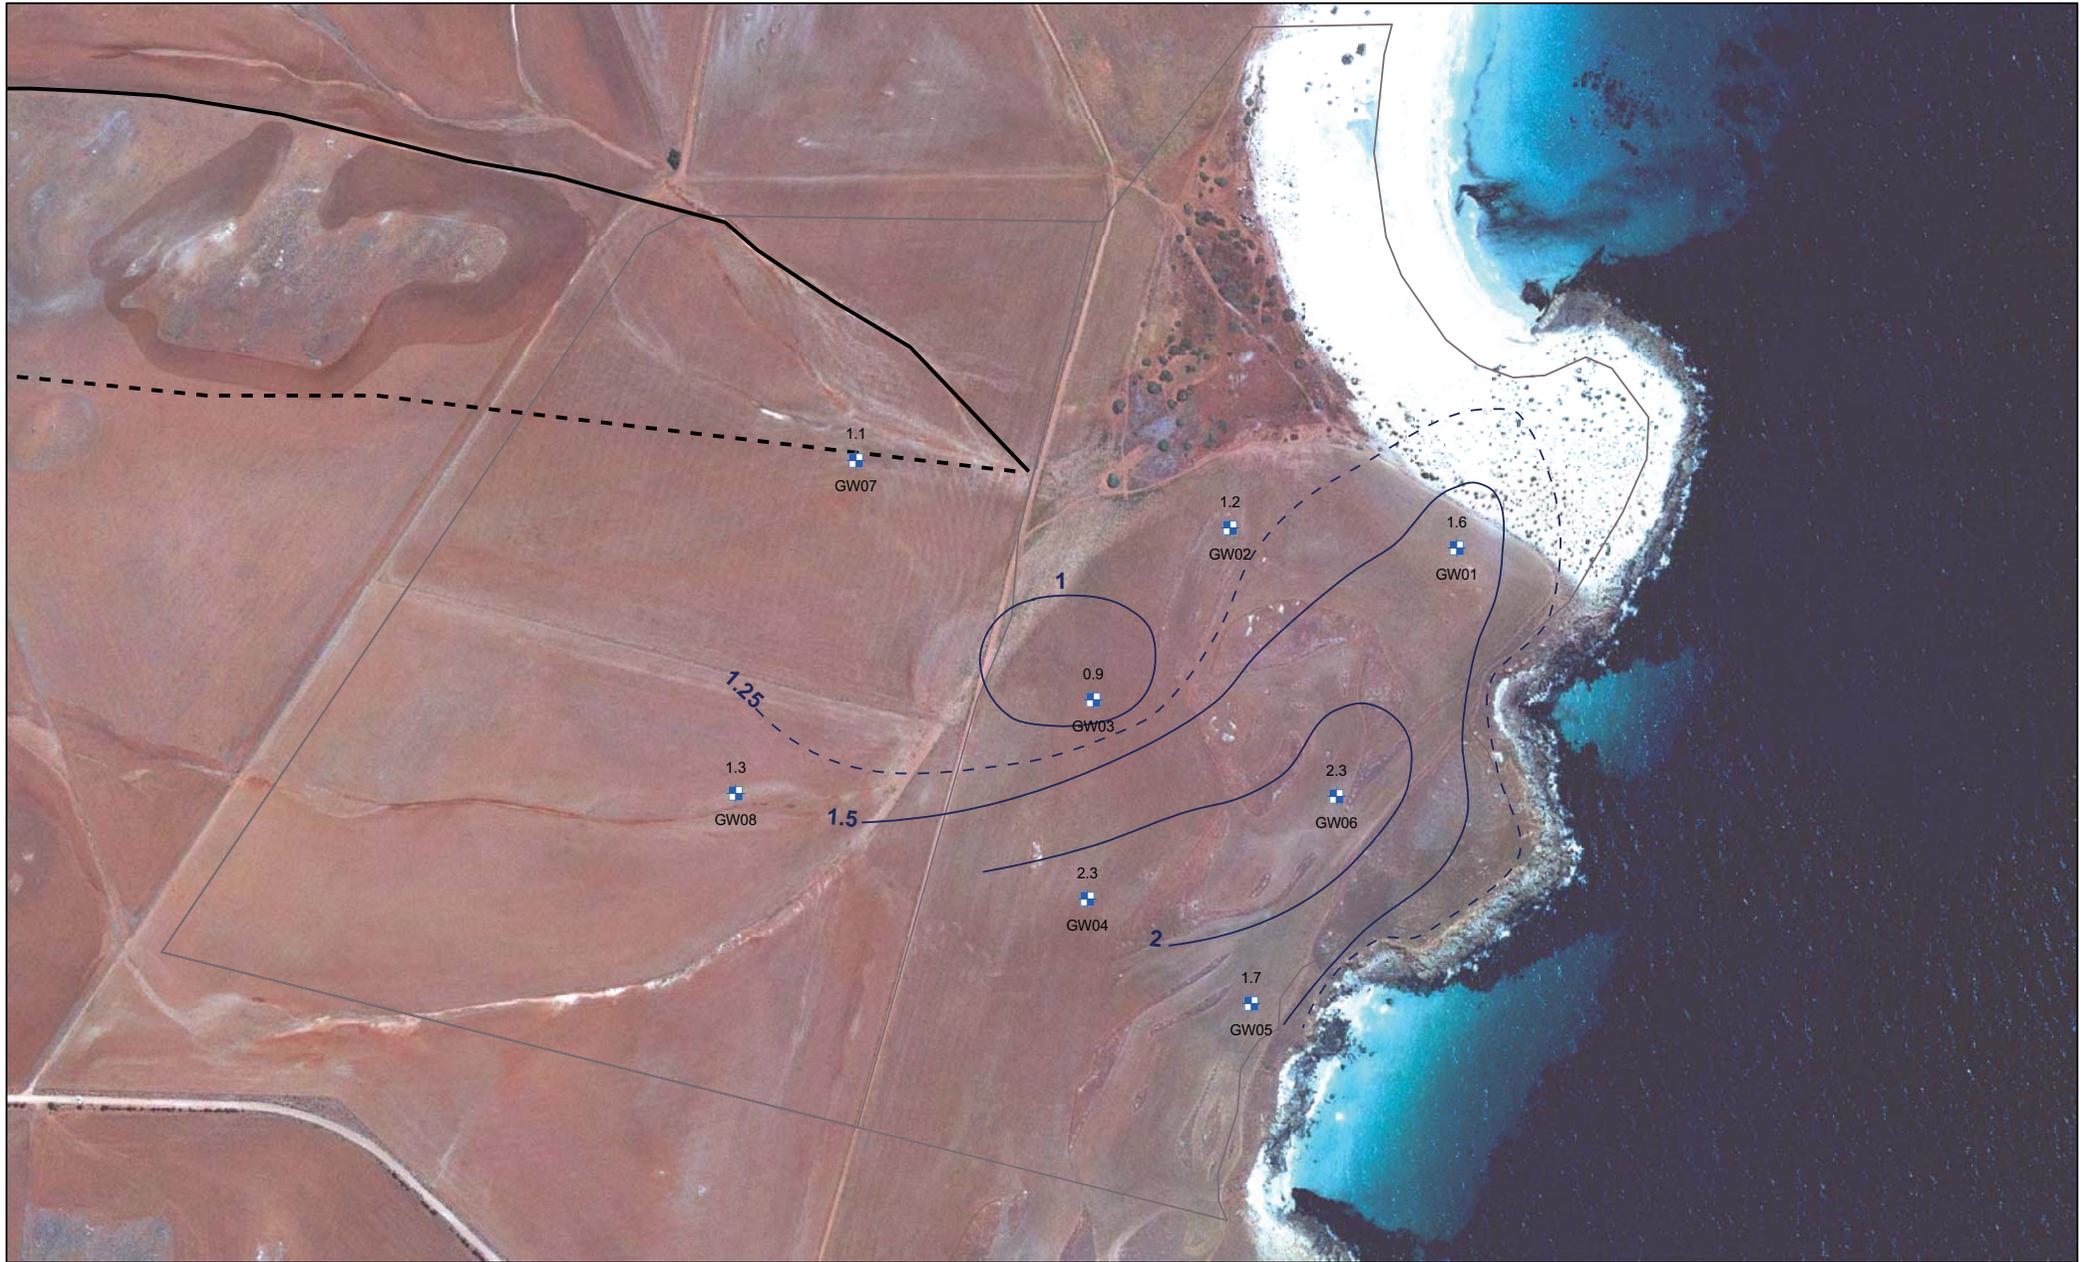
**Figure 5 – Interpreted Groundwater Elevation**

**INTERPRETED GROUNDWATER ELEVATION**

Assuming the groundwater system is isotropic, lateral groundwater movement would be perpendicular to the contours. Groundwater appears to move from a ridge (roughly following a line between GW01 to GW06) towards the east (sea), north (sandy beach to the north of the site) and west/northwest. The northwesterly flow appears to be the most significant as it connects the fractured rock environment to the sedimentary deposits. The fractured rock contains the groundwater beneath GW01 to GW06; the sediments were encountered in GW07 and GW08 and on the surface adjoining a drainage feature that terminates in a deltaic dampland. At present the dampland is separated from the sea by a sandy beach. The dampland appears to be the most likely receptor of surface water and the majority of groundwater flows. The dampland was probably an outlet to the sea under more humid conditions.
