Worker exposed to fall from height

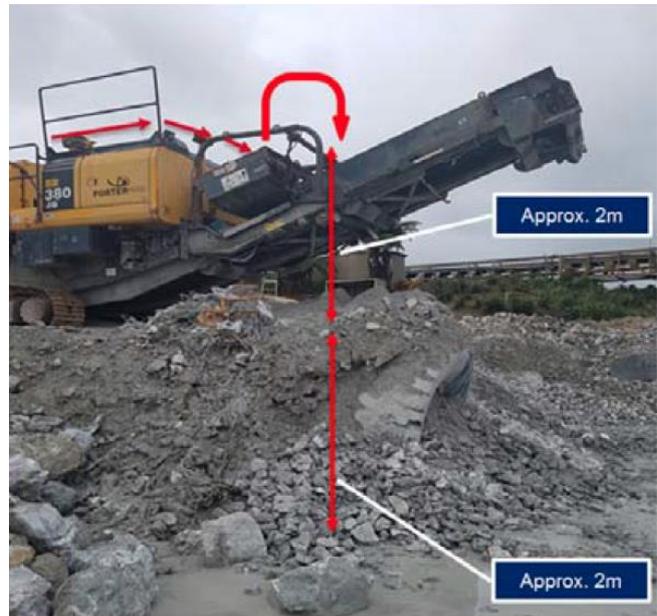
He was at the wrong angle to get good purchase on the mesh, so he stepped over the front rail of the magnet mounting frame and down on to the discharge conveyor belt where he was able to remove the mesh. The action of stepping on to the magnet and then the discharge conveyor belt exposed the operator to a potential free fall of 2 metres to ground level and then on a further 2 metres down the face of a steep crushed rock stockpile.

Indication of fall height from crusher

- **Appropriate handrails are installed on mobile plant to allow safe access when conducting pre-start inspections and normal equipment operation.**
- **Equipment compliance/safety checks are conducted on mobile equipment prior to being put into service. This will identify shortcomings in access and egress, and other safety features.**
- **Working at heights procedures and/or risk assessments are understood by all workers and are adequately supervised, and tasks observed, to ensure risk controls are in place and are effective.**
