HAZARD ALERT

Rebar impalement

March 2018

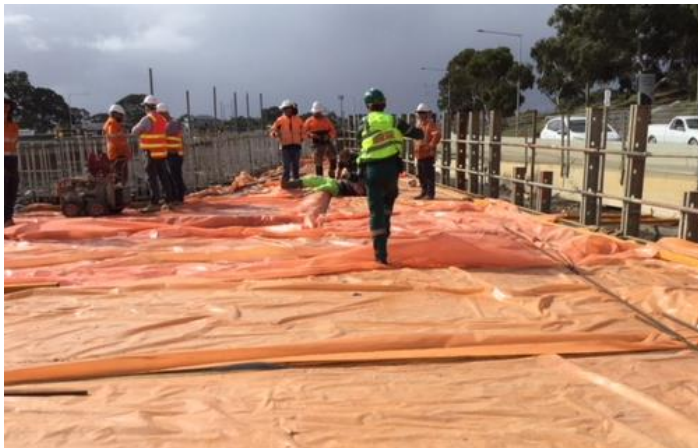
- The rebar was not visually identified and was covered by plastic sheeting contributing to the trip hazard.
- All the risks associated with this task were not identified and necessary controls were not implemented.

Plastic sheeting covering unidentified hazards underneath

- Eliminate site slip, trip and fall hazards.
- Use guardrails, screens or other means to separate workers from the exposed rebars.
- Place boards over the rebar to walk on.
- Ensure rebar caps are designed to provide impalement protection and are the correct size. Standard mushroom rebar caps and/or covers are visual warnings only in preventing cuts, abrasions or other minor injuries.
- Replace rebar caps where there is the possibility of degradation from exposure to direct sunlight.

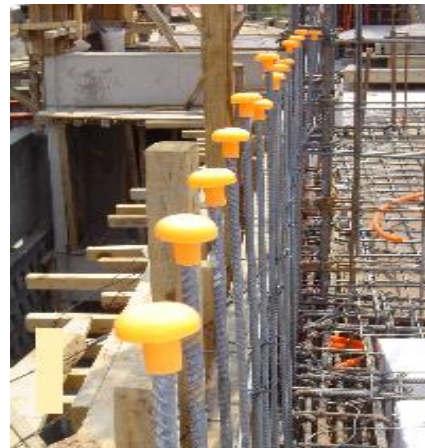
Use correct fitting rebar caps
