Road Structures Inspection Manual

Part 4A: Condition State Guidelines and Photographs

Bridges

RAS Document No: RAMA-ST-PRC-048
Knet Document No: 14888945
Document version: 1.3 (08/05/2020)

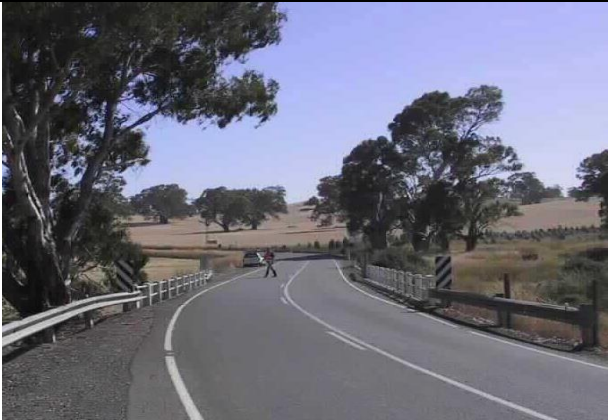
<p>10 - Bridge approach – other</p> <p>This component defines the carriageway immediately behind the abutments, and includes such items as settlement of and the traffic surface on the pavement and approach slabs if any, and transition from the approach to the bridge surface.</p> <p>Where a concrete approach slab is visible and able to be inspected, this shall be considered under Component 4C. This would only usually occur in conjunction with a concrete roadway (e.g. Northern Connector).</p>	<p>Units</p> <p>Each</p>
<p>Condition state 1 -Description</p> <ul style="list-style-type: none"> • The transition between the road and bridge is smooth with no level difference, rutting, bumps, depressions cracking or potholes. • Approach slabs are in good condition and have not settled. 	<p>Photo</p>

<p>Smooth, constant approach to bridge</p>
<p>Condition state 2 -Description</p> <ul style="list-style-type: none"> • The approaches may have settled slightly but the transition is generally smooth with minor rutting, bumps, depressions, potholes or some minor cracking due to embankment movement. • Settling approach slabs have caused a small height difference and opened up the abutment expansion joint slightly. 	<p>Photo</p>

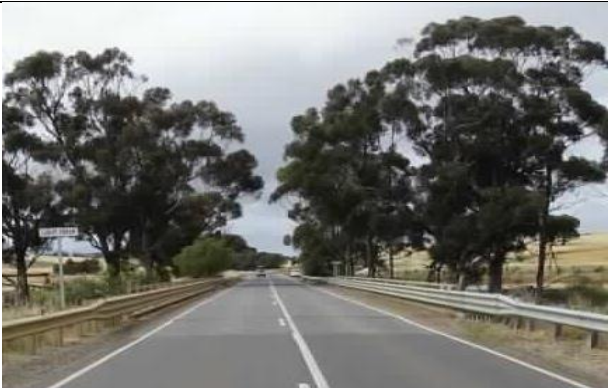
<p>Minor settlement at approach</p>

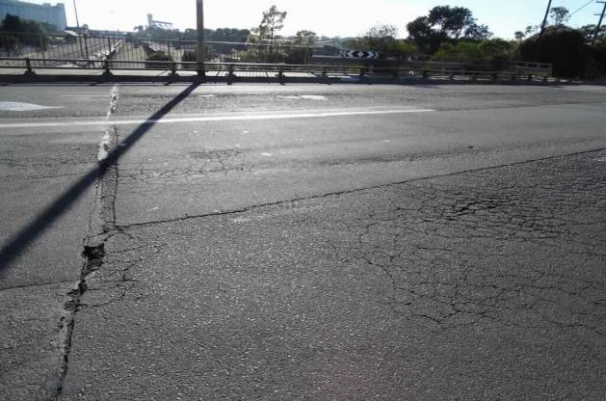
<p>Condition state 3 -Description</p> <ul style="list-style-type: none"> • Settlement of approaches is advancing with moderate level difference within 1m of the bridge. • Rutting, bumps, depressions or potholes are starting to affect the rideability and transition onto the bridge. • Approach slabs have continued to settle and started to rotate causing an opening of the abutment expansion joints but without failure of the joint. 	<p>Photo</p>

<p>Settlement of approach with cracking and potholes beginning to occur</p>
<p>Condition state 4 -Description</p> <ul style="list-style-type: none"> • Settlement of approaches has advanced further with significant level difference within 1m of the bridge. • Rutting, bumps, depressions or potholes are affecting the rideability and transition onto the bridge. • Approach slabs may have settled substantially and rotated causing a further opening of the abutment expansion joints with joint starting to show signs of failure. 	<p>Photo</p>

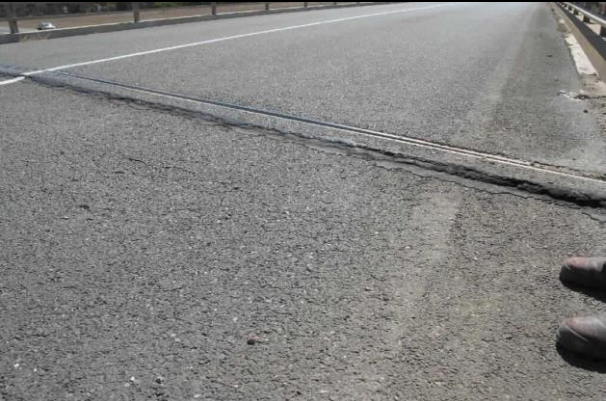
<p>Significant settlement of approach carriageway</p>

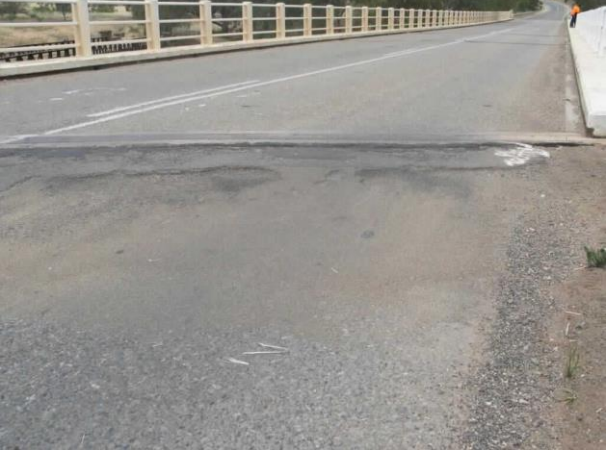
<p>Condition state 5 -Description</p> <ul style="list-style-type: none"> • Settlement of the approaches is pronounced with substantial level difference within 1m of the bridge. • The approaches may also have rutting, bumps, depressions or potholes affecting the rideability and transition onto the bridge. • Approach slabs may have settled dramatically causing rotation at the abutment expansion joint sufficient to cause total failure of the joint. 	<p>Photo</p>

<p>Severe drop and rutting in the wheel path on bridge approach.</p>

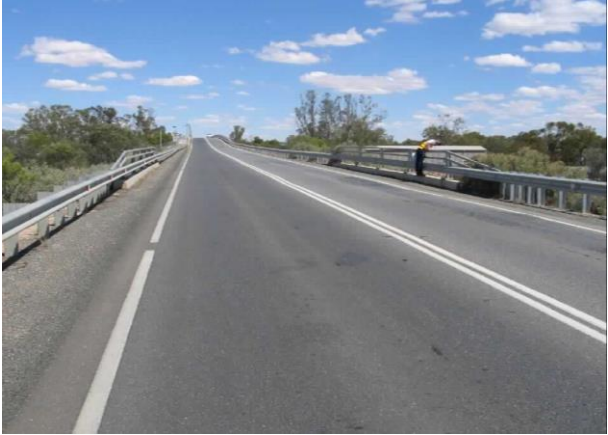
<p>20 - Bridge approach road – other</p> <p>This component defines the carriageway immediately behind the abutments, and includes such items as the delineation of the bridge approach including linemarking, reflectors and signs.</p>		<p>Units</p> <p>Each</p>
<p>Condition state 1 -Description</p> <ul style="list-style-type: none"> All bridge delineation (signs, reflectors and linemarking) are in good condition 	<p>Photo</p>

<p>All delineation in very good condition</p>	
<p>Condition state 2 -Description</p> <ul style="list-style-type: none"> All bridge delineation (signs, reflectors and linemarking) are generally in good condition although some minor deterioration may be present 	<p>Photo</p>

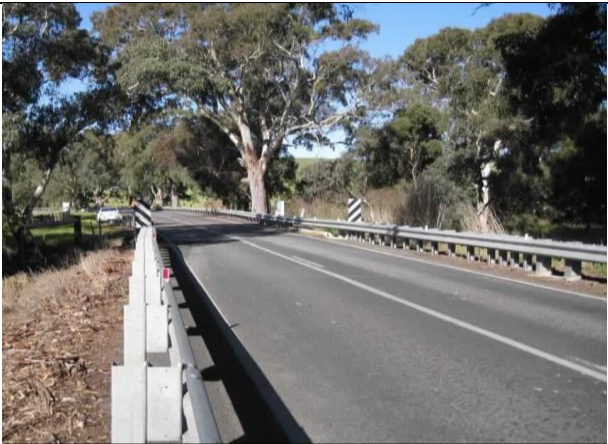
<p>Approach delineation in good condition</p>	
<p>Condition state 3 -Description</p> <ul style="list-style-type: none"> Bridge delineation generally in sound condition, although moderate deterioration may be present. Signs and reflectors in fair condition only. Some fading may be apparent. Linemarking is wearing so that lines are starting to fade. 	<p>Photo</p>

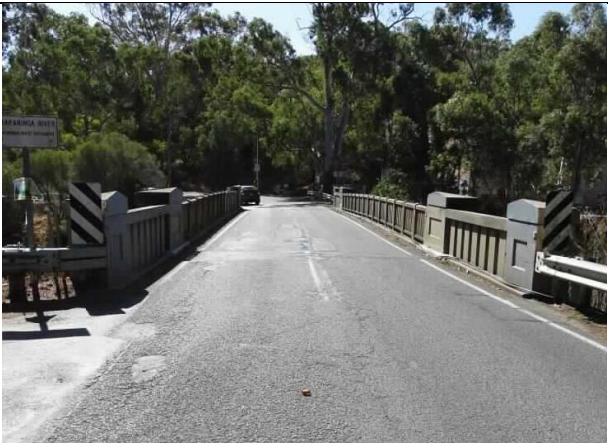
<p>Linemarking has started to fade</p>

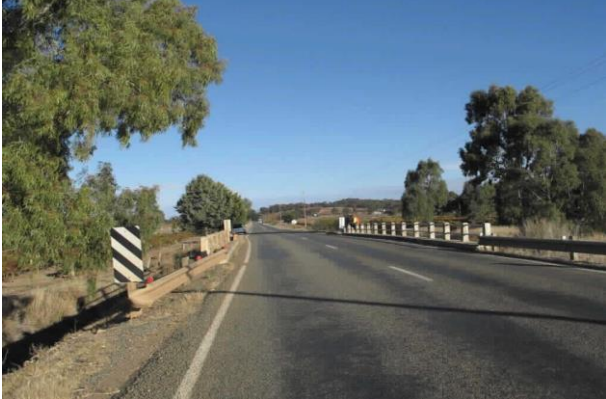
Condition state 4 -Description	Photo
<ul style="list-style-type: none"> • Width markers / hazard boards installed at incorrect places. • Linemarking has worn to the extent that lines have faded and may be starting to lose reflectivity.

<p data-bbox="791 598 1347 651">Width markers at wrong place, should be at bridge corners</p>
Condition state 5 -Description	Photo
<ul style="list-style-type: none"> • Sighter posts missing. • Width markers / hazard boards missing. • Linemarking does not exist or has almost totally faded and has completely lost reflectivity.

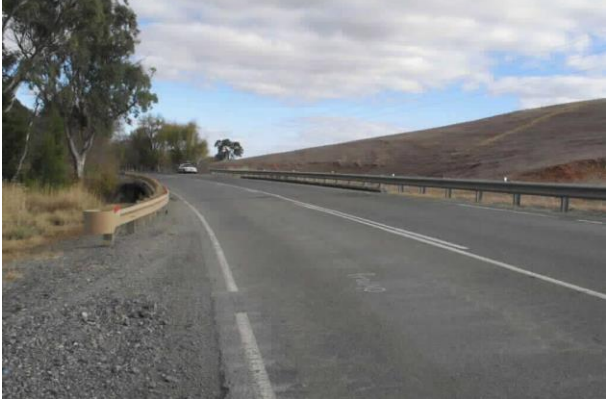
<p data-bbox="791 1099 1043 1131">Width markers missing</p>

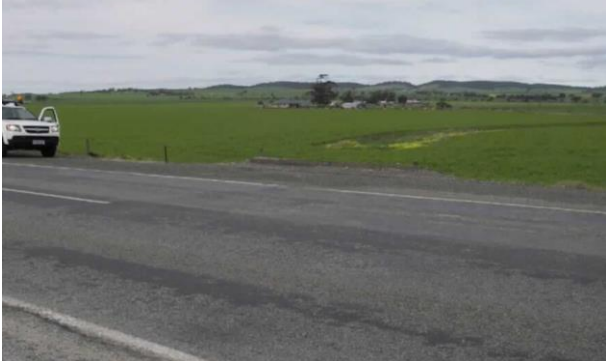
<p data-bbox="791 1503 1267 1534">Sighter posts missing above edge of culvert</p>

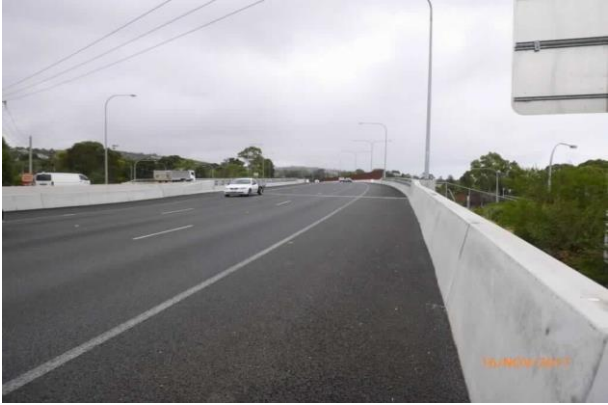
<p>3C - Bridge approach barriers – concrete (precast or cast in-situ)</p> <p>This component defines all types and shapes of approach barrier where the principal component is concrete (this may be cast-in-situ concrete OR precast concrete units) leading up to the bridge and / or bridge railing.</p> <p>The length of the approach barrier is at the discretion of the Inspector but generally should be no more than 20 m.</p>		<p>Units</p> <p>Linear metres</p>
<p>Condition state 1 -Description</p>		
<ul style="list-style-type: none"> The approach barrier is in good condition with no accident damage, and is well connected to the bridge endpost or railing. 	<p>Photo</p>

<p>Precast concrete barrier on the bridge approaches, in good condition</p>	
<p>Condition state 2 -Description</p>		
<ul style="list-style-type: none"> The approach barrier is generally in good condition with only minor cracking, spalling or minor accident damage having no effect on the serviceability of the railing or connections to the endpost or bridge railing. 	<p>Photo</p>

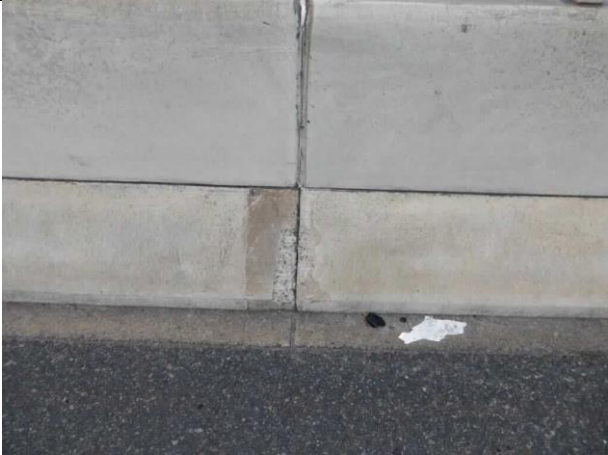
<p>Minor spalling in previously repaired barrier wall section</p>

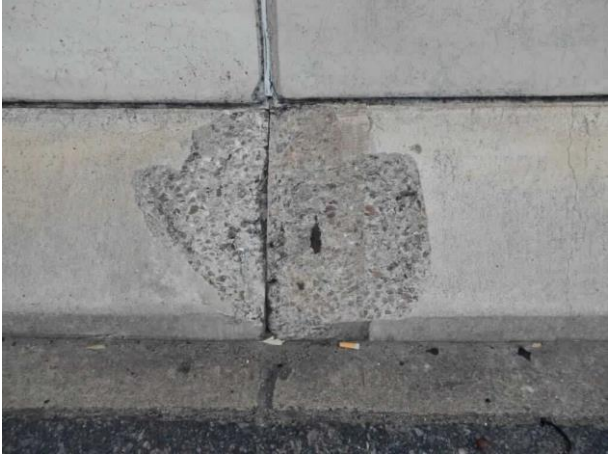
<p>Condition state 3 -Description</p> <ul style="list-style-type: none"> The approach barrier is in fair condition and may have some moderate cracking, spalling or minor accident damage having no effect on the serviceability of the railing or connections to the endpost or bridge railing. 	<p>Photo</p>

<p>Moderate spalling of barrier wall</p>
<p>Condition state 4 -Description</p> <ul style="list-style-type: none"> The approach barrier may have moderate accident damage or has medium cracking or spalling which may have a minor effect on its serviceability or connection to the endpost or bridge railing. The approach barrier may be in good condition but is not connected to the endposts and is a potential hazard. 	<p>Photo</p> <p>Not available</p>
<p>Condition state 5 -Description</p> <ul style="list-style-type: none"> The approach barrier has heavy cracking or spalling, severe accident damage, has lost the connections or is unconnected to the endpost, or has moved relative to the endpost and is a hazard to any errant vehicle. 	<p>Photo</p> <p>Not available</p>

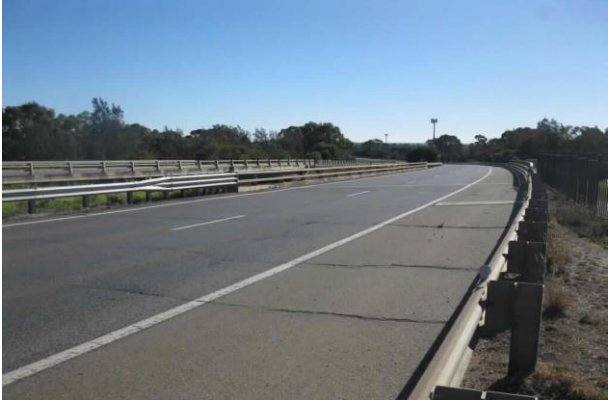
<h3>3S - Bridge approach barriers – steel</h3> <p>This component defines the approach guardrail leading up to the bridge endposts and/or bridge railing. Also included in this component are the posts and endposts, which support the railing.</p> <th data-bbox="1252 159 1422 376"> Units Linear metres </th>		Units Linear metres
Condition state 1 -Description <ul style="list-style-type: none"> The approach railing is in good condition with no accident damage, and is well connected to the endpost or bridge railing. 	Photo

<p>Approach guardrail in good condition and well attached to strengthening railing on bridge</p>	
Condition state 2 -Description <ul style="list-style-type: none"> The approach guardrail is generally in good condition with only minor rusting and/or minor accident damage. The railing is well connected to the endposts or bridge railing and has sufficient strength, i.e. posts closer than 2½m centres. 	Photo

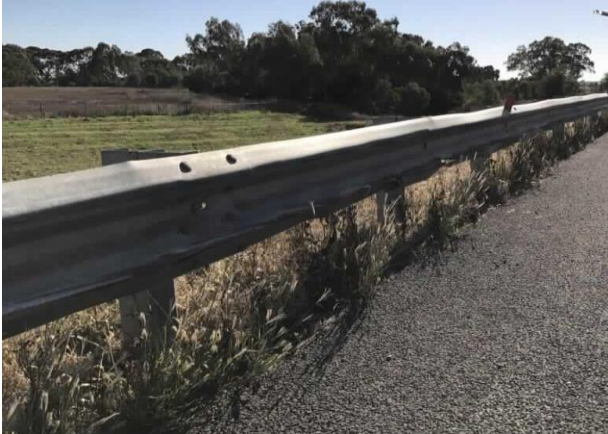
<p>Steel approach guardrail hit but still functioning.</p>

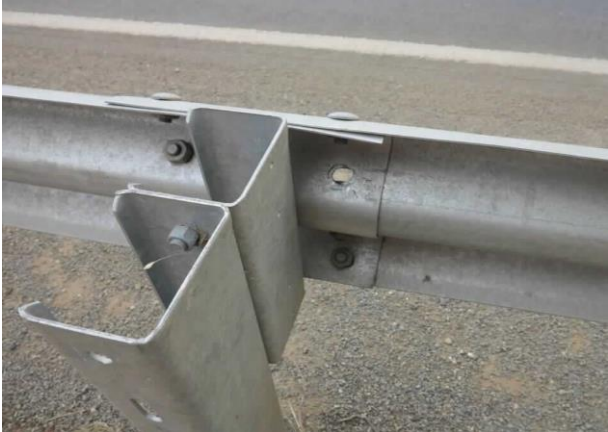
Condition state 3 -Description	Photo
<ul style="list-style-type: none"> • The approach guardrail is in fair condition with moderate rusting and/or minor accident damage. • The railing is well connected to the endposts or bridge railing and has sufficient strength, i.e. posts closer than 2½m centres.

<p data-bbox="791 629 1316 656">Missing bolt on approach barrier railing support</p>
Condition state 4 -Description	Photo
<ul style="list-style-type: none"> • The approach guardrail may be moderately damaged due to vehicular impact or the guardrail is poorly or not connected to the endposts but have sufficient strength with posts not greater than 2½m spacings. • The guardrail may be heavily rusted or may be connected to the endposts but have insufficient strength with post spacings greater than 2½m centres.

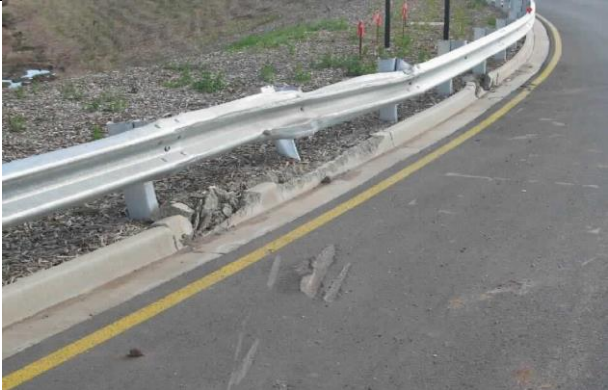
<p data-bbox="791 1084 976 1111">Damaged barrier</p>

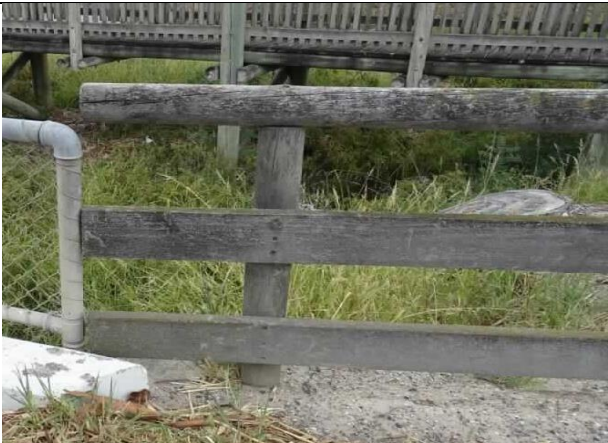
<h3>3T - Bridge approach barriers – timber</h3> <p>This component defines the timber approach barrier leading up to the bridge endposts and/or bridge railing.</p>		<p>Units</p> <p>Linear metres</p>
<p>Condition state 1 -Description</p> <ul style="list-style-type: none"> • The component shows only minor deterioration and all the bolting is tight. • No accident damage is visible. 	<p>Photo</p>

<p>Timber barrier in good condition</p>	
<p>Condition state 2 -Description</p> <ul style="list-style-type: none"> • The component shows signs of minor decay, splitting or cracking but does not affect the strength or serviceability. • Bolting of the posts and rails is generally tight. • Accident damage is only minor with no effect on strength or serviceability. 	<p>Photo</p>

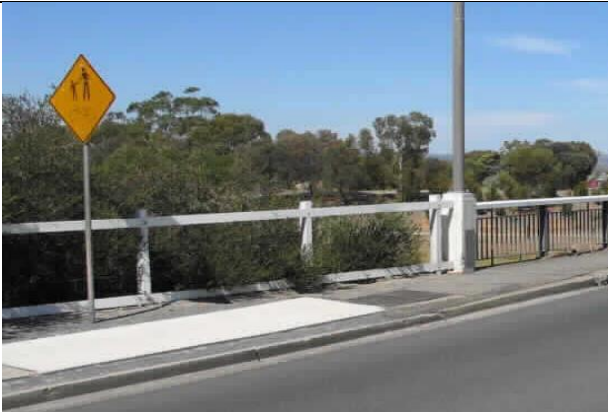
<p>Minor deterioration only</p>

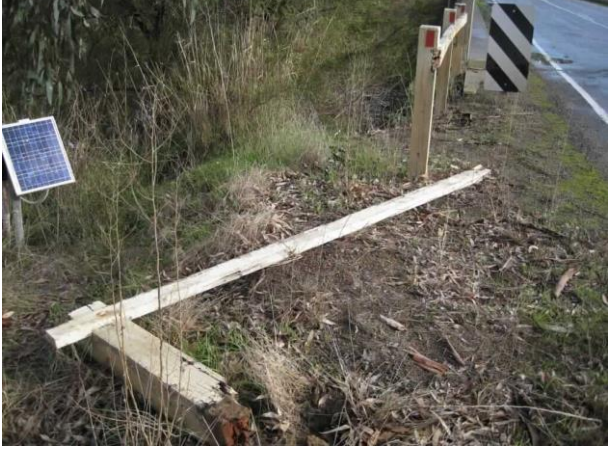
<p>Condition state 3 -Description</p> <ul style="list-style-type: none"> • Moderate decay, splitting cracking or crushing may be present affecting the strength and serviceability of the railing to a minor extent. • Bolting may be starting to loosen in a number of areas. • Accident damage may have a minor effect on the strength or serviceability of the railing. 	<p>Photo</p>   <p>Moderate rotting of rail</p>
<p>Condition state 4 -Description</p> <ul style="list-style-type: none"> • Significant decay, splitting cracking or crushing may be present affecting the strength and serviceability of the railing to a moderate extent. • Bolting may be loose in a number of areas. • Accident damage may have a moderate effect on the strength or serviceability of the railing. 	<p>Photo</p>   <p>Bottom rail missing</p>
<p>Condition state 5 -Description</p> <ul style="list-style-type: none"> • Severe decay splitting cracking or crushing may be present affecting the strength and serviceability of the railing. • Bolting may be quite loose affecting the strength of the railing. • Accident damage is major affecting the serviceability of the railing. 	<p>Photo</p>

<p>Broken approach barrier due to termite attack</p>

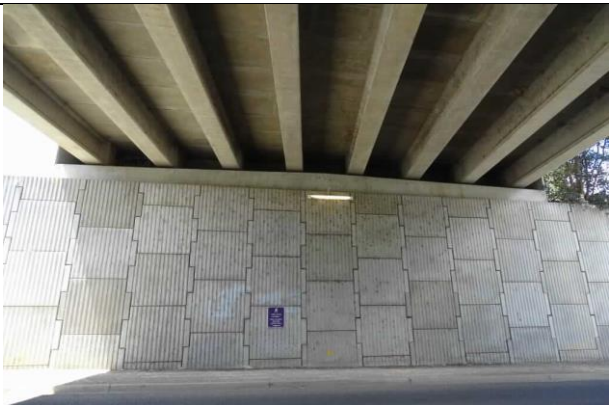
5P - Abutments – precast concrete		Units m² of exposed surface area
<p>This component describes all precast concrete abutments or precast concrete components used in abutments. Included in this component are precast RC sheeting planks, precast RC earth retaining slabs, precast RC facing panels for reinforced earth walls (including cast-in-situ sill or ground beam on top), precast RC crib walls (including sill or ground beam on top), and precast RC crossheads where the crossheads are at ground or top of batter level. Where the crossheads are well above the ground level (height exceeding 1.0 m) with embankment supporting walls below, the crossheads shall be considered under Component 19.</p> <p>Reinforced Earth walls are covered by Component No 8P. Wingwalls and retaining walls are covered by Component No 9P.</p>		
Condition state 1 -Description	Photo	
<ul style="list-style-type: none"> The units are in good condition with only minor fine cracking of no consequence. There should be no settlement of units or gaps between units allowing loss of embankment fill to occur. Where units form retaining walls, they must be securely positioned and have no bulging due to earth pressure.

<p>Precast reinforced earth panels in good condition with no cracking, spalling, settlement or bulging</p>

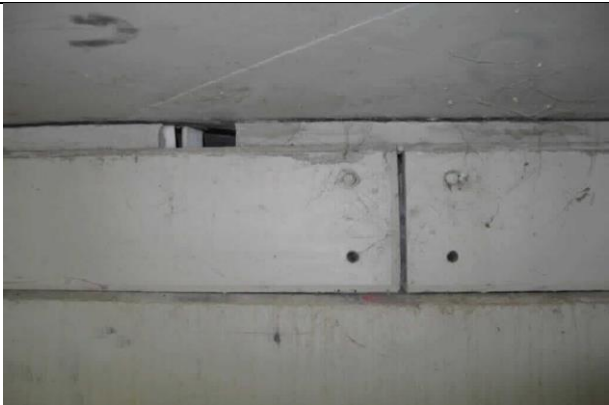
Condition state 2 -Description	Photo	
<ul style="list-style-type: none"> There may be fine cracking or minor spalling of the units due to corroding reinforcement or earth pressure. There may be minor bulging or settlement of units but allowing only minor loss of embankment fill from behind.

<p>Precast slab in abutment wall with panel bolts missing and minor spalling</p>

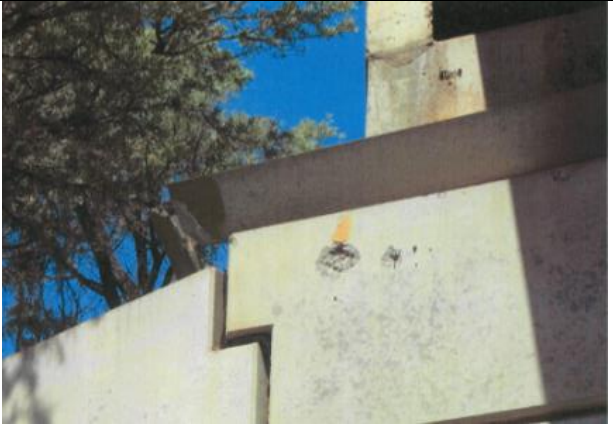
<p>Minor spalling on precast RC facing panel</p>
<p>Condition state 3 -Description</p>	<p>Photo</p>
<ul style="list-style-type: none"> • There may be minor cracking or moderate spalling of the units due to corroding reinforcement or earth pressure. • There may be moderate bulging or settlement of units allowing minor loss of embankment fill from behind.

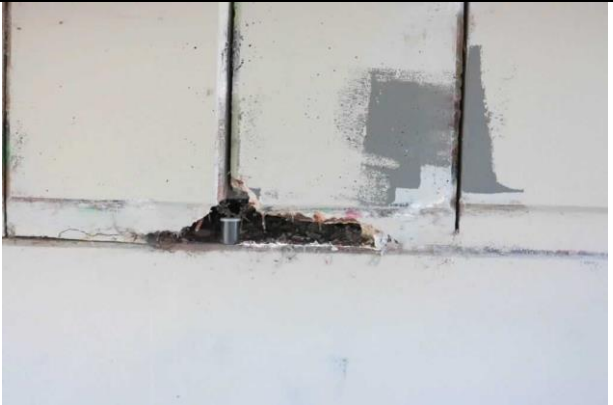
<p>Spalling to precast concrete panel</p>
<p>Condition state 4 -Description</p>	<p>Photo</p>
<ul style="list-style-type: none"> • There may be moderate cracking or spalling of the units due to corroding reinforcement or earth pressures. • Moderate bulging, settlement or separation of units may be allowing medium loss of the embankment fill.

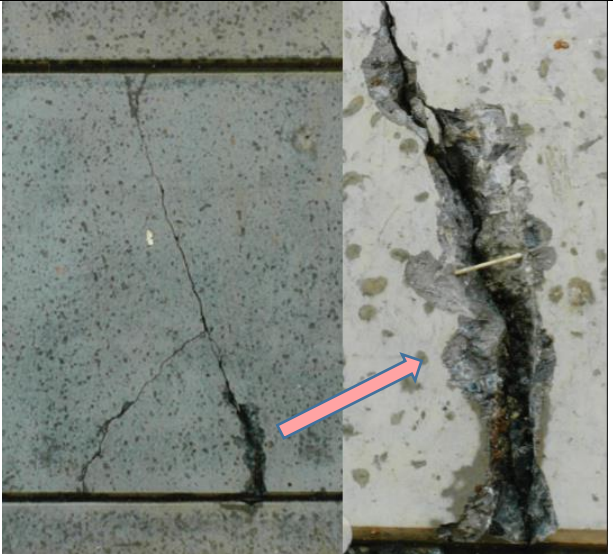
<p>Moderate cracking and spalling in RC facing panel</p>

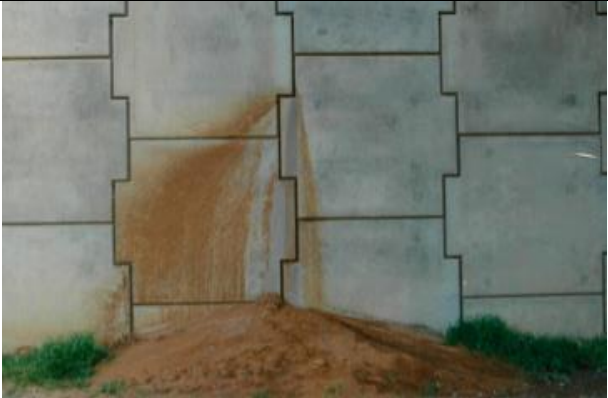
<p>Medium loss of embankment fill</p>
<p>Condition state 5 -Description</p> <ul style="list-style-type: none">• Severe cracking and spalling of the units may be occurring due to reinforcement corrosion or earth pressure.• Excessive bulging, settlement or separation of the units may be allowing heavy loss of embankment fill.	<p>Photo</p>

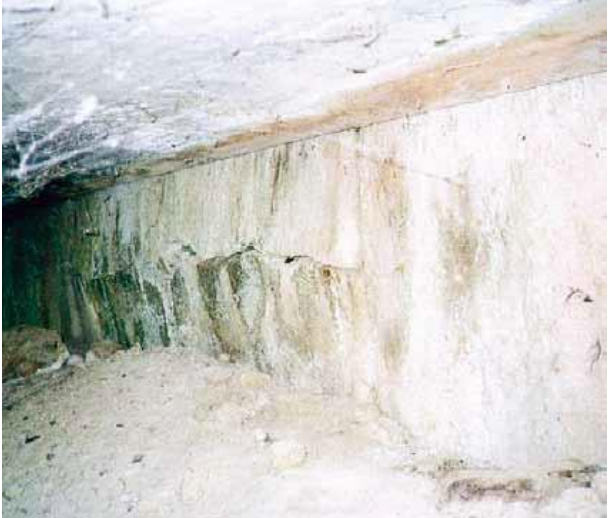
<p>Severely cracked and heavily bulged precast retaining slab (VicRoads)</p>

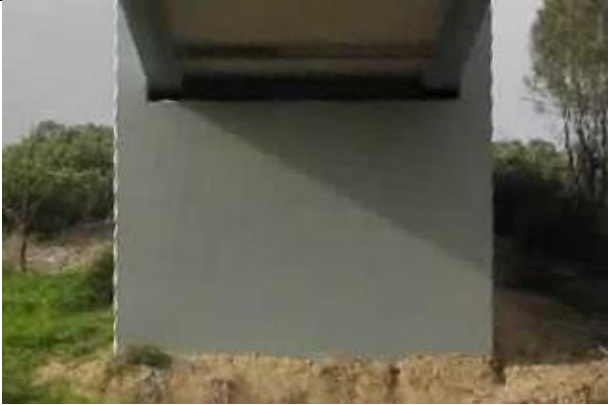
5C - Abutments – cast in-situ concrete This item includes all abutments constructed of cast in-situ concrete and includes the short integral return walls which support the barrier end posts or terminals, ballast walls and side keeper walls. Where the crossheads are well above the ground level or batter level (height exceeding 1.0m) the crossheads should be considered under Component 19. Wingwalls, whether integral, attached or independent, are considered separately as part of Component No. 9. Damage to seating areas caused by faulty bearings is covered under the bearing items.		Units m² of exposed surface area
Condition state 1 -Description <ul style="list-style-type: none"> • The abutment and ballast walls are in good condition with only minor cracking due to corroding reinforcement. • There is no flexural cracking due to earth pressures or differential settlement of foundations. • Crossheads are reasonably dry and clean. • No movement of abutment should be discernible; that is, bearings shearing towards ballast wall or subsidence of the road surface behind the abutment. 	Photo

Abutment wall in good condition

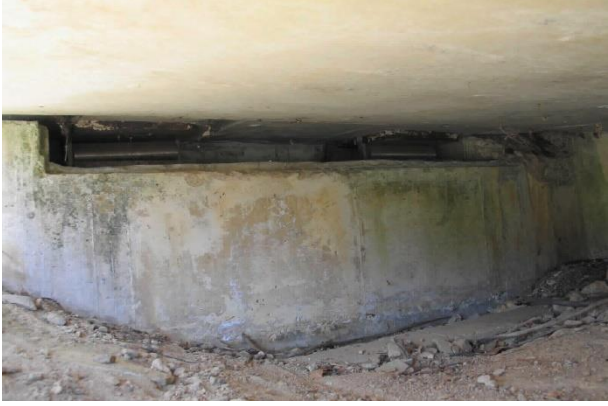
Condition state 2 -Description <ul style="list-style-type: none"> • The abutment wall may have minor cracking and spalling due to corroding reinforcement, earth pressure, beam friction on differential movements. • Crossheads should be reasonably clean and dry. Minor movement of the wall may have occurred. Crossheads may have fine moment, ASR or shear cracking. • The ballast wall may be cracked or spalled as a result of earth pressure, girders bearing on it or corrosion of reinforcement. Minor subsidence of the road surface may be evident behind the abutment. 	Photo

Spalling of abutment wall, no obvious change and no reinforcement visible

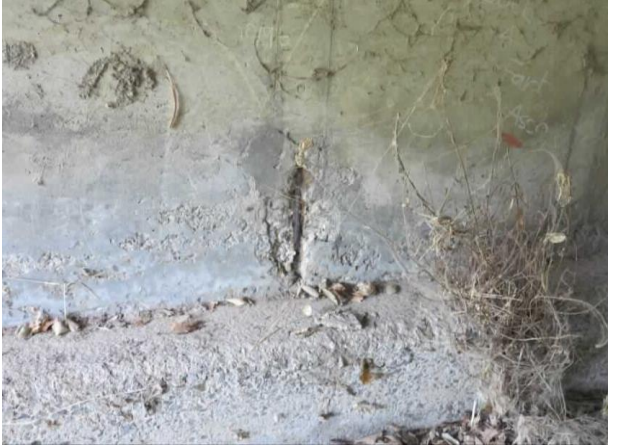
<p>Condition state 3 -Description</p> <ul style="list-style-type: none"> • Moderate cracking and spalling may be visible due to earth pressure, beam friction, edge bearing or differential movements. • Reinforcement may be corroded, with minor loss of section and associated moderate to severe cracking, spalling and delamination of concrete. • Crossheads may be damp but there is no heavy staining or evidence of water being retained on the shelf. Moderate movement of the abutment. Crossheads may have medium ASR or moment cracks or fine shear cracks. • The ballast wall may be moderately cracked or spalled. The road surface behind the bridge has moderate subsidence. 	<p>Photo</p>

<p>Spalling and exposed reinforcement</p>
<p>Condition state 4 -Description</p> <ul style="list-style-type: none"> • More advanced cracking and spalling may be visible due to earth pressure, beam friction, edge bearing or differential movements. • Corrosion of the reinforcement is advanced, with moderate loss of section and associated moderate to severe cracking, spalling and delamination of concrete. • Crossheads may be damp with some staining or evidence of water being retained on the shelf. Moderate movement of the abutment. Crossheads may have medium ASR or moment cracks or fine shear cracks. • The ballast wall may be severely cracked or spalled. The road surface behind the bridge has subsided noticeably. 	<p>Photo</p>

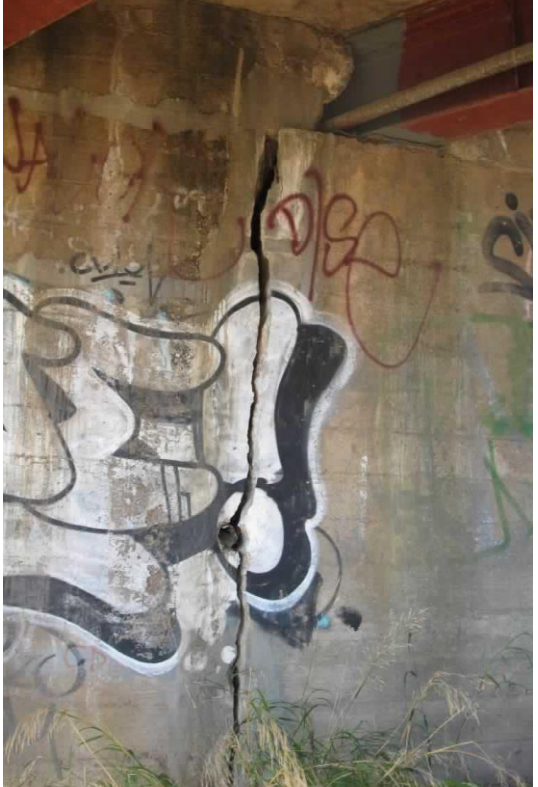
<p>Large (40mm) crack in abutment wall</p>

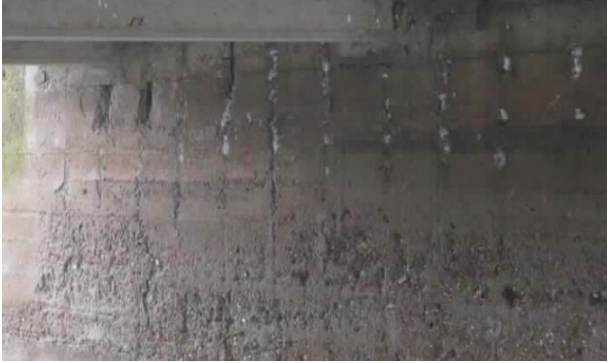
Condition state 5 -Description	Photo
<ul style="list-style-type: none">• Severe cracking and spalling due to structural mechanisms is evident in abutment and ballast walls.• Corrosion of the reinforcement is well advanced with more severe section loss.• The bearing shelf/crosshead may be very wet, heavily stained or have excessive water resting on top.• Severe moment cracks or moderate shear cracks may be evident. The ballast wall has failed, is bearing against the girders and embankment material is being lost.• There may be significant movement of the abutment wall.• There may be severe subsidence of the road surface behind the abutment.

<p data-bbox="791 562 1337 589">Severe spalling and fretting of concrete abutment</p>

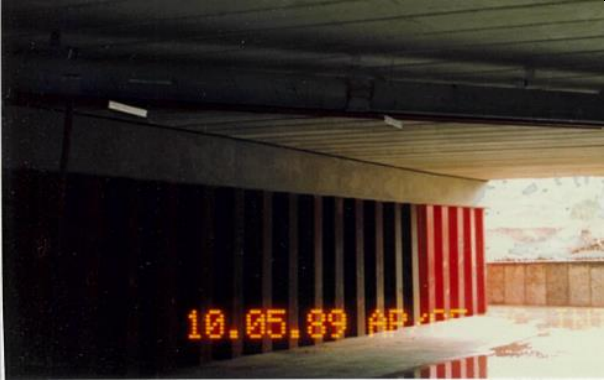
<h3>5S - Abutments– steel</h3> <p>This item includes abutments where the main embankment support material consists of corrugated steel/iron sheeting or steel sheet piles between the piles or acting as a ballast wall.</p> <p>Wingwalls and retaining walls are covered by Component No. 9S.</p>		Units m ² of exposed surface area
<p>Condition state 1 -Description</p> <ul style="list-style-type: none"> • The steel is in good condition with only minor rusting at the ends of sheets. • Soil retention is effective and there is no bulging of sheets between supports. 	<p>Photo</p>

<p>Sheet pilings in good condition</p>	
<p>Condition state 2 -Description</p> <ul style="list-style-type: none"> • There is minor corrosion at the sheet ends but no corrosion of the main body of the sheeting. • Soil retention is substantially effective and there is only minor bulging of sheets between supports. 	<p>Photo</p>

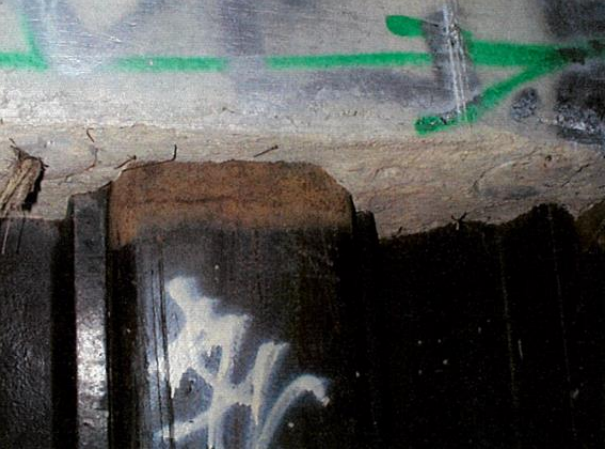
<p>Paint chipped off on corners and corrosion starting on sheet ends</p>

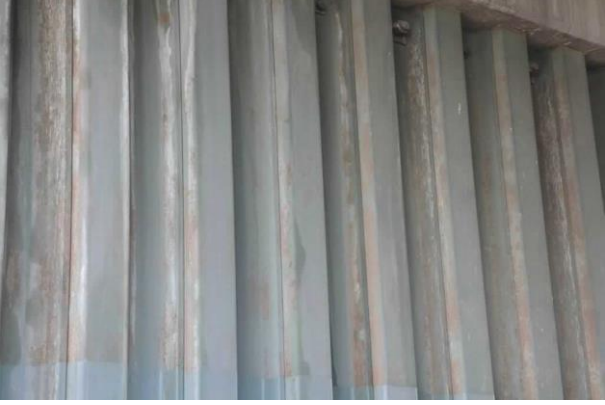
<p>Condition state 3 -Description</p> <ul style="list-style-type: none"> • Moderate corrosion is evident in the sheeting but there is only minor bulging of sheets between supports. • Soil retention is starting to become compromised and there may be evidence of minor subsidence of the road surface behind the abutment. 	<p>Photo</p>

<p>Corrosion of sheet pilings</p>

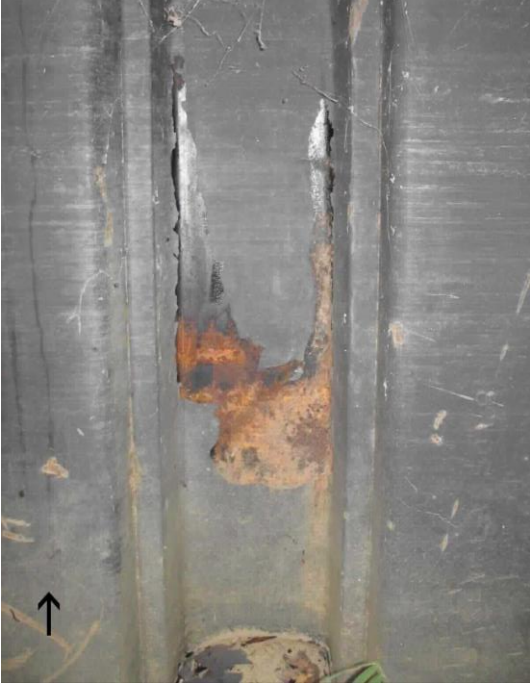
Condition state 4 -Description	Photo
<ul style="list-style-type: none"> • Moderate corrosion is evident in the sheeting, bulging of sheets between supports is significant and some of the joints between sheets may have sprung. • Soil retention has been compromised and there may be evidence of subsidence of the road surface behind the abutment.

<p data-bbox="794 882 1198 907">Paint flaking and moderate corrosion</p>
<ul style="list-style-type: none"> • Severe corrosion is evident in the sheeting, bulging of sheets is excessive and joints in the sheeting have sprung. • Loss of embankment fill is occurring due to earth pressure or the material is being lost due to water wash at the base of the abutment. Severe subsidence of the road surface behind the abutment may be evident.

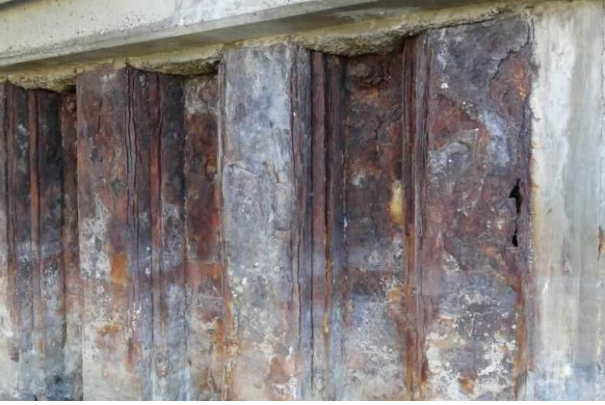
<p data-bbox="794 1352 1230 1370">Severely corroded abutment sheet piles</p>

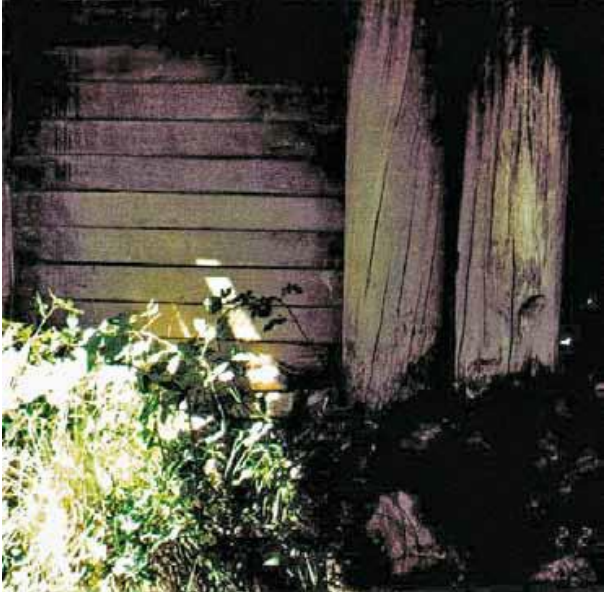
5T - Abutments – timber		Units
<p>This component includes abutments where the main embankment support material consists of timber sheeting or high timber piles. Timber piles and crossheads at abutments will be considered under other substructure components because of their uniqueness. Timber sill beams resting on a concrete footing may be considered in this component as well as timber bedlogs embedded in the embankment.</p> <p>Wingwalls and retaining walls are covered by Component No. 9T.</p>		<p>m² of exposed surface area</p>
Condition state 1 -Description	Photo	
<ul style="list-style-type: none"> The timber may have minor decay, splits or checks but is generally in good condition.

<p>Timber sheeting in good condition (VicRoads)</p>	
Condition state 2 -Description	Photo	
<ul style="list-style-type: none"> Timber units may have moderate decay, splits or checks, but are generally in good condition.

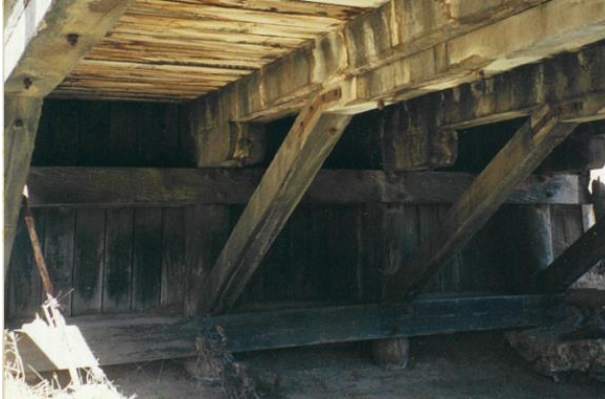
<p>Timber sheeting showing signs of minor rot and weathering but still in generally good condition.</p>

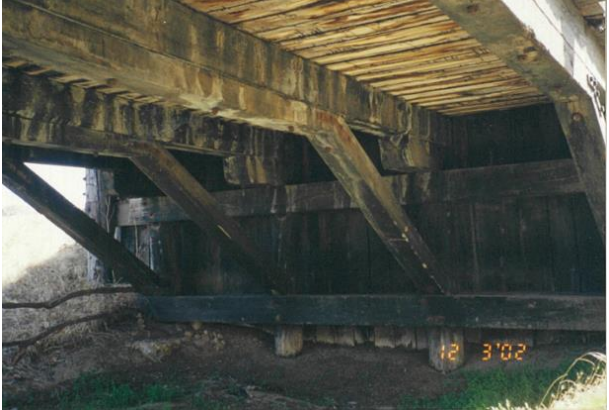
Condition state 3 -Description	Photo
<ul style="list-style-type: none"> • Timber units may have moderate decay, splits or checks, but are generally in fair condition. • Settlement of sheeting units may be starting to occur however there is no evidence of subsidence of the road surface behind the abutment.

<p data-bbox="791 600 1402 633">Moderate rotting at ends of timber abutment sheets</p>
Condition state 4 -Description	Photo
<ul style="list-style-type: none"> • Timber units may be heavily decayed with sheeting planks rotted out or attacked by termites. • Settlement of sheeting units may be occurring or a loss of fill may be occurring due to water wash beneath the sheeting or due to sheeting rotting out. • Subsidence of the road surface behind the abutment may be evident.

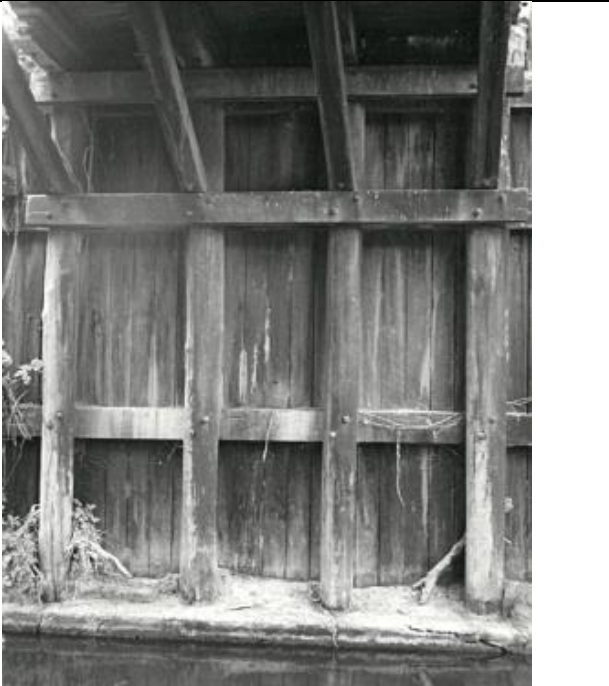
<p data-bbox="791 1350 1402 1368">Evidence of termite attack on some abutment timbers</p>

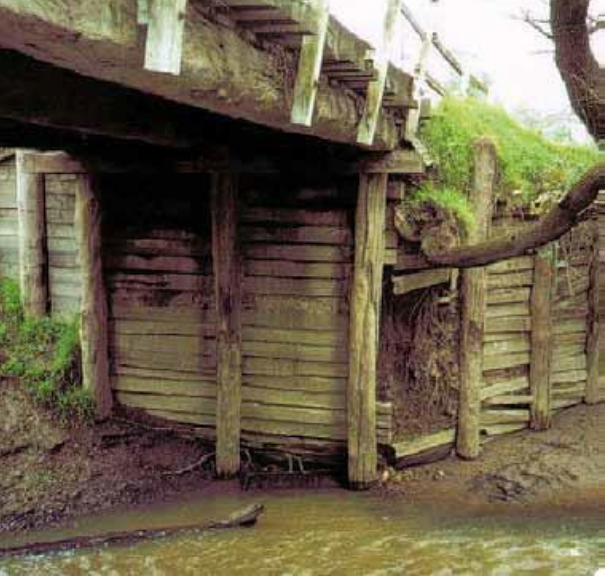
Condition state 5 -Description	Photo
<ul style="list-style-type: none">• Timber units may be severely decayed and whole areas may have rotted out or been eaten out by termites.• Loss of embankment fill is occurring due to earth pressure or the material is being lost due to water wash at the base of the abutment.• Severe subsidence of the road surface behind the abutment may be evident.

<p data-bbox="794 775 1407 860">Rotted out timber sheeting, collapsed sheeting and washout of embankment filling behind the abutment (VicRoads)</p>

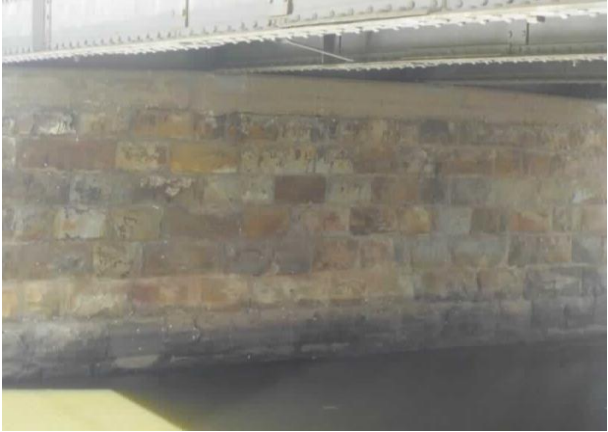
Condition state 1 -Description	Photo
<ul style="list-style-type: none"> The wall is in good condition with only minor fine cracks in the mortar between bricks, stones or masonry blocks. There should be no cracking due to differential settlement of the foundations, or bulging due to earth pressures on the walls. There should be no loss of mortar between the blocks. The wall and sill cap should be reasonably dry with no staining.

<p data-bbox="791 958 1136 987">Masonry wall in good condition</p>
Condition state 2 -Description	Photo
<ul style="list-style-type: none"> The wall may have a number of fine cracks in the mortar but no cracking of the blocks. There may be minor loss of mortar of no concern. Fine cracks may exist due to differential settlement of the foundations or minor bulging due to earth pressures. The wall and sill cap should be reasonably dry. The wingwalls may have slight movement away from the abutment but not sufficient to cause loss of embankment fill material.

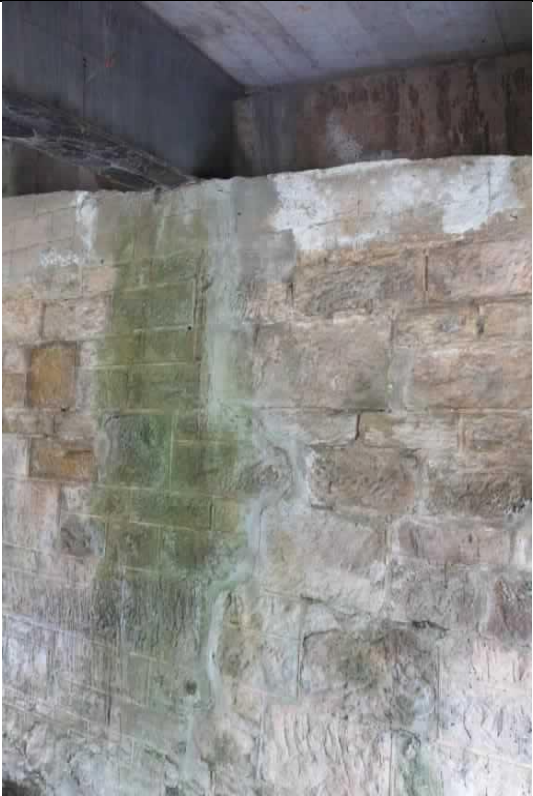
<p data-bbox="791 1816 1273 1843">Cracking in mortar between masonry blocks</p>

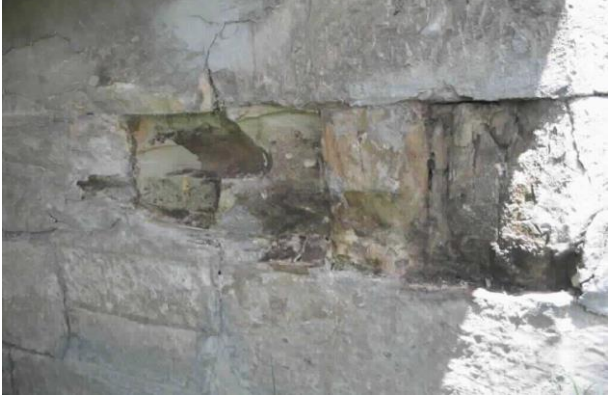
Condition state 3 -Description	Photo
<ul style="list-style-type: none"> • The wall may have a number minor cracks in the mortar and fine cracking of the blocks. There may be minor loss of mortar of no concern. • Minor cracks may exist due to differential settlement of the foundations or minor bulging due to earth pressures. • The wingwalls may have movement away from the abutment but not sufficient to cause loss of embankment fill material.

<p data-bbox="791 600 1002 622">Fretting stonework</p>
Condition state 4 -Description	Photo
<ul style="list-style-type: none"> • Moderate cracking of the mortar or moderate mortar loss may be occurring due to water wash. • There should be only minor mortar loss beneath any masonry sill caps. Medium cracking may exist due to differential settlement of the foundations. • Wingwalls may have moderate movement away from the abutments causing some loss of fill material. • Abutment walls may have moderate bulging due to earth pressure.

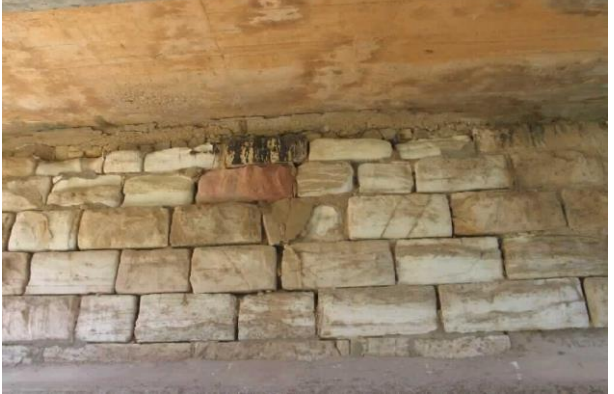
<p data-bbox="791 1064 1407 1122">Heavy fretting with moderate mortar loss and spalling of concrete sill</p>

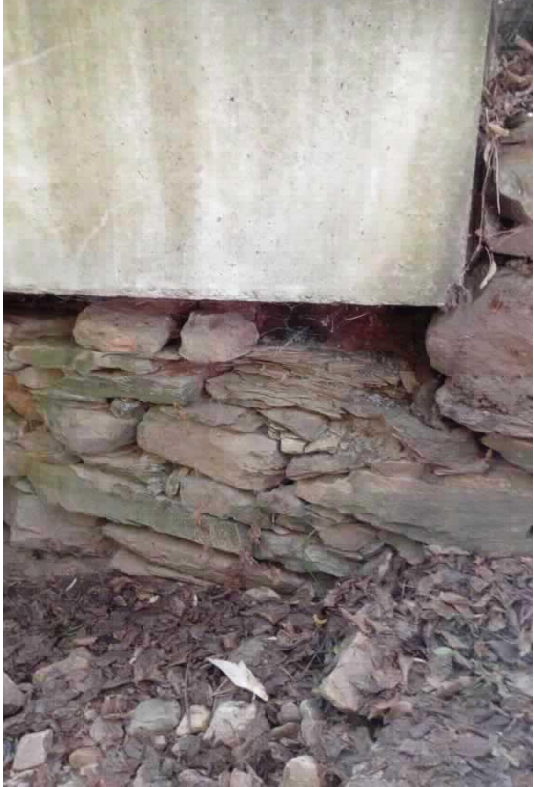
Condition state 5 -Description	Photo
<ul style="list-style-type: none"> • Severe cracking of the mortar or heavy loss of mortar may be occurring in the wall. • There may be medium loss of mortar beneath the masonry sill caps. • Heavy cracking may exist due to differential settlement of the foundations or bulging of the walls due to earth pressures. • Wingwalls may have severe movement away from the abutments causing excessive loss of fill material from behind.

<p data-bbox="791 1955 1235 1977">Masonry missing, headwall unsupported</p>

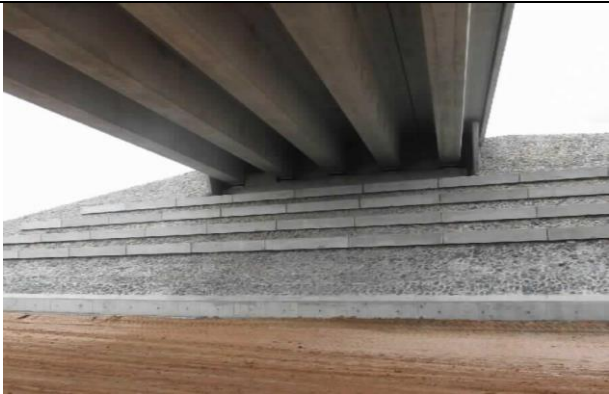
6P - Batter protection – precast concrete		Units
<p>This component defines those bridge abutment batters protected by precast concrete units placed either separately or locked together to prevent loss of embankment fill. Small walls at the toe of the batter may be included in this item even if constructed of a different material, but high vertical or near vertical walls with an abutment on top or behind should be included under the item for abutments.</p>		m² of exposed surface area
Condition state 1 -Description	Photo	
<ul style="list-style-type: none"> The precast concrete units are in good condition with no damage, differential settlement between units or scour beneath the toe of the units.

<p>Precast concrete units (supporting grouted stone) in good condition</p>	
Condition state 2 -Description	Photo	
<ul style="list-style-type: none"> There may be local minor damage to units or minor differential movement between units. Minor local scour may be beginning to uncover the toe of the batter beaching.

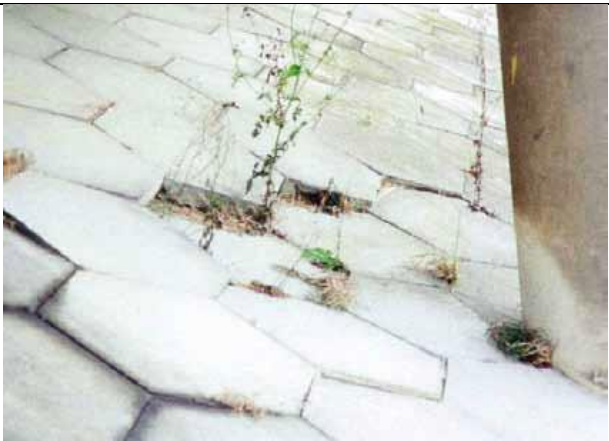
<p>Minor local damage and settlement of precast unit (VicRoads)</p>

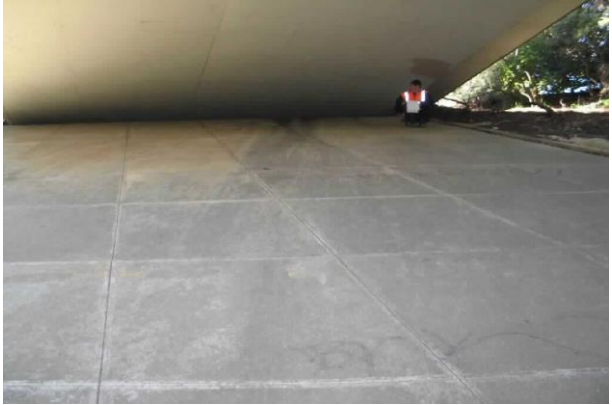
<p>6C - Batter protection – cast in-situ concrete</p> <p>This component defines those bridge abutment batters protected by cast-in-situ concrete. Concrete may be cast in forms, pumped into a nylon fabric mattress, or sprayed on the batter with or without anchorage rods into the fill material. Small retaining walls may be used at the toe of the batter and these should be considered as part of the batter protection.</p>		<p>Units</p> <p>m² of exposed surface area</p>
<p>Condition state 1 -Description</p> <ul style="list-style-type: none"> • The batter is in good condition with no cracking or spalling noticed. • The embedded toe of the batter is in good condition with no scouring. 	<p>Photo</p>

<p>Concrete batter slope in good condition</p>	
<p>Condition state 2 -Description</p> <ul style="list-style-type: none"> • Minor local cracking or spalling may have occurred or separation or movement at casting joints. • Minor local scour may be beginning to occur, uncovering part of the toe of the beaching. 	<p>Photo</p>

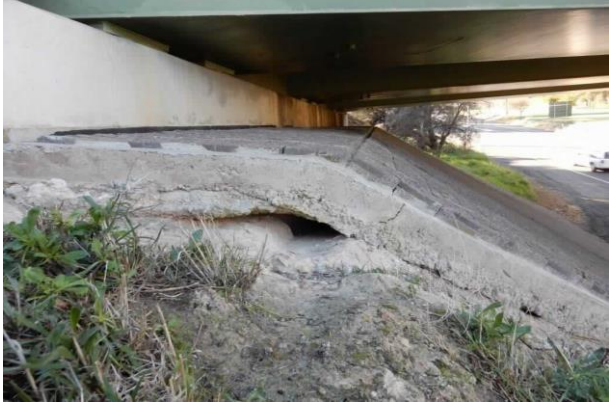
<p>Scour or animals causing hole beneath batter protection</p>

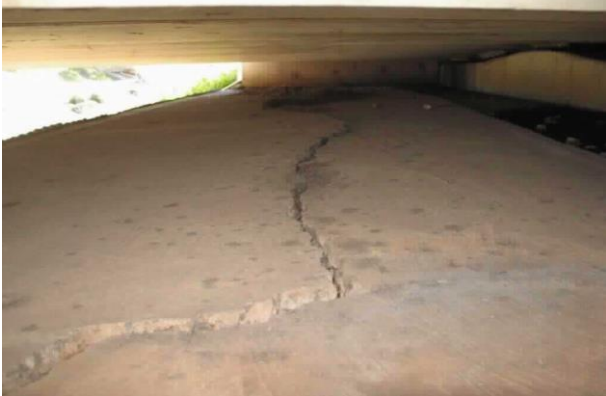
Condition state 3 -Description	Photo
<ul style="list-style-type: none"> Moderate local cracking or spalling may have occurred or separation or movement at casting joints. Moderate local scour may have occurred with minor erosion at the toe of the beaching. 	Not available
Condition state 4 -Description	Photo
<ul style="list-style-type: none"> Local cracking and spalling is more pronounced with small areas broken and possibly missing. Movement at casting joints is more pronounced with possible loss of batter material from beneath the concrete. Scouring is becoming a problem with the toe of the batter eroded over a reasonable length and possible erosion of batter material beneath the toe.

<p data-bbox="791 846 1399 875">Large crack along batter slope protection</p>
Condition state 5 -Description	Photo
<ul style="list-style-type: none"> Severe cracking and spalling with large broken areas or areas of missing concrete are providing erosion of batter material from beneath the concrete batter. Movements at the casting joints are excessive and batter material has been eroded away. Severe erosion has undermined the toe of the batter with loss of batter material below the concrete 	Not available
