Road Structures Inspection Manual

Part 4A: Condition State Guidelines and Photographs

Bridges

RAS Document No: RAMA-ST-PRC-048
Knet Document No: 14888945
Document version: 1.3 (08/05/2020)

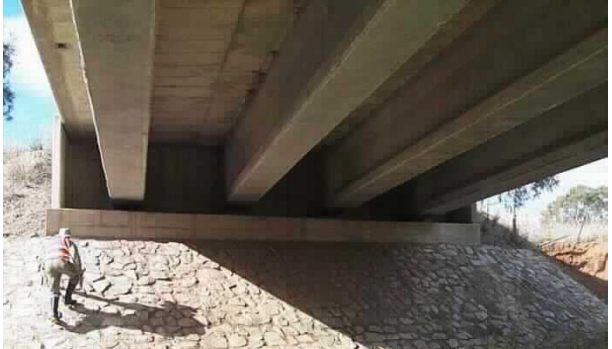
60 - Batter protection – other		Units
<p>This component includes those batters either unprotected, grassed, protected with stone or rocks (grouted or ungrouted), stone filled cages or mattresses, stone with reinforcing mesh tied down on top, or placed fabric tied down by light wire mesh. Small retaining walls may be used at the toe of the batter and these should be included as part of the batter protection.</p>		<p>m² of exposed surface area</p>
Condition state 1 -Description	Photo	
<ul style="list-style-type: none"> The unprotected batters or protected batters are generally in good condition with no scour evident. Some of the rock beaching may have been lost from the batter and is now in the stream, but there is no scour of the unprotected areas or toe of beaching.

<p>Grouted stone batter in good condition.</p>	
Condition state 2 -Description	Photo	
<ul style="list-style-type: none"> There may be some local damage to the protective system or minor differential settlement or movement of cages or mattresses. Some wires may be damaged or broken with minor loss of the stone filling. Minor local erosion or scour of the batters may be occurring or the toe of the beaching may be beginning to be uncovered.

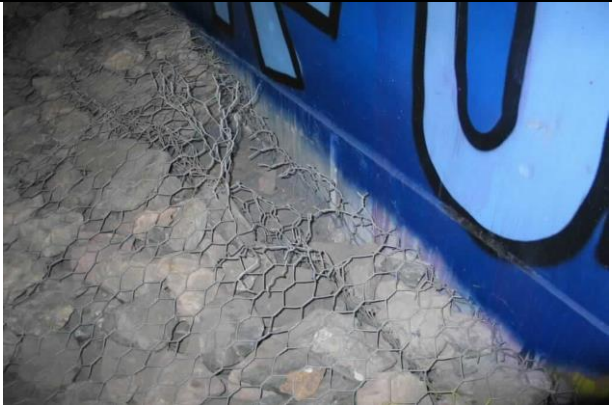
<p>Broken wire and some rocks missing from reno mattress</p>

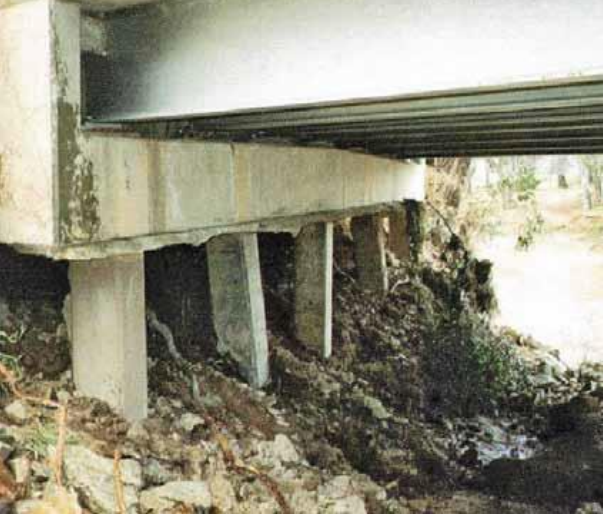
Condition state 5 -Description	Photo
<ul style="list-style-type: none"> • Failure of the beaching has allowed erosion and scouring of the banks to occur. • Severe scour has undermined the toe of the beaching and batter fill material is being eroded away. • Settlement or movement of the beaching has exposed the underside of the abutments with loss of fill material in the road embankment.

<p data-bbox="794 1688 1382 1742">Scour has completely removed stone beaching and fill beneath and in front of abutment (VicRoads)</p>

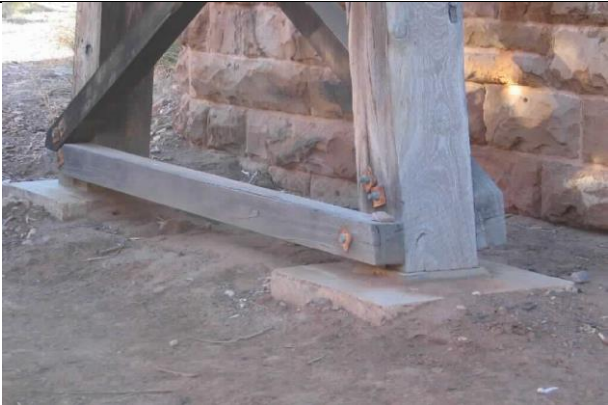
7C - Footing – cast in-situ concrete This item covers all spread footing foundations constructed in cast in-situ concrete. It also covers the concrete pedestal footings used to support timber pile bases at piers and abutments.		Units m² of exposed surface area
Condition state 1 -Description <ul style="list-style-type: none"> The footing is in good condition with only minor cracking due to shrinkage or corroding reinforcement. There is no cracking due to differential settlement of footings or scouring under spread footings. 	Photo

<p>Timber prop footings in very good condition</p>	
Condition state 2 -Description <ul style="list-style-type: none"> There is minor cracking or spalling due to corroding reinforcement or differential settlement of footings. There is no scour beneath the spread footing base. 	Photo

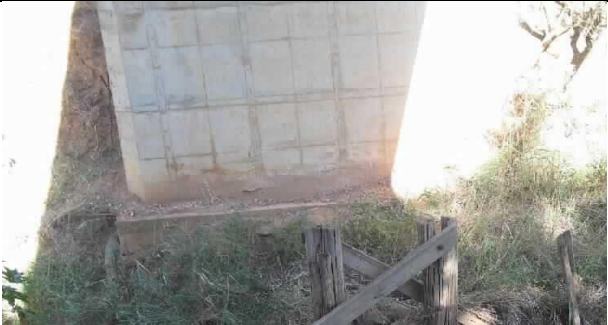
<p>Pier footing in good condition</p>	
Condition state 3 -Description <ul style="list-style-type: none"> Moderate cracking or spalling due to differential settlement or log impact may have occurred. Moderate to severe cracking or spalling due to corroding reinforcement or ASR may be evident. There is minor loss of reinforcement section. 	Photo <p>Not available</p>

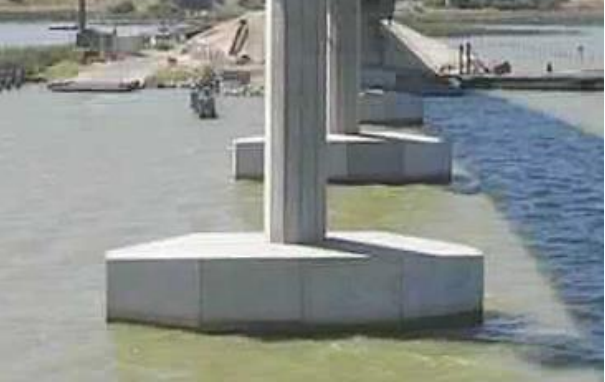
8C - Pile cap – cast in-situ concrete This item covers all pile cap foundations constructed in cast in-situ concrete. It also covers the concrete pedestal footings used to support timber pile bases at piers and abutments.		Units m² of exposed surface area
Condition state 1 -Description <ul style="list-style-type: none"> The pile cap is in good condition with only minor cracking due to shrinkage or corroding reinforcement. There is no cracking due to differential settlement of piles. Overall depth of scour holes is less than 0.5 m. 	Photo

<p>Pile cap in good condition</p>	
Condition state 2 -Description <ul style="list-style-type: none"> There is minor cracking or spalling due to corroding reinforcement or differential settlement of piles. Piles have adequate edge clearances and have been placed within the specified tolerances. Overall depth of localised scour holes ranges from 0.5 m to 1.5 m. 	Photo

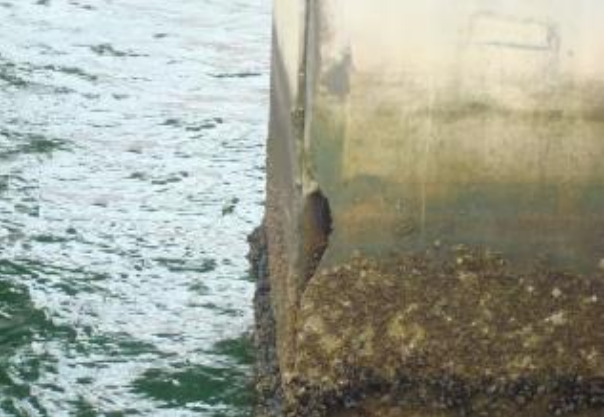
<p>Minor spalling</p>

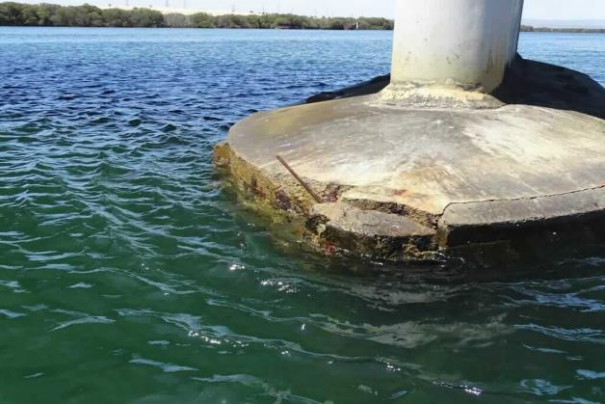
Condition state 3 -Description <ul style="list-style-type: none"> Moderate cracking or spalling due to log impact or differential settlement may have occurred. Moderate cracking and spalling due to corrosion of reinforcement or ASR may be evident. There is minor loss of reinforcement section due to corrosion. Piles have been driven slightly out of positional tolerance but the structural strength and serviceability are not affected. Overall depth of localised scour holes ranges from 1.5 m to 3 m. 	Photo

<p>Spalling and dislodged pile cap skirt</p>

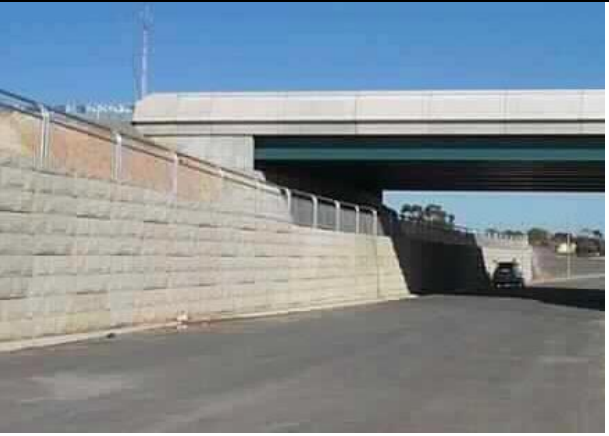
9P - Reinforced Earth – precast concrete		Units
<p>This item covers reinforced earth (also called mechanically stabilised earth, MSE) abutment walls with exterior facing comprising precast concrete elements also used in abutments. Included in this item are precast RC sheeting planks, precast RC earth retaining slabs, precast RC facing panels and precast RC crib walls.</p>		<p>m² of exposed surface area</p>
Condition state 1 -Description	Photo	
<ul style="list-style-type: none"> • In good condition with little deterioration. • There is no settlement of units or gaps between units allowing loss of embankment fill. There is no vegetation growing between the units. • The units are in good condition with only minor fine cracking of no consequence. No reinforcement is exposed. • There is no movement of units.

<p>Reinforced Earth wall in good condition.</p>	
Condition state 2 -Description	Photo

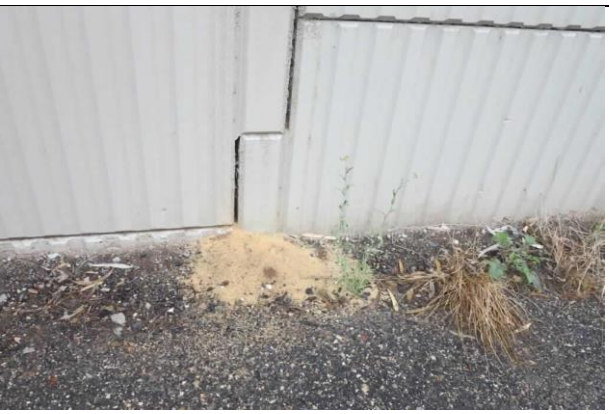
<ul style="list-style-type: none"> • In good condition with minor deterioration. • There may be fine cracking or minor spalling of the units due to corroding reinforcement or earth pressure. • There may be minor bulging or settlement of units but allowing only minor loss of embankment fill from behind. There is no vegetation growing between the units.

<p>Minor loss of embankment fill</p>	
Condition state 3 -Description	Photo	
<ul style="list-style-type: none"> • In fair condition with minor deterioration. • No exposure of soil reinforcement. • There may be minor cracking or moderate spalling of the units due to corroding reinforcement or earth pressure. • Units may have moderate movement or settlement enabling minor loss of embankment fill. • There may be some vegetation growing between the units indicating breakdown of the backing strip.

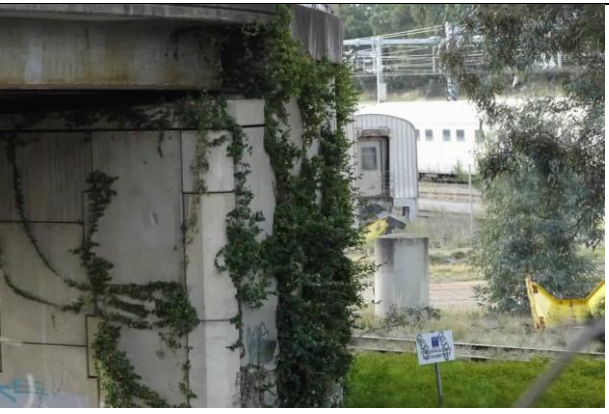
<p>Reinforced earth wall panels with vegetation growth</p>

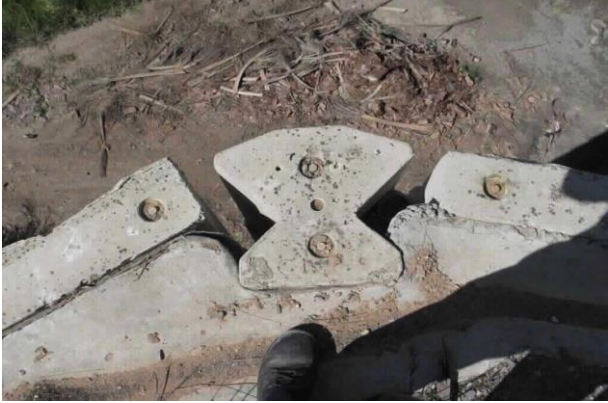
Condition state 4 -Description	Photo
<ul style="list-style-type: none"> • In poor condition, deterioration and defects are significant although imminent failure or reduced rating is not expected in the medium term. It is likely remedial repairs will be required to be scheduled. • Some soil reinforcement is exposed with signs of minor corrosion. • Units may have moderate movement, settlement or separation of units that may have resulted in medium loss of embankment fill. • There may be vegetation growing between the units indicating breakdown of the backing strip.

<p data-bbox="791 600 1136 629">Large gaps at top of wall corner</p>

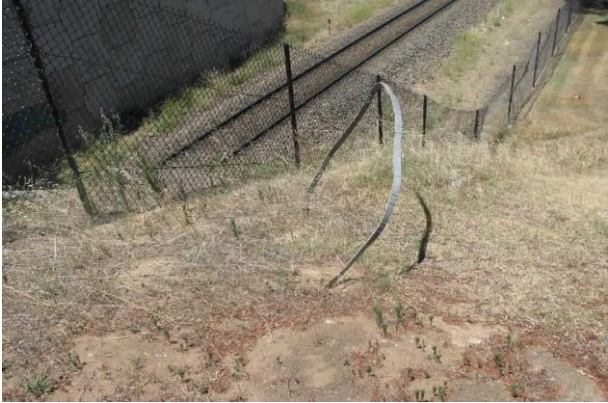
<p data-bbox="791 1034 944 1064">Exposed strap</p>
Condition state 5 -Description	Photo
<ul style="list-style-type: none"> • In very poor condition. Deterioration and defects are severe and it is likely that without intervention failure of the component may be expected in the short to medium term. • Areas of soil reinforcement are exposed due to flooding or other significant movement of the reinforced fill. • Severe cracking and spalling of the units may be occurring due to reinforcement corrosion or earth pressure. • Units have excessive movement, settlement or separation of units which may be allowing heavy loss of embankment fill. • There may be a lot of vegetation growing between the units indicating breakdown of the backing strip.

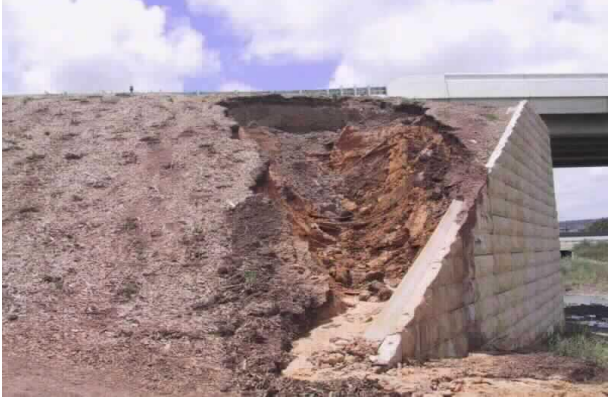
<p data-bbox="791 1507 1166 1536">Severe erosion of embankment fill</p>

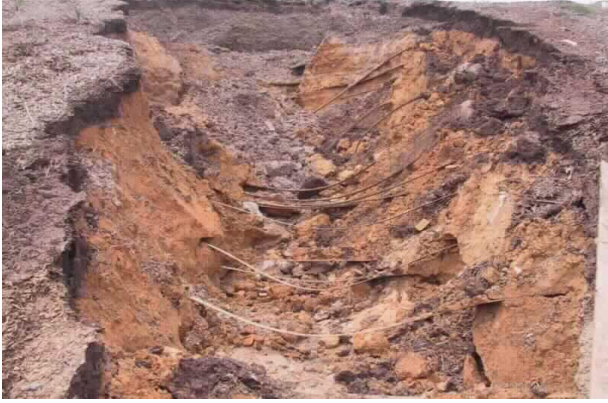
<p data-bbox="791 1942 1110 1971">Cavity showing anchor straps</p>

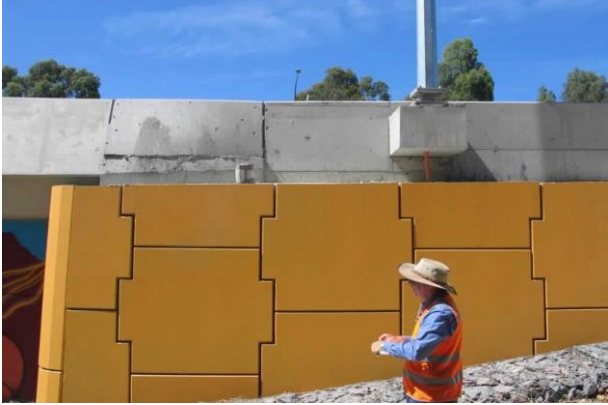
10P - Wingwalls / Retaining Walls – precast concrete		Units
<p>This item includes all bridge wingwalls and retaining walls constructed using precast reinforced concrete, and covers elements such as precast RC sheeting planks, precast RC earth retaining walls, precast RC facing panels for reinforced soil walls and precast RC crib walls.</p>	<p>m² of exposed surface area</p>	
<p>Condition state 1 -Description</p> <ul style="list-style-type: none"> • The elements are in good condition with only minor cracking or spalling noticed. There should be no movement or moment cracking in the wingwalls. • There should be no settlement of the elements or gaps between elements allowing loss of embankment fill to occur. • Where the elements form retaining walls, they must be securely positioned and have no bulging due to earth pressure. 	<p>Photo</p>

<p>Precast panels in good condition</p>	
<p>Condition state 2 -Description</p> <ul style="list-style-type: none"> • There may be minor cracking and spalling due to corroding reinforcement or due to earth pressures. • Retaining walls may be showing signs of minor rotation or small movements which are of no consequence. • There may be minor bulging or settlement of elements but allowing only minor loss of embankment fill from behind. 	<p>Photo</p>

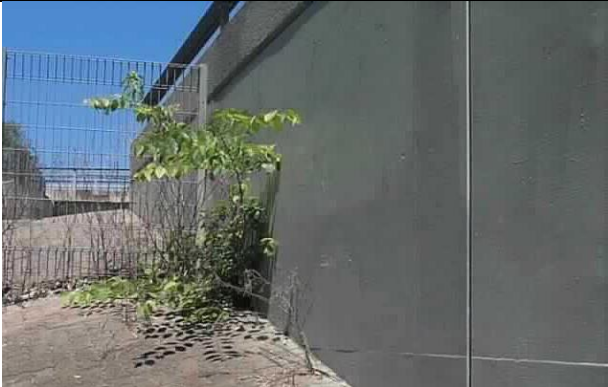
<p>Small tree growing against wingwall</p>

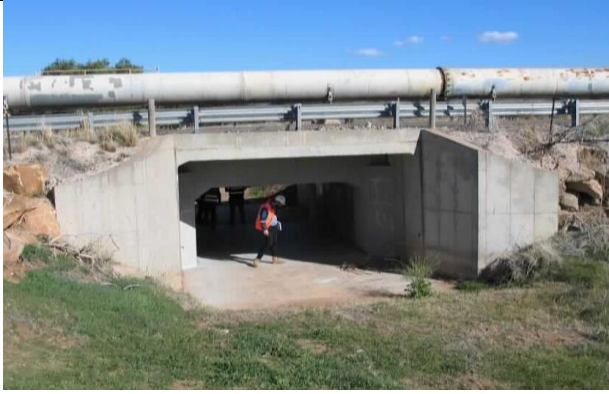
<p>10C - Wingwalls / Retaining Walls – cast in-situ concrete</p> <p>This item includes all bridge wingwalls and retaining walls constructed using cast insitu reinforced or plain concrete. Wingwalls, whether integral, attached or independent, are included.</p>		<p>Units</p> <p>m² of exposed surface area</p>
<p>Condition state 1 -Description</p> <ul style="list-style-type: none"> • The wall is in good condition with no cracking, spalling, rotation, movement or moment cracking. • Independent wingwalls are hard up against the abutment walls. 	<p>Photo</p>

<p>Concrete wingwalls in good condition</p>	
<p>Condition state 2 -Description</p> <ul style="list-style-type: none"> • There may be some minor cracking or spalling due to corroding reinforcement or earth pressures. • Any joint with the abutment may be cracked as a result of differential movement. • Independent walls may be rotating or show small forward movements but there is no loss of embankment material. 	<p>Photo</p>

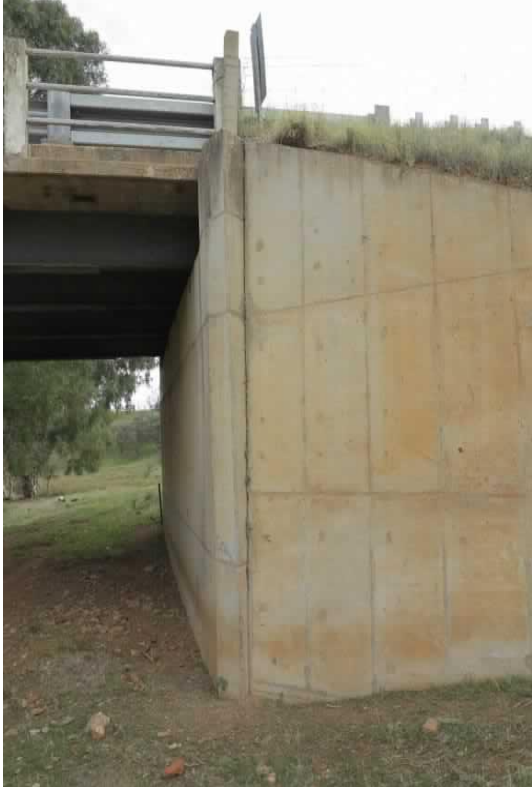
<p>Slight rotation of wingwall but no loss of embankment</p>

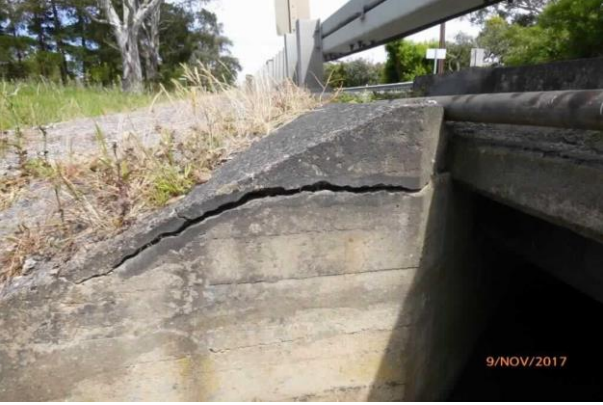
Condition state 3 -Description	Photo
<ul style="list-style-type: none"> • There may be moderate cracking or spalling due to corroding reinforcement or earth pressures. There may be minor loss of section of reinforcement due to corrosion. • Any joints with the abutment may have minor cracking and minor spalling of the adjoining edges may be evident. • Retaining walls and independent wingwalls may show minor rotations or movements. • There is some loss of fill but little effect on serviceability as a result of differential movements.

<p data-bbox="794 595 1399 629">Moderate cracking</p>
Condition state 4 -Description	Photo
<ul style="list-style-type: none"> • There may be medium cracking or spalling due to corroding reinforcement, ASR or earth pressures. There may be moderate loss of section of reinforcement due to corrosion. • Any joints with the abutment may be cracked and spalling of the adjoining edges may be evident. • Retaining walls and independent wingwalls may show moderate rotations or movements. • There is moderate loss of fill with minor effect on serviceability as a result of differential movements.

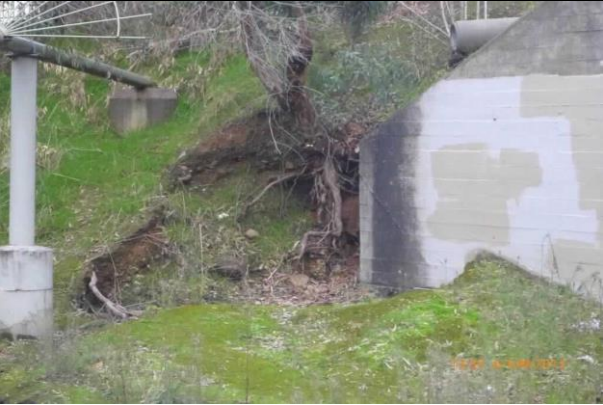
<p data-bbox="794 1133 1399 1167">Loss of fill and scour behind wingwall</p>

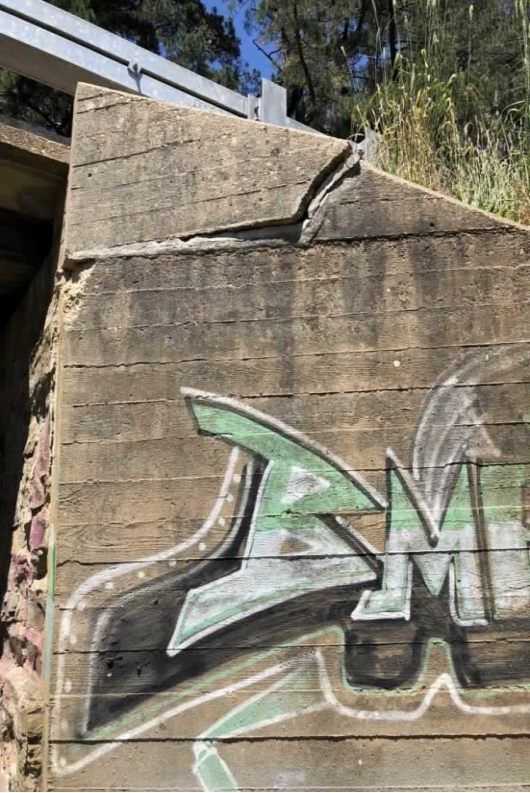
Condition state 5 -Description	Photo
<ul style="list-style-type: none">• There may be heavy cracking or spalling due to corroding reinforcement or earth pressures. There may be more severe loss of section of reinforcement due to corrosion (and the resultant cracking and spalling this may cause). This may include any joint with the abutment that is cracked and badly spalled as a result of differential movements.• The water bar may be torn and fill escaping through the gap.• Retaining walls and independent wingwalls may show large rotations or movements due to earth pressure causing excessive loss of fill material from behind.

<p data-bbox="794 992 1326 1010">Heavy cracking and large rotation of wingwall</p>

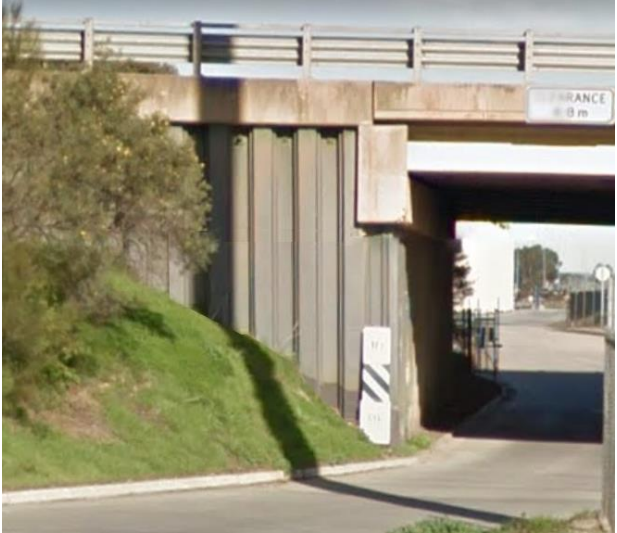
10S - Wingwalls / Retaining Walls – steel		Units
<p>This item includes all wingwalls and retaining walls where the main embankment support material consists of corrugated steel/iron sheeting or steel sheet piles between the wing piles.</p>		<p>m² of exposed surface area</p>
Condition state 1 -Description	Photo	
<ul style="list-style-type: none"> The steel is in good condition with only minor rusting at the ends of sheets. Soil retention is effective and there is no bulging of sheets between supports.

<p data-bbox="791 958 1145 987">Steel wingwall in good condition</p>	
Condition state 2 -Description	Photo	
<ul style="list-style-type: none"> There is minor corrosion at the sheet ends but no corrosion of the main body of the sheeting. Soil retention is substantially effective and there is only minor bulging of sheets between supports.

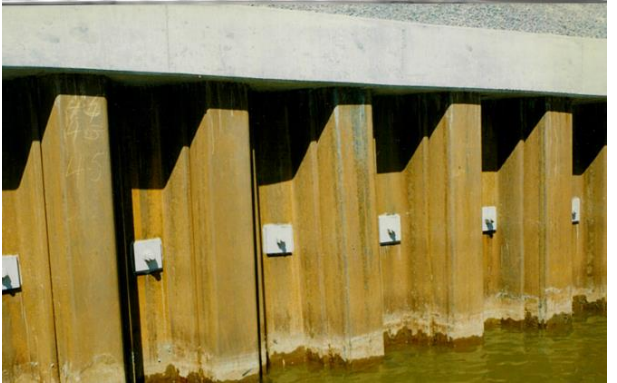
<p data-bbox="791 1406 1310 1473">Wingwall with light rusting of sheets and minor corrosion at sheet ends</p>

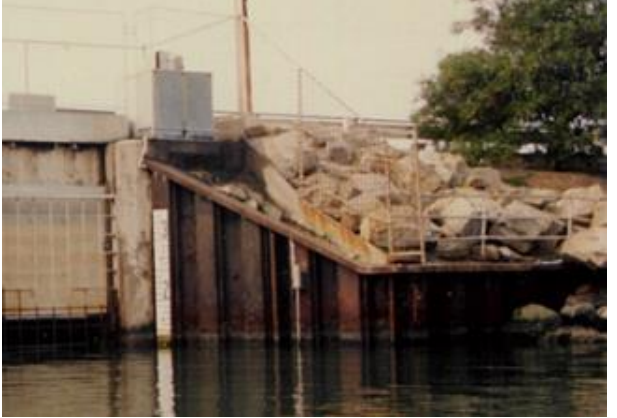
Condition state 3 -Description	Photo	
<ul style="list-style-type: none"> There is minor corrosion evident in the sheeting with only minor bulging of sheets between supports. Soil retention is substantially effective and there may be evidence of minor subsidence of the road surface behind the abutment.

<p data-bbox="791 1928 970 1955">Minor corrosion</p>

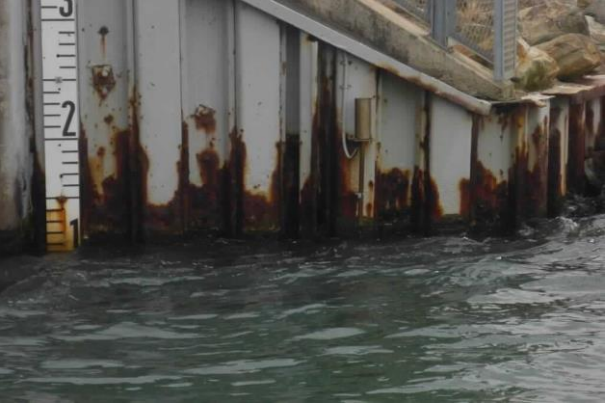
Condition state 4 -Description	Photo
<ul style="list-style-type: none">• Moderate corrosion is evident in the sheeting, bulging of sheets between supports is significant and some of the joints between sheets may have sprung.• Soil retention has been compromised and there may be moderate subsidence of the road surface behind the abutment.

<p data-bbox="794 600 1142 622">Moderate corrosion of wingwall</p>
Condition state 5 -Description	Photo
<ul style="list-style-type: none">• Severe corrosion is evident in the sheeting, bulging of sheets is excessive and joints in the sheeting have sprung.• Loss of embankment fill or wingwall fill is occurring, due to earth pressure, or the material is being lost due to water wash at the base of the wingwalls.• Severe subsidence of the road surface in the vicinity of the wingwall or retaining wall may be evident.	<p data-bbox="794 696 938 719">Not available</p>

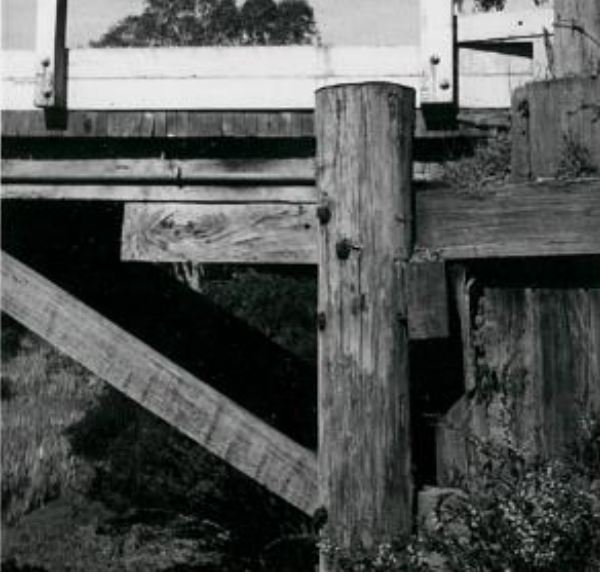
Condition state 4 -Description	Photo
<ul style="list-style-type: none">• Timber units may be heavily decayed with sheeting planks rotted out or attacked by white ants.• Settlement of sheeting units may be occurring or a loss of fill may be occurring due to water wash beneath the sheeting or due to sheeting rotting out, and subsidence of the embankment may be evident.

<p data-bbox="794 763 1396 792">Termite attack on wingwall</p>
Condition state 5 -Description	Photo
<ul style="list-style-type: none">• Timber units may be severely decayed and whole areas may have rotted out or been eaten out by white ants.• Loss of embankment fill or wingwall fill is occurring due to earth pressure or the material is being lost due to water wash at the base of the wingwalls, and severe subsidence may be evident.

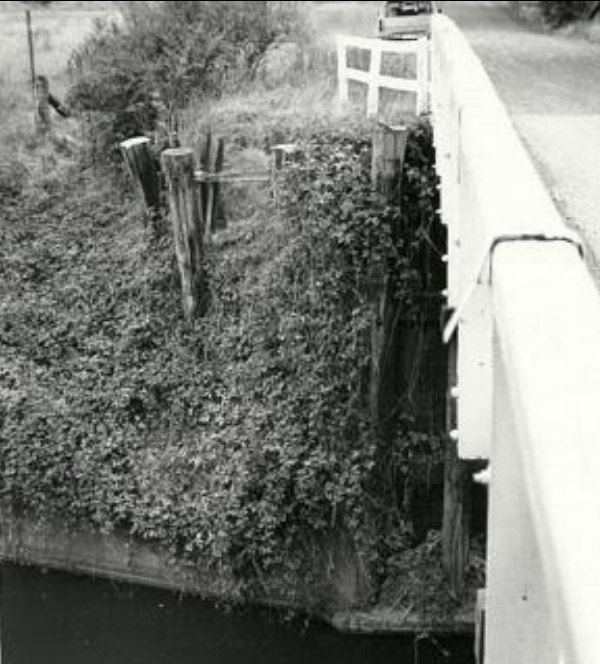
<p data-bbox="794 1487 1396 1550">Wingwall has collapsed due to rotting and severe termite attack</p>

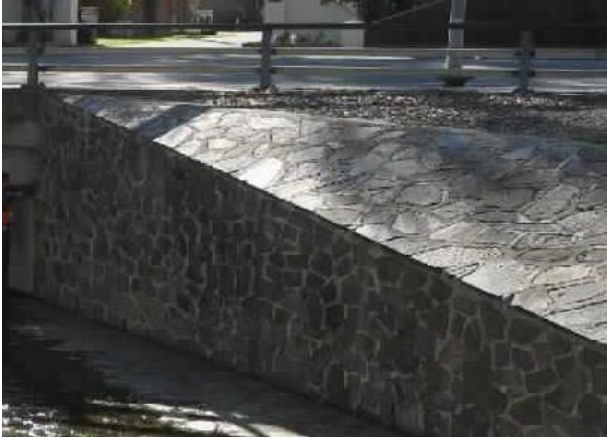
<p>100 - Wingwalls / Retaining Walls – other</p> <p>This component includes all bridge wingwalls and retaining walls constructed using ashlar blocks, rubble masonry or brickwork.</p>		<p>Units</p> <p>m² of exposed surface area</p>
<p>Condition state 1 -Description</p>	<p>Photo</p>	
<ul style="list-style-type: none"> • The wall is in good condition with only fine cracks in the mortar joints. There should be no cracking due to differential settlement of foundations or bulging due to earth pressure. • There should be no loss of mortar between blocks, the wall should be dry and no forward rotation or movement is evident.

<p>Masonry wingwall in good condition</p>	
<p>Condition state 2 -Description</p>	<p>Photo</p>	
<ul style="list-style-type: none"> • There may be a number of fine cracks in the mortar joints but no cracking of the blocks or there may be minor loss of mortar of no concern. Fine cracks may exist due to differential settlement of the foundations or minor bulging due to earth pressures. • The wall is reasonably dry and there is only a slight forward movement or rotation but no loss of fill.

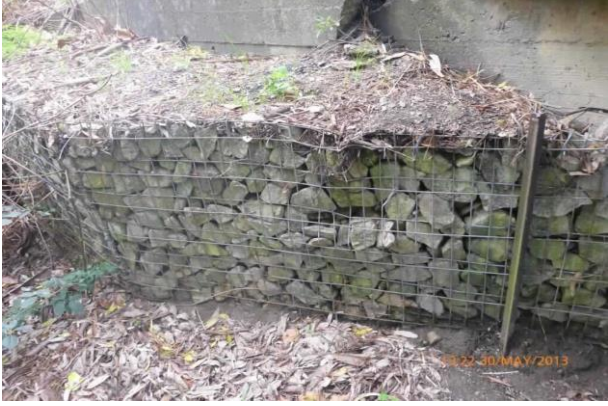
<p>Secondary gabion wingwall with minor displacement of rocks</p>

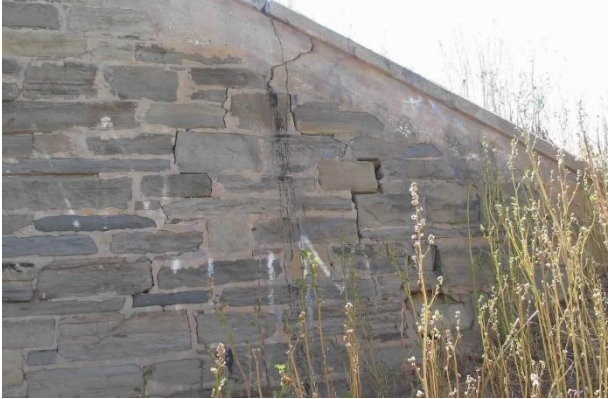
<p>Condition state 3 -Description</p>	<p>Photo</p>	
<ul style="list-style-type: none"> • Minor cracking of mortar or loss of mortar may be evident. Minor cracking due to differential footing settlement and minor bulging due to earth pressure may be seen. • Walls have rotated or show small forward movement, causing some loss of fill material.

<p>Cracking and small movement in masonry wingwall</p>

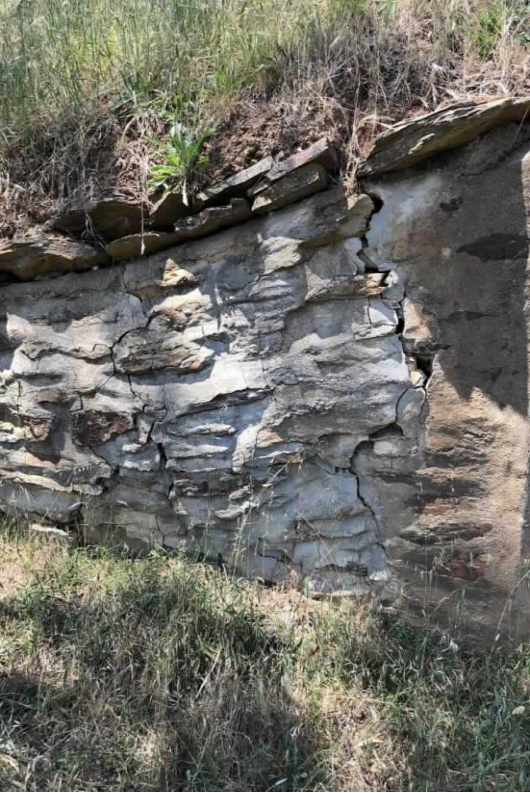
Condition state 4 -Description	Photo
<ul style="list-style-type: none">• Moderate cracking of mortar or loss of mortar may be evident. Moderate cracking due to differential footing settlement and moderate bulging due to earth pressure may be seen.• Walls may show moderate rotations or movements causing moderate loss of fill material.

<p data-bbox="794 992 1369 1016">Moderate cracking and bulging in dry stone wingwall</p>
Condition state 5 -Description	Photo
<ul style="list-style-type: none">• Severe cracking or loss of mortar is occurring. Severe cracking is evident as a result of differential settlement or bulging due to earth pressures.• Walls show large rotations or movements causing excessive loss of fill material from behind.

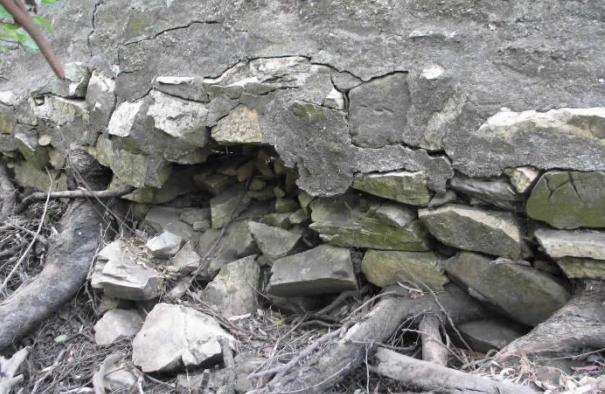
<p data-bbox="794 1456 1023 1480">Stone wall collapsing</p>

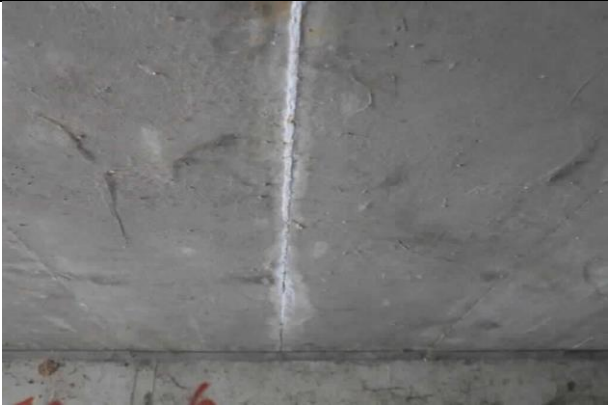
12P - Deck Slab – precast concrete		Units
<p>This item includes all contiguous precast concrete deck slabs and superstructure units forming both the span and the deck.</p> <p>This item does not include:</p> <ul style="list-style-type: none"> transversely stressed deck units, considered as Component No. 12P. T-slabs (a trapezoidal beam with an integral top flange developed by VicRoads). A reinforced concrete in-situ slab is cast over the top flange. These are considered as Component No. 13P. inverted T-slabs. Bottom flanges are contiguous. Voids between units may be filled with insitu concrete; alternatively, a conventional deck slab may be cast over the top flanges. These are also considered as Component No. 13P. 		m ² of exposed surface area
Condition state 1 -Description	Photo	
<ul style="list-style-type: none"> The units are in good condition with only minor faint cracking or minor edge chipping of the units. Minor efflorescence powder may be visible.

Efflorescence between precast units	
Condition state 2 -Description	Photo	
<ul style="list-style-type: none"> Minor cracks or spalls may be present with only minor reinforcement corrosion. Edge spalling of the units may have exposed some reinforcement.

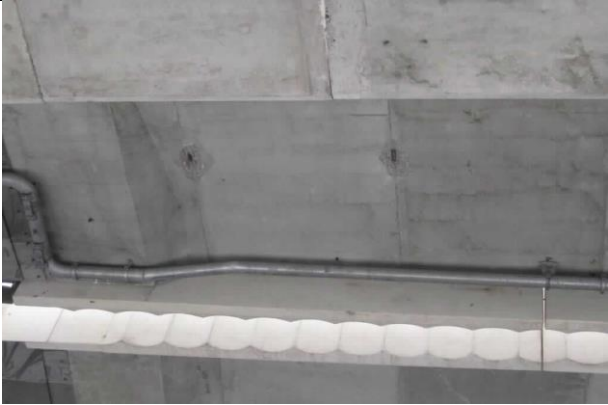
Minor spalling with exposed reinforcement

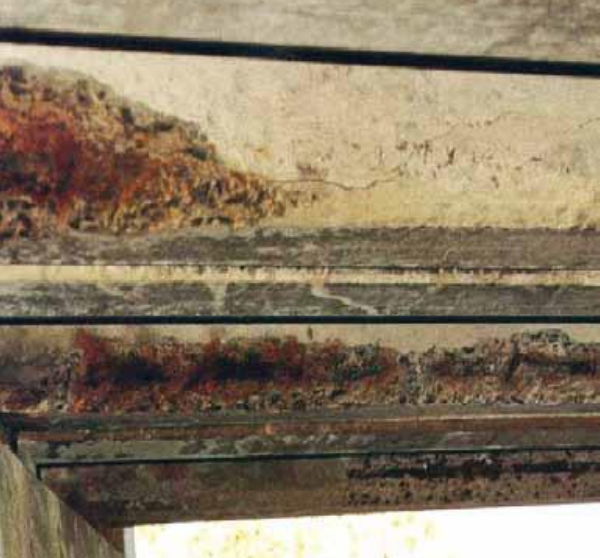
Condition state 3 -Description	Photo
<ul style="list-style-type: none"> Moderate cracking and spalling may be present with minor loss of section of the reinforcement. Some of the hold down bolts for the precast deck slabs may be loose. 	Not available
Condition state 4 -Description	Photo
<ul style="list-style-type: none"> Medium cracking and spalling may be present with moderate loss of section of the reinforcement. Many of the hold down bolts are loose or missing and the units are moving when loaded, causing heavy edge spalling of the units. 	Not available
Condition state 5 -Description	Photo
<ul style="list-style-type: none"> Heavy spalling and advanced corrosion may be present, or the precast deck units are completely loose and moving excessively under load. Heavy edge spalling or delaminated concrete may be present.

<p data-bbox="794 1283 1396 1341">Severe cracking and spalling due to chloride ingress corroding the reinforcement (VicRoads)</p>

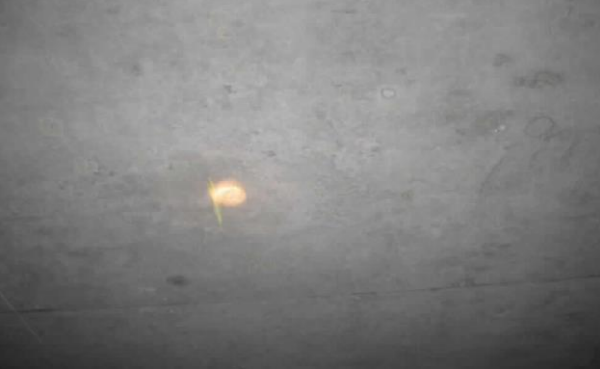
Condition state 1 -Description	Photo
<ul style="list-style-type: none"> The units are in good condition with minor moisture staining between the slabs and white efflorescence powder. The units may have minor faint cracking but no spalling. The transverse tensioning rods are in good condition with no sign of corrosion.

<p data-bbox="794 1865 1396 1890">Minor longitudinal cracks up to 0.2mm</p>

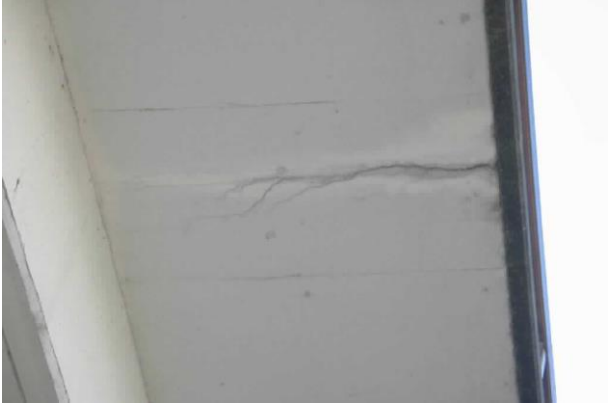
Condition state 2 -Description	Photo
<ul style="list-style-type: none"> • The units may have slight moisture staining and efflorescence powder visible but no rust staining due to corrosion of the transverse rods. • The asphalt surface may exhibit fine longitudinal cracking along the lines of these units. • There may be minor cracks and spalls but no exposure of the stressing strands. • Impact forces have caused minor damage but have not exposed reinforcement. • The transverse tensioning rods may have minor surface corrosion.

<p data-bbox="791 600 1299 629">Cracking with no exposure of stressing strands</p>
Condition state 3 -Description	Photo
<ul style="list-style-type: none"> • The units may have moderate moisture staining with stalactite growths and efflorescence powder visible powder in the joints, along with some rust staining due to corrosion of the transverse rods. • The asphalt surface may have moderate cracking, due to differential movement between the units or loss of tensioning force in the transverse rods; however, the anchorages are still tight in the recesses. • There may be moderate cracking and spalling with minor loss of section of the stressing strands due to corrosion. • Non-prestressed reinforcement may be corroded with minor section loss. • Impact damage comprising minor spalls of cover concrete with no significant damage to reinforcement or prestressing strands 	<p data-bbox="791 801 938 831">Not available</p>

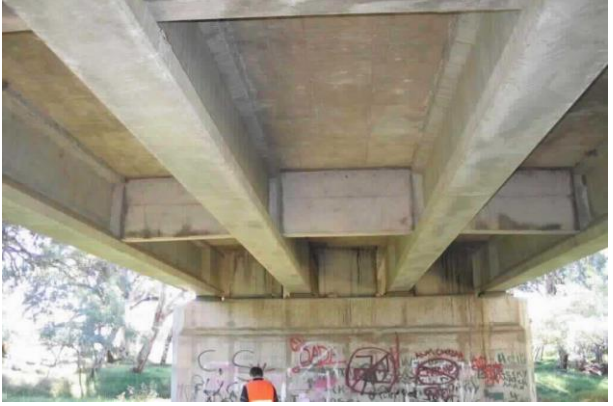
<p>12C - Deck / slabs – cast in-situ concrete</p> <p>This item includes all reinforced concrete decks cast in-situ, including overlays cast non-composite with precast units beneath.</p>		<p>Units</p> <p>m² of exposed surface area</p>
<p>Condition state 1 -Description</p>	<p>Photo</p>	
<ul style="list-style-type: none"> • The deck shows little or no deterioration though there may be some dampness and efflorescence. • Minor cracking due to corroding reinforcement may be present. • The characteristic shrinkage crack down the centre of the flat slab is fine and dry.

<p>Cast in-situ RC slab deck in good condition</p>	
<p>Condition state 2 -Description</p>	<p>Photo</p>	
<ul style="list-style-type: none"> • Minor cracking and spalling may be present with corroding reinforcement visible. • Dampness patches and efflorescence powder may be more visible. • The characteristic shrinkage crack along the centre of flat slab bridges is fine and dry.

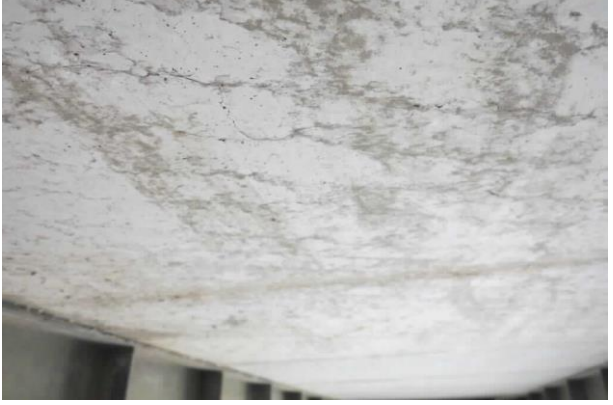
<p>Shrinkage cracking in deck</p>

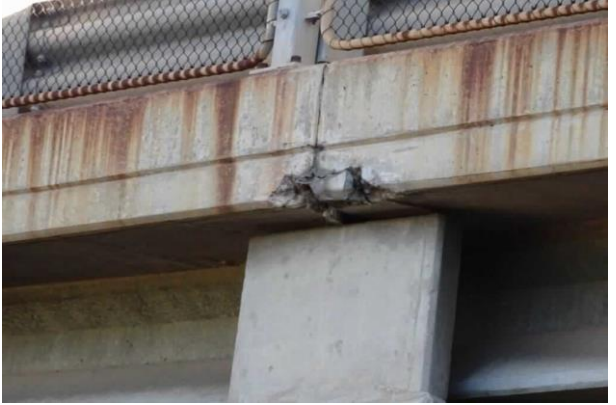
<p>Condition state 3 -Description</p> <ul style="list-style-type: none"> • Moderate cracking and spalling may be present with corrosion of the reinforcement causing minor loss of section in areas. • Dampness patches and efflorescence powder may be more prominent. • The characteristic shrinkage crack along the centre of flat slab bridges is fine with some evidence of moisture. • Deck has some fine crazed cracking but no differential movement between honeycomb sections. 	<p>Photo</p>

<p>Deck edge spalling</p>
<p>Condition state 4 -Description</p> <ul style="list-style-type: none"> • Moderate cracking and spalling may be present with corrosion of the reinforcement causing moderate loss of section in areas. • Patches of dampness and efflorescence may be large with numerous stalactites and lime flows visible. • The characteristic shrinkage crack along the centre of flat slab bridges may be medium with some moisture and staining around the crack. • Deck has extensive crazed cracking but no differential movement between honeycomb sections. 	<p>Photo</p>

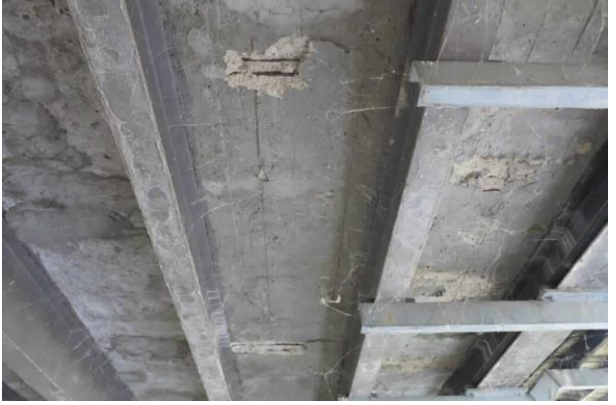
<p>Cracking and spalling in all bays of the deck</p>

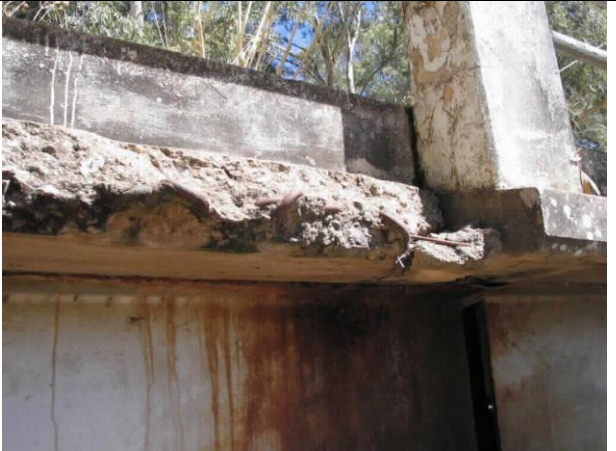
<p>Condition state 5 -Description</p> <ul style="list-style-type: none"> • Severe cracking and spalling may be present with advanced corrosion of the reinforcement over large areas, with more severe loss of section of reinforcement (and any cracking or spalling associated with it). • The characteristic shrinkage crack along the centre of flat slab bridges may be severe with excessive moisture penetration and heavy staining around the crack. • Deck has extensive honeycomb cracking with differential movement between sections of the deck, i.e. lateral load distribution has been greatly affected. 	<p>Photo</p>

<p>Deck edges with severe spalling and cracking</p>

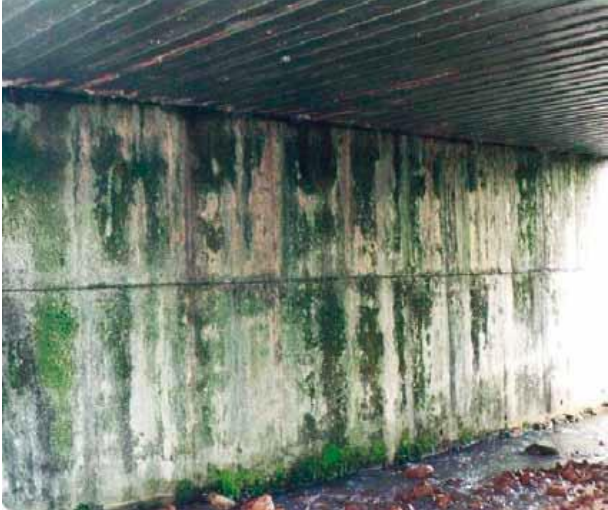
Condition state 1 -Description	Photo	
<ul style="list-style-type: none"> • There is no cracking of the concrete infills. The underside of the rails may have minor rusting. • The deck does not deflect excessively under load.

<p>Steel rails in concrete deck with only minor rusting of the rails (VicRoads)</p>	
Condition state 2 -Description	Photo	
<ul style="list-style-type: none"> • There may be fine transverse cracks in the infills at midspan but no longitudinal cracking along the rail/concrete interface. • The rails may be quite rusty but no pitting or corrosion is occurring. • Distributor rails may be slightly loose or there may be minor cracking and spalling of the concrete encasement. • The deck is not deflecting excessively under load. 	<p>Not available.</p>

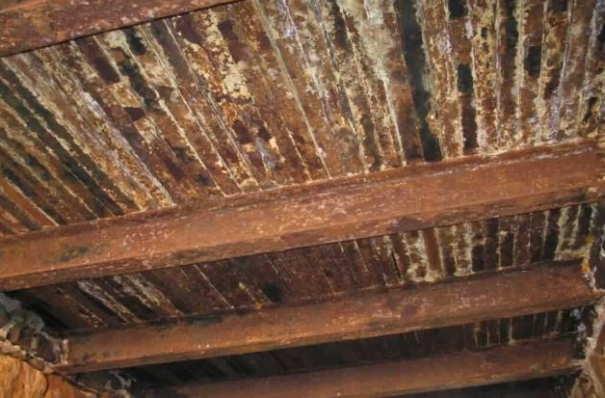
Condition state 3 -Description	Photo
<ul style="list-style-type: none"> • There may be minor transverse cracks in the infills at midspan but no longitudinal cracking along the rail/concrete interface. • The rails may be quite rusty with slight pitting or corrosion occurring. • Distributor rails may be slightly loose or there may be moderate cracking and spalling of the concrete encasement. • The deck is not deflecting excessively under load. • If thin cover concrete has been cast under the rails then heavy spalling of the cover concrete will occur when the rails rust. This is only of concern when the cover concrete begins to disintegrate in the bearing area.

<p data-bbox="794 600 1364 660">Minor corrosion of the rails especially at the ends of deck</p>
Condition state 4 -Description	Photo
<ul style="list-style-type: none"> • There may be medium transverse cracks in the infill concrete coupled with cracking or minor edge spalling along the rail/concrete interface. • Rails may be moderately rusty with moderate to heavy corrosion occurring. • Distributor rails may be quite loose or encasement concrete may be heavily spalled. • The deck may deflect substantially under load due to some loss of lateral distribution. • Cover concrete has cracked, spalled or is crushing under the rails at the bearing areas and a mortar or a neoprene rubber strip will need to be placed under the rails. • Steel deck plates may be loose allowing the plate to move or sit up, causing a tripping hazard for pedestrians. • Steel steps may be loose, well worn or corroded or cracked at the edges or side beam joint.

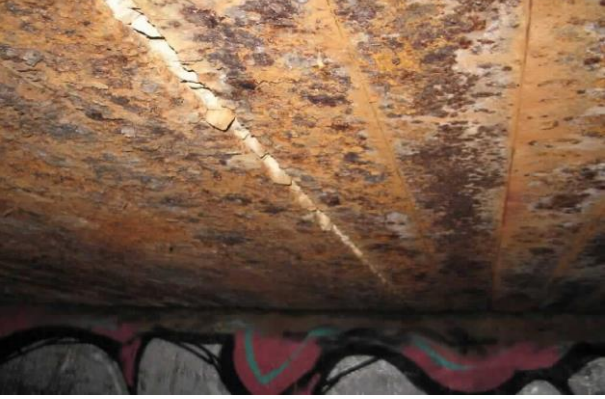
<p data-bbox="794 1252 1129 1281">Heavy corrosion of rail decking</p>

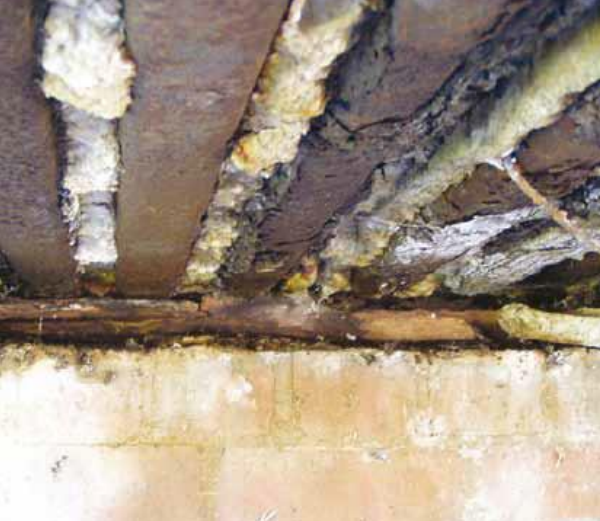
Condition state 5 -Description	Photo
<ul style="list-style-type: none"> • Heavy cracking, spalling or crumbling of the infill concrete is occurring with loss of strength and lateral distribution. Consequently the deck is deflecting excessively under load. • The rails may be heavily pitted and corroded. Distributor rails will possibly be very loose or have broken away. • If the rails only have concrete up to the head of the rail, the outer rails may separate from the deck as bond is lost between rail and concrete. • These bridges have much reduced capacity due to lack of lateral distribution. • Holes may be found as concrete is pushed through the deck. • Steel steps may be broken and require replacement or re-welding. • Steel deck plates may be very loose and buckled requiring replacement

<p data-bbox="794 728 1396 784">Steel rails heavily corroded and concrete infill cracked and breaking up (VicRoads)</p>

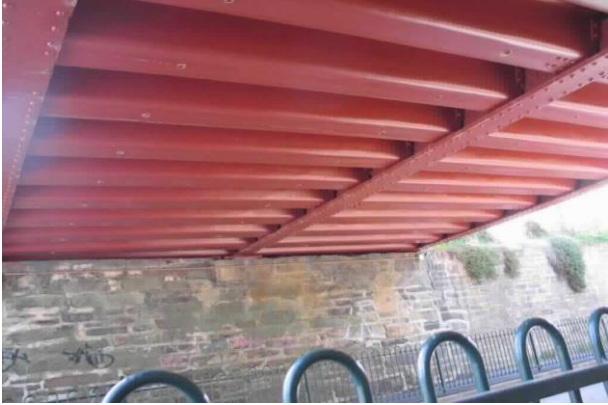
Condition state 1 -Description	Photo
<ul style="list-style-type: none"> The steel is in good condition with only minor rusting at the joints. The surfacing or infill is in good condition with no cracking, rutting or potholes. The decking units are well bolted to the support, or all rivets are good and tight. Connections between the units are in good condition with no separation.

<p data-bbox="791 600 1401 658">Steel trough decking supporting deck material in sound condition</p>
Condition state 2 -Description	Photo
<ul style="list-style-type: none"> There is rusting and minor corrosion at the joints but all bolting, tap screw connections, welds or rivets are good and tight. There may be minor cracking and rutting of the asphalt surface.

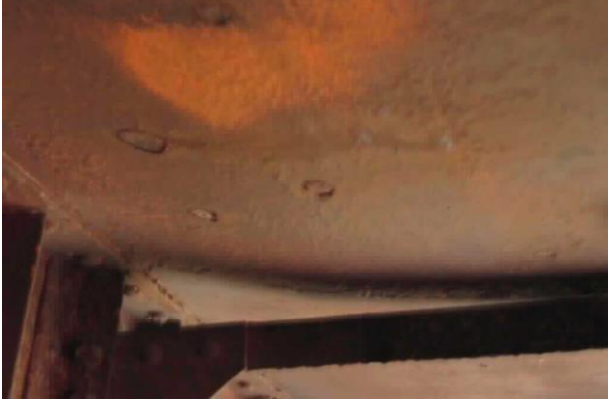
<p data-bbox="791 1099 1401 1128">Paint failure evident on buckle plate</p>
Condition state 3 -Description	Photo
<ul style="list-style-type: none"> Moderate corrosion is occurring at the joints and buckle plates are showing minor leakage at the joints. With trough decking the welds between the units may have minor cracking or some tap screws may be loose with minor separation of the units. The hold down of the units may be slightly loose allowing too much flexing of the sections. Asphalt surface may have medium cracking, rutting, small broken up areas or small potholes.

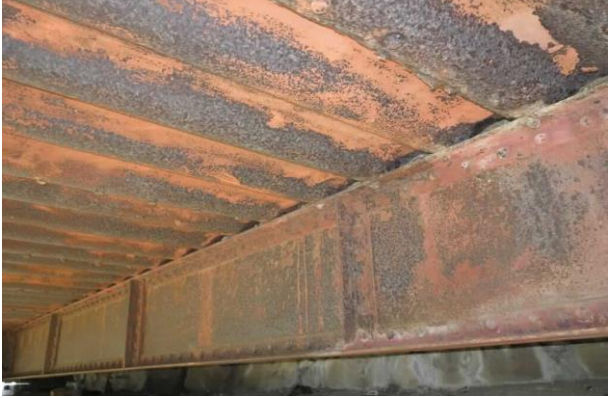
<p data-bbox="791 1570 1401 1599">Corrosion of corrugated steel decking</p>

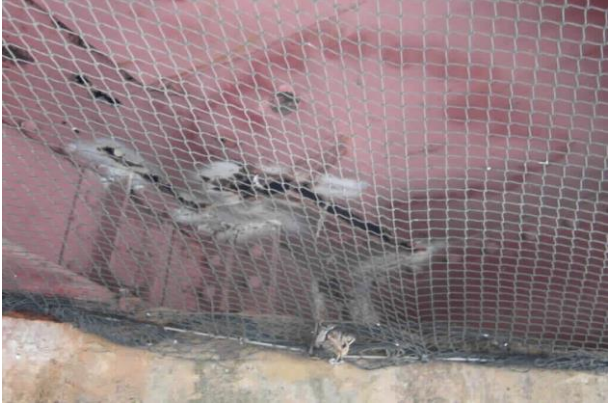
Condition state 4 -Description	Photo
<ul style="list-style-type: none"> • Medium corrosion is occurring at the joints. • Buckle plates show moderate leakage at the joints with small stalactites forming. • With trough decking the welds between the units may have moderate cracking or some tap screws may be loose or sheared off with minor separation of the units. • The hold down of the units may be loose allowing too much flexing of the sections. • Asphalt surface may have moderate cracking, rutting, broken up areas or potholes. • Concrete infill may be breaking up allowing excessive moisture penetration.

<p data-bbox="791 600 1125 629">Corrosion of steel buckle plate</p>
Condition state 5 -Description	Photo
<ul style="list-style-type: none"> • Heavy corrosion is occurring with holes appearing in the trough decking and concrete or asphalt fill above. • Trough decking units may be separating with many of the joining tap screws broken or missing, may also be cracked transversely to the ribs • Hold down bolts may be completely loose and the sections are flexing up and down under load. • The asphalt surfacing is severely cracked, rutted, or has large badly broken areas and potholes. • Rivets holding the buckle plates in position may have sheared or the edge material of the buckle plates may have sheared. • The buckle plates may have severely corroded with holes appearing. • Large stalactite growths indicate excessive moisture penetration of the severely cracked weak concrete above. • Holding down bolts and/or channels may be severely corroded.
