Road Structures Inspection Manual

Part 4A: Condition State Guidelines and Photographs

Bridges

RAS Document No: RAMA-ST-PRC-048
Knet Document No: 14888945
Document version: 1.3 (08/05/2020)

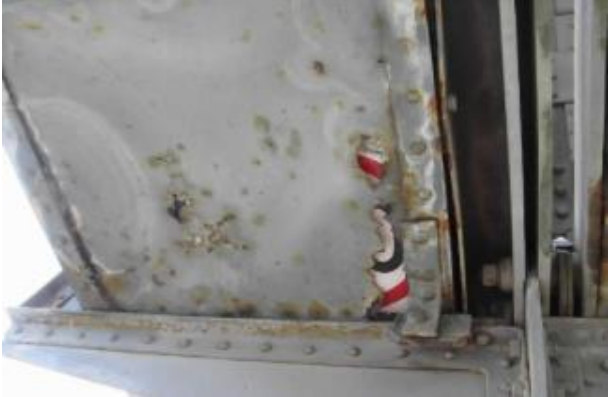
<p data-bbox="791 1312 1252 1341">Severe corrosion and holes in buckle plate</p>

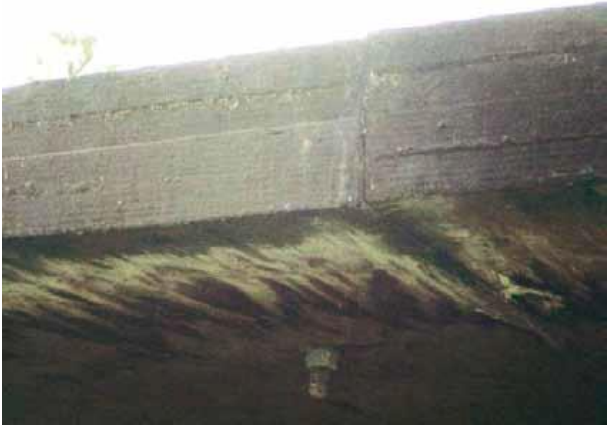
12T - Deck / slabs – timber		Units
<p>This component includes all types of timber decks constructed using fully treated timber and acting as a plate deck. Included in this component are nailed laminated pine decks, stress laminated timber decks and glued laminated timber sheet decks either as a longdecking or crossdecking replacement or as a span replacement.</p>		<p>m² of exposed surface area</p>
Condition state 1 -Description	Photo	
<ul style="list-style-type: none"> The timber may have minor cracks, splits or checks but is fully protected by the preservatives, with no untreated heartwood. The decks are well bolted to the supports. Tensioning rods have adequate stressing and there is no damage to the timber at the stressing plates.

<p>Transverse 'Bridgewood' glued laminated decking in good condition (VicRoads)</p>	
Condition state 2 -Description	Photo	
<ul style="list-style-type: none"> Preservative protection may be beginning to dissipate with small leaching of preservative salts (white powder on underside of deck) and with some weathering and rot of timber. Bolting of the deck may be slightly loose with fine reflective cracks through the asphalt on top. Tensioning rods should still have adequate stressing and there should be no damage to the timber at the stressing plates.

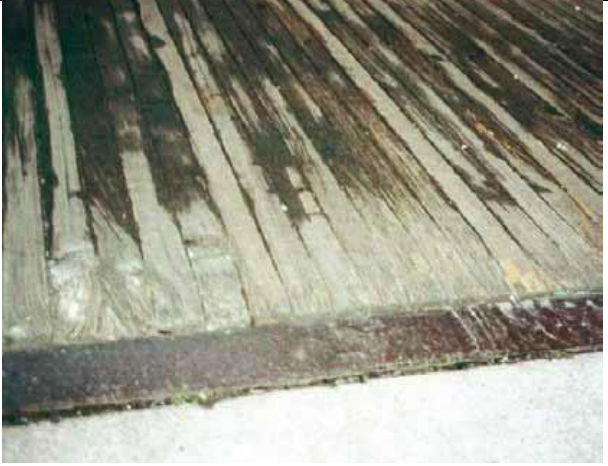
<p>Nailed laminated pine decking showing signs of weathering and end decay (VicRoads)</p>

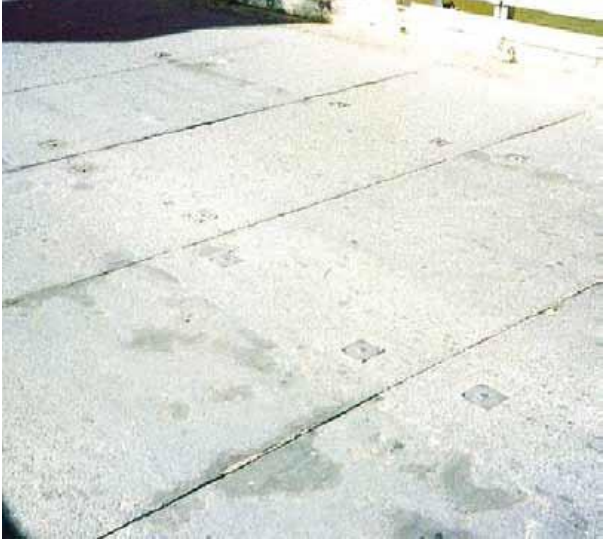
Condition state 5 -Description	Photo
<ul style="list-style-type: none"> • Deterioration of the timber may be well advanced with substantial loss of the preservative protection. • Weathering and rot of the timber is severe with some laminations almost rotted out. Bolting of the decks is very poor with excessive movement of the decking. • If small washers were used, the bolts may have punched through the decking which lead to loose panels. • Tensioning rods may be loose with movement and separation of the laminations. • Longitudinal cracking in the asphalt above the laminations will be seen if this is occurring. • The decking will also deflect excessively under load as the lateral distribution has been severely affected.

<p>'Bridgewood' decking sheets showing edge damage to top ply layers. Bolting is loose with one sheet having lost all intermediate hold down bolts (VicRoads)</p>

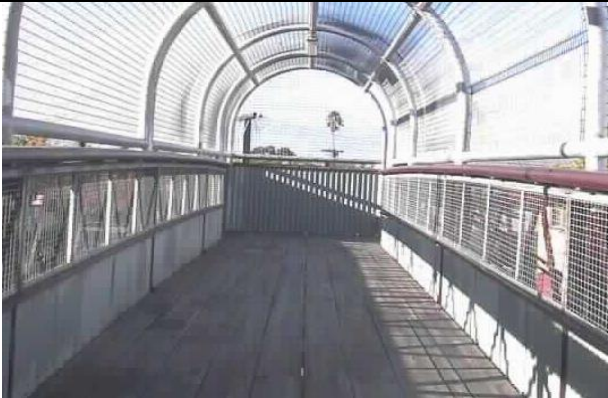
13T - Longdecking / crossdecking – timber		Units
<p>This component includes all timber planked decking systems whether the system is longdecking or crossdecking with or without thin longitudinal running planks, though the latter system is generally to be found on lower classified roads. If timber spiking planks are used with the crossdecking, then their condition should also be considered as part of this component.</p>		<p>m² of exposed surface area</p>
Condition state 1 -Description	Photo	
<ul style="list-style-type: none"> The timber is in good condition with only minor checks, splits or weathering having no effect on strength. The longdecking is tightly bolted at the ends and each alternate crossbeam. Longdecking is continuous over at least 3 crossbeams. Crossdecking is firmly held at each stringer or spiking plank and running planks are firmly held to the crossdecking. Crossdecking should also span across 3 supports.

<p>Longdecking in good condition</p>

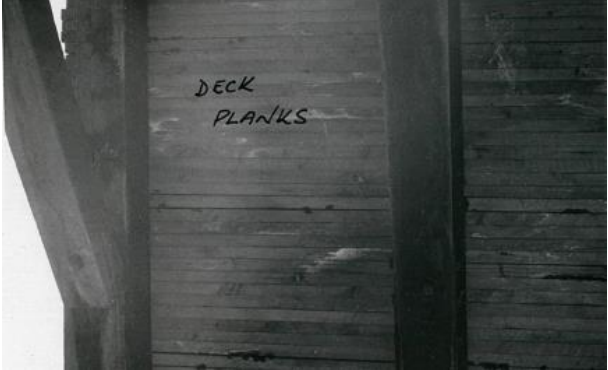
Condition state 2 -Description	Photo	
<ul style="list-style-type: none"> The timber shows only minor signs of decay, weathering, splitting or checks but does not affect the strength of the members. Bolted connections may be slightly loose or longdecking is only held down at the ends of the planks. Crossdecking may be slightly loose or not bolted at each support. Running planks may be slightly loose or held down at the ends only. Spiking planks are in good condition.

<p>Crossdecking with minor signs of weathering</p>

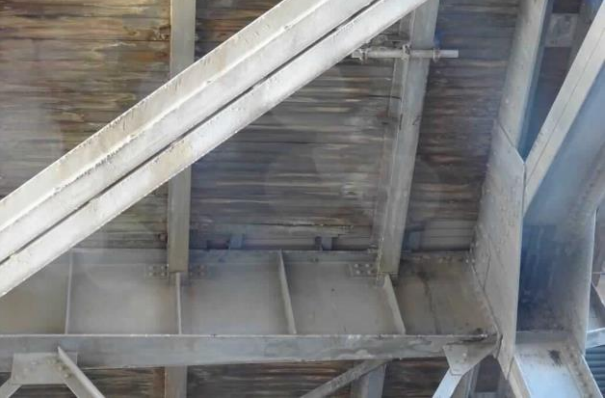
Condition state 3 -Description	Photo
<ul style="list-style-type: none"> • The timber shows moderate signs of decay, weathering, splitting or checks but does not affect the strength of the members. • Bolted connections may be slightly loose or longdecking is only held down at the ends of the planks. • Crossdecking may be slightly loose or not bolted at each support. • Running planks may be slightly loose or held down at the ends only. • The spiking planks may have minor rot, splits or are loose but still serviceable.

<p data-bbox="794 600 1407 663">Timber crossdecking generally sound (despite appearance)</p>
Condition state 4 -Description	Photo
<ul style="list-style-type: none"> • Medium decay, weathering, splitting or checks may be present, affecting the strength of the member to a minor extent. • Bolted connections may be loose or the longdecking may only have two supports. • Crossdecking may be rotting beneath the running planks, or may only have 2 supports, or may be allowing the member to move excessively under load. • Running planks may be split with sections broken away or the planks split in half. • The spiking planks may have moderate rot, splits or are loose but still serviceable.

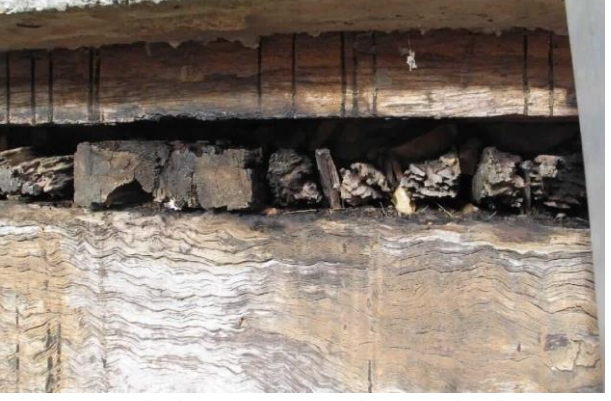
<p data-bbox="794 1111 1407 1137">Timber crossdecking in poor condition with edge rot</p>

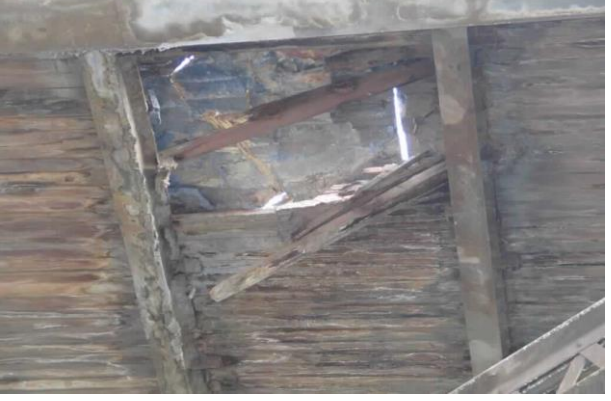
Condition state 5 -Description	Photo
<ul style="list-style-type: none"> • The member is heavily damaged, weathered, split or rotted which affects the strength of the member. • Ends of the longdecking may be in poor condition and bolting may be completely loose allowing the member to flap up and down when loaded. • Crossdecking may be severely rotted under the longdecking or may be completely loose. • Running planks are split, broken or completely loose. • The spiking planks may be split in two and no longer effective or they may have fallen out completely.

<p data-bbox="794 1794 1407 1821">Hole in timber crossdecking</p>

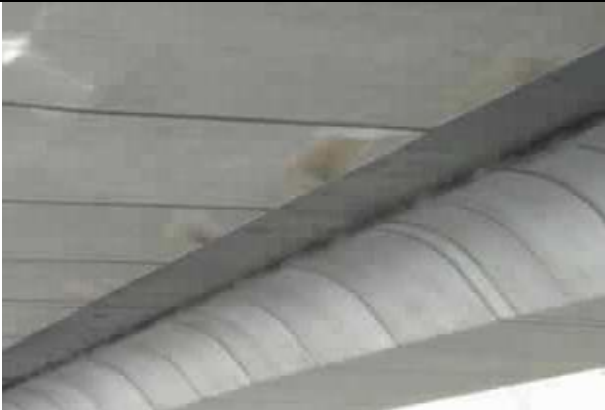
14P - Girders – closed web / box girder – precast concrete		Units
<p>This component includes all closed web or box girder bridges constructed of precast units and includes segmental post tensioned box girders and precast prestressed bath tub beams with a cast-in-situ deck to form the closed box shape. This component includes the deck whether precast with the box or cast in-situ at a later date.</p>		<p>m² of exposed surface area</p>
Condition state 1 -Description	Photo	
<ul style="list-style-type: none"> • There may be only minor cracking of the units due to corroding reinforcement or lack of distribution reinforcement but definitely no spalling or cracking of a structural nature or exposure of stressing ducts. • Some minor discolouration or white efflorescence powder may be visible at the former lifting holes.

<p>Hint of efflorescence and discolouration on underside of box</p>	
Condition state 2 -Description	Photo

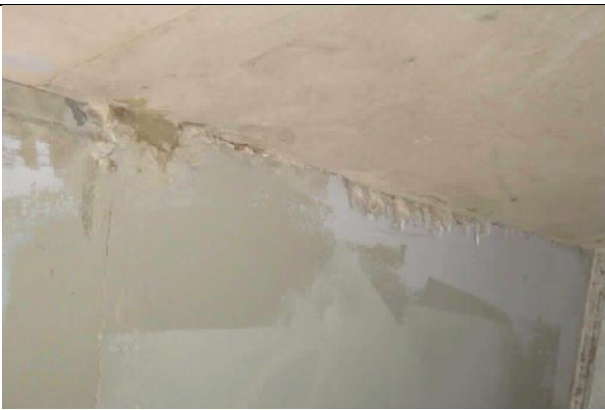
<ul style="list-style-type: none"> • There may be a few minor cracks or spalls due to corroding reinforcement in locations but there should be no exposure of any stressing tendons or stressing ducts. • Some minor discolouration or white efflorescence powder may be visible at a few joints between the precast units.

<p>Minor spalling</p>

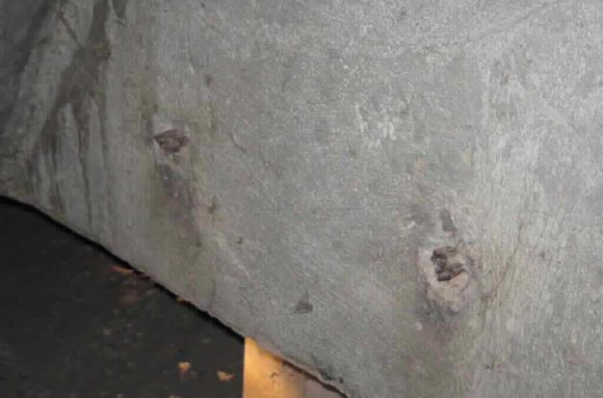
Condition state 3 -Description	Photo
<ul style="list-style-type: none"> • There may be some spalling in isolated areas with the stressing tendons or stressing ducts exposed but with little or no corrosion occurring. • Other exposed reinforcement may have minor corrosion of the bars in isolated areas.

<p data-bbox="794 598 1399 622">Exposed reinforcement in girder end block</p>
Condition state 4 -Description	Photo
<ul style="list-style-type: none"> • There may be some delamination or spalling in isolated areas with the stressing tendons or stressing ducts exposed with minor corrosion occurring. • Other exposed reinforcement may have moderate corrosion of the bars in isolated areas. 	Not available
Condition state 5 -Description	Photo
<ul style="list-style-type: none"> • There may be severe cracking due to structural defects or advanced corrosion of the reinforcement. • Delamination or spalling is present in large areas with heavy corrosion of reinforcing bars. • Stressing tendons exposed in the spalled areas may have moderate corrosion. Some strands may also be broken or there may be heavy cracking or failure at the anchorages. • There may also be lateral cracking of the underside of the box at the midspan or heavy cracking in the deck above the supports. 	Not available

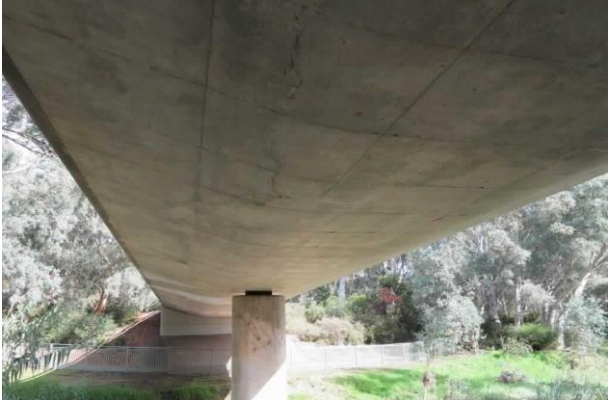
14C - Girders – closed web / box girder – cast in-situ concrete		Units
<p>This component includes all cast-in-situ, post tensioned concrete box girder and voided slab bridges, and includes the deck as part of the component. Voided slab bridges can be recognised by their shallow depth compared to a box girder. These structures are generally built on, or over freeways and are well suited to spans of 34 to 40 metres. Voided slabs greater than 35 metres will generally have a variable depth due to their massive dead load compared with box girders.</p>		<p>m² of exposed surface area</p>
Condition state 1 -Description	Photo	
<ul style="list-style-type: none"> • There may be minor cracking of the girder or deck due to corroding reinforcement or a lack of distribution reinforcement, but there should be no structural cracking or spalling. • Minor discolouration of efflorescence powder may be visible in a few locations.

<p>Minor cracking in voided slab</p>

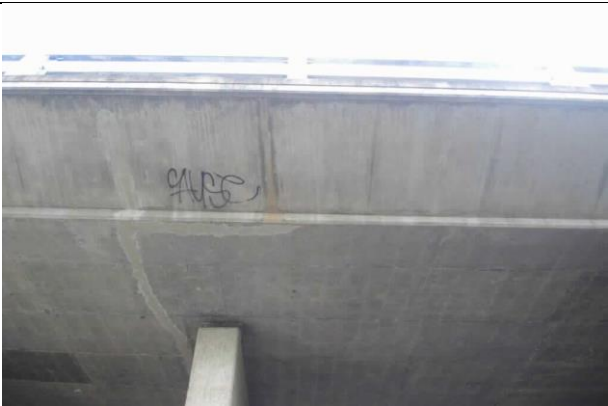
Condition state 2 -Description	Photo	
<ul style="list-style-type: none"> • There may be a few minor cracks or spalls due to corroding reinforcement in locations but there should be no exposure of the stressing ducts. • Some minor discolouration or white efflorescence powder may be visible in a few locations.

<p>Cracking in voided slab repaired with epoxy, performing satisfactorily</p>

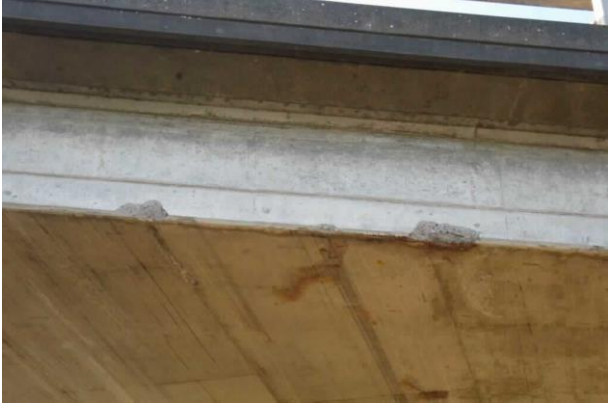
<p>Condition state 3 -Description</p> <ul style="list-style-type: none"> • There may be some spalling in isolated areas with the stressing tendons or stressing ducts exposed but with little or no corrosion occurring. • Other exposed reinforcement may have minor corrosion of the bars in isolated areas. 	<p>Photo</p>

<p>Spalling to voided slab girder edge</p>
<p>Condition state 4 -Description</p> <ul style="list-style-type: none"> • There may be some delamination or spalling in isolated areas with the stressing tendons or stressing ducts exposed with minor corrosion occurring. • Other exposed reinforcement may have moderate corrosion of the bars in isolated areas. 	<p>Photo</p> <p>Not available</p>
<p>Condition state 5 -Description</p> <ul style="list-style-type: none"> • There may be severe cracking due to structural defects or advanced corrosion of the reinforcement. • Delamination or spalling is present in large areas with heavy corrosion of reinforcing bars. • Stressing tendons exposed in the spalled areas may have moderate corrosion. Some strands may also be broken or there may be heavy cracking or failure at the anchorages. • There may also be lateral cracking of the underside of the box at the midspan or heavy cracking in the deck above the supports. 	<p>Photo</p> <p>Not available</p>

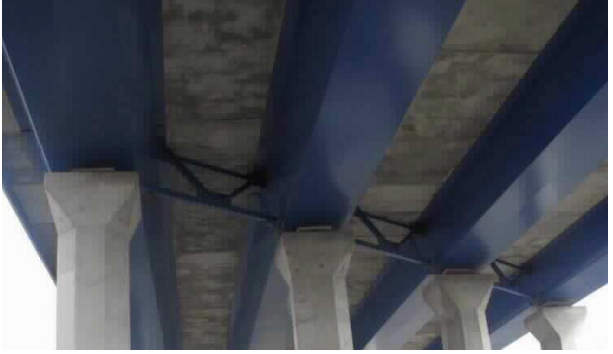
14S - Girders – closed web / box girder – steel		Units
<p>This component includes all closed web steel box girder bridges with concrete or steel deck closing the top of the box or boxes. The steel may be painted or galvanized. The component does not include the deck.</p>		<p>m² of exposed surface area</p>
Condition state 1 -Description	Photo	
<ul style="list-style-type: none"> The paint system is generally sound with minor chalking, peeling or curling but no exposure of the metal. All welds or bolts are in good condition with no corrosion, cracking or loose bolts.

<p>Steel box girders in good condition</p>	
Condition state 2 -Description	Photo	
<ul style="list-style-type: none"> Light rust spotting of the paint system to the surface area is occurring and the paint system is losing effectiveness. No corrosion or section loss has occurred. All welds or bolts are in good condition with no cracking, corrosion or loose bolts.

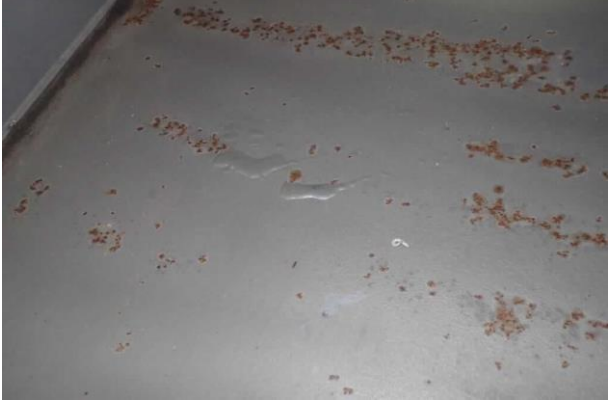
<p>Surface rust on girder floor</p>

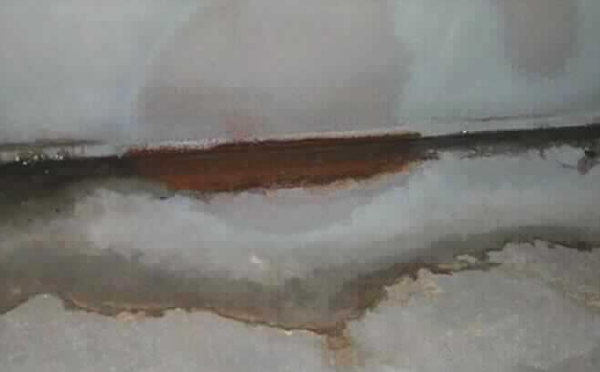
<p>Condition state 3 -Description</p> <ul style="list-style-type: none"> • Minor rust spotting of the paint system to the surface area is occurring and the paint system is no longer effective. Minor corrosion has occurred but has not affected the strength of the member as a whole. • Nuts and bolts are in fair condition and are still tight and no cracking of welds has occurred. 	<p>Photo</p>

<p>Rust on floor of girder caused by water ponding</p>
<p>Condition state 4 -Description</p> <ul style="list-style-type: none"> • Some surface pitting present and active corrosion is occurring in isolated areas, but no significant loss of area is occurring to affect the strength of the member as a whole. • Paint system has broken down with moderate surface rusting and pitting present in a number of locations. • Nuts and bolts may be corroded but are still tight and no cracking of welds has occurred. 	<p>Photo</p>

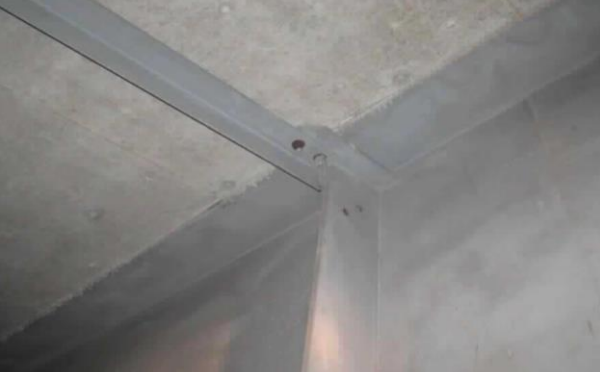
<p>Nut missing from stiffener inside box</p>

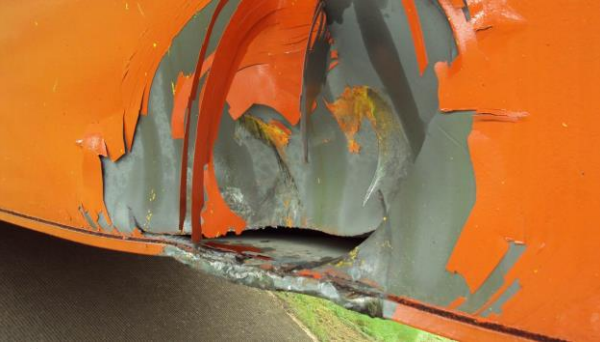
<p>Condition state 5 -Description</p> <ul style="list-style-type: none"> • Corrosion is well advanced and significant loss of section has definitely occurred which may have a detrimental effect on the strength of the member e.g. a flange badly corroded over much of its length. • Welds may be cracked. Nuts or bolts are severely corroded and possibly no longer functioning to full capacity. There is distortion of webs/soffit as a result of vehicular impact. • Protection coating system is completely lost 	<p>Photo</p>

<p>Collision damage to box girder</p>

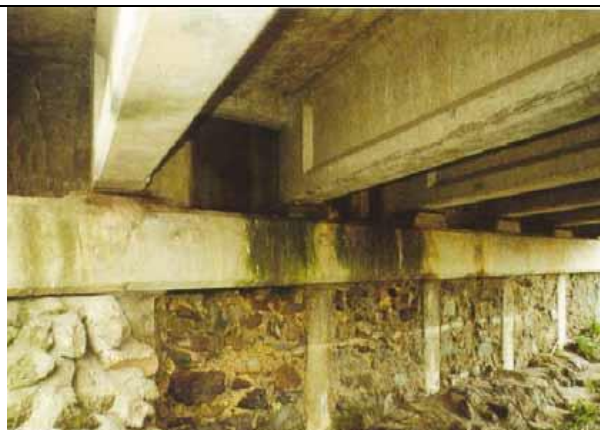
- The girders are in good condition with only very minor cracking due to corroding reinforcement, shrinkage, lack of curing.

Precast high strength reinforced concrete "I" beams in good condition (VicRoads)

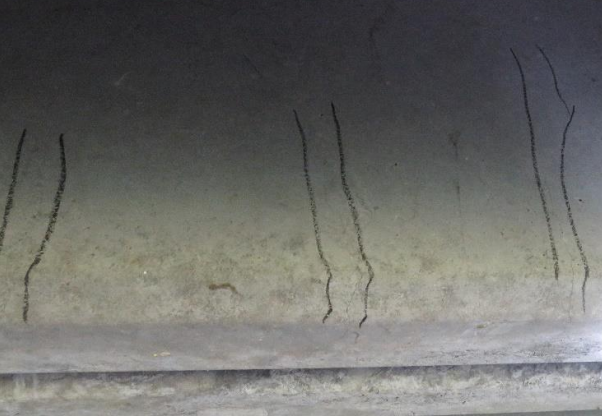
Condition state 2 -Description	Photo
<ul style="list-style-type: none"> Flexural cracking and cracking due to reinforcement corrosion is fine though no rust staining is visible in the cracks. A few minor spalls may be present. Fine cracking may have occurred at the bearing areas of the beam.

<p data-bbox="794 678 1398 734">Fine flexural cracking between 0.1 mm to 0.3 mm with no rust staining evident (VicRoads)</p>
Condition state 3 -Description	Photo
<ul style="list-style-type: none"> Flexural cracking and cracking due to reinforcement corrosion is minor with slight rust staining visible in the cracks. Minor spalling is present. Minor cracking may have occurred at the bearing areas of the beam.

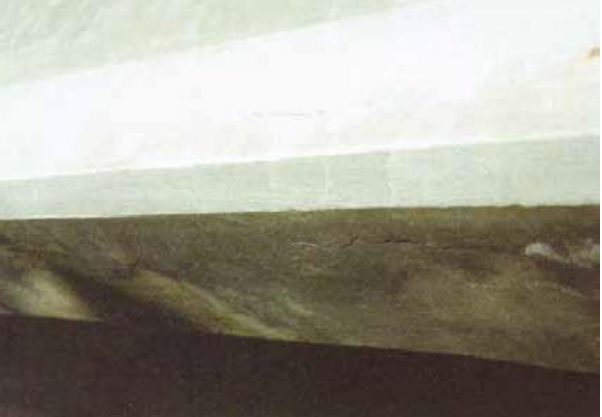
<p data-bbox="794 1202 1398 1258">Cracking along side and underside of reinforced concrete "I" beam (VicRoads)</p>
Condition state 4 -Description	Photo
<ul style="list-style-type: none"> Flexural cracking has increased with cracks in the medium size. Cracking due to reinforcement corrosion is medium and a number of spalls may have occurred, and/or heavy rust staining is present at the cracks. Where reinforcement is close together, some delamination of the concrete may have occurred. Moderate loss of section of corroding reinforcement is evident. Medium cracking may have occurred at the ends of the beam affecting the bearing area of the unit.

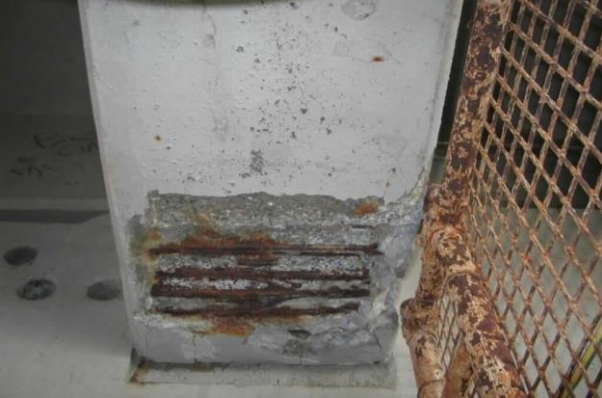
<p data-bbox="794 1709 1398 1765">Large spall to underside of reinforced concrete beam, with rust staining and corrosion present</p>

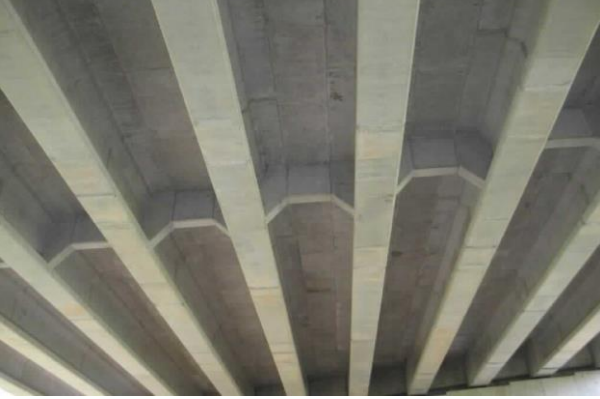
Condition state 1 -Description	Photo
<ul style="list-style-type: none"> The beams are in good condition with only very minor cracking due to corroding reinforcement, shrinkage, lack of curing or prestressing (longitudinal cracks in webs of ends of girder).

<p data-bbox="794 1070 1396 1093">Prestressed beams in good condition</p>
Condition state 2 -Description	Photo
<ul style="list-style-type: none"> The beams may have minor cracking due to corrosion of reinforcement but there is no rust staining in cracks. There are a few minor spalls but the stressing strand is not exposed. Impact damage has not exposed reinforcement (some minor discoloration or efflorescence powder may be visible at joints between segments).

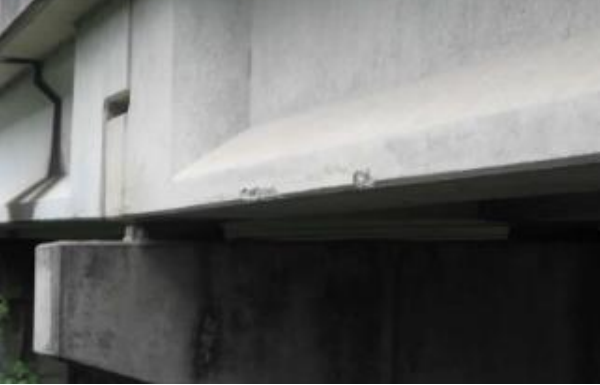
<p data-bbox="794 1534 1396 1554">Minor spalls in bottom flange of prestressed beam</p>

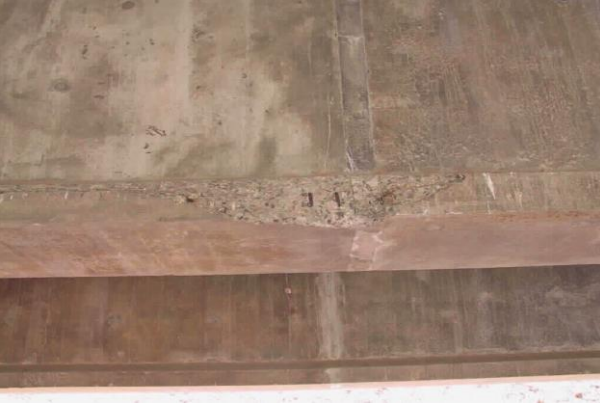
<p>Spalling to girder</p>
<p>Condition state 4 -Description</p> <ul style="list-style-type: none"> • Cracking has increased in size and a few medium spalls or delaminations may have occurred exposing stressing strands and/or heavy rust staining is present at the cracks • The stressing strands should only have very minor corrosion whilst non-prestressed reinforcement may moderate loss of section. • Medium cracking may have occurred at the ends of the beam affecting the bearing area of the unit. • Medium flexural cracks may be evident in beams. 	<p>Photo</p>

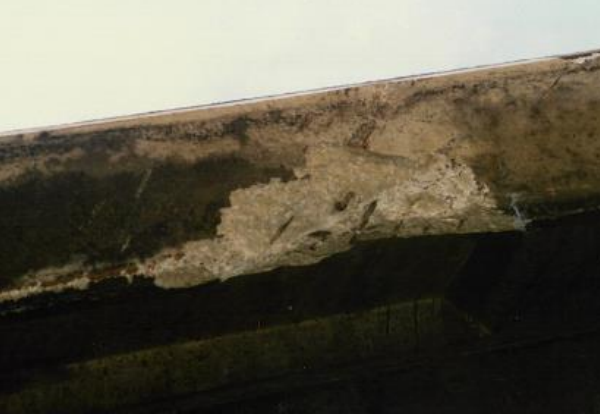
<p>Medium spalling and broken ligature to girder, caused by overheight train impact</p>

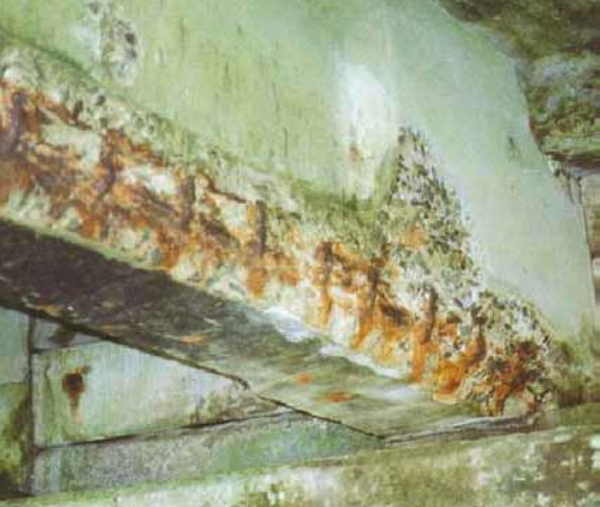
<p>Severe spalling along bottom of beam with corroding reinforcement (VicRoads)</p>

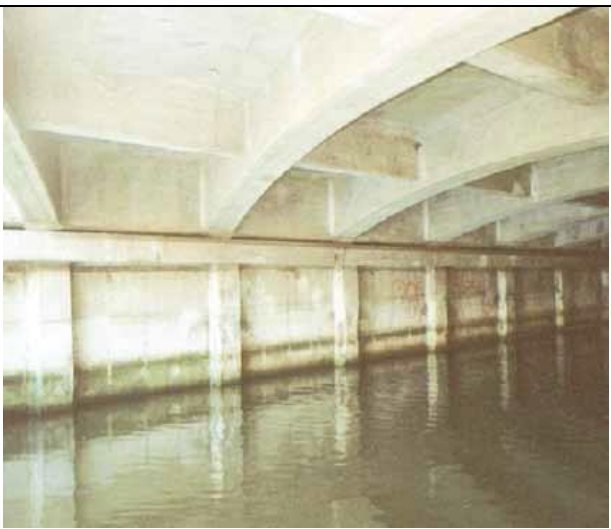
Variable depth cast-in-situ RC T-beams in good condition with diaphragm bracing at quarter points of span (VicRoads)	
Condition state 2 -Description <ul style="list-style-type: none"> The girders may have fine flexural and/or shear cracking. Vertical shrinkage cracks and cracking at built-in supports may be fine. Longitudinal cracking along the bottom of the beams due to reinforcement corrosion may be of fine size with minor spalling. The ends of simply supported beams may have minor cracking in the bearing areas due to the bearings or locating dowels. 	Photo

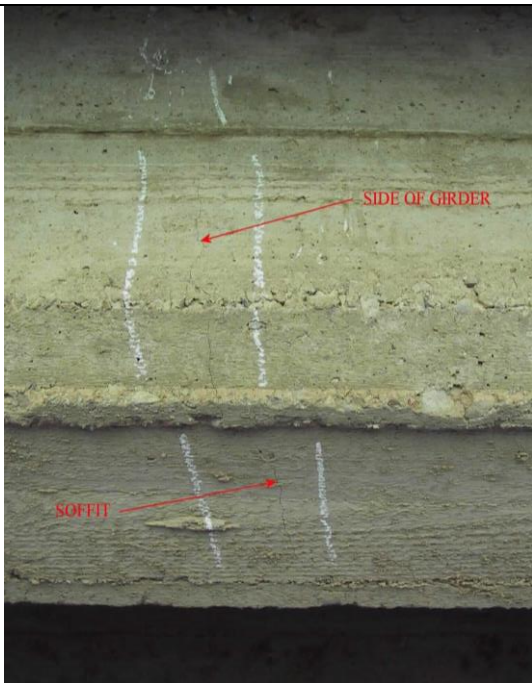
Fine flexural cracking between 0.1 mm to 0.3 mm with no rust staining evident

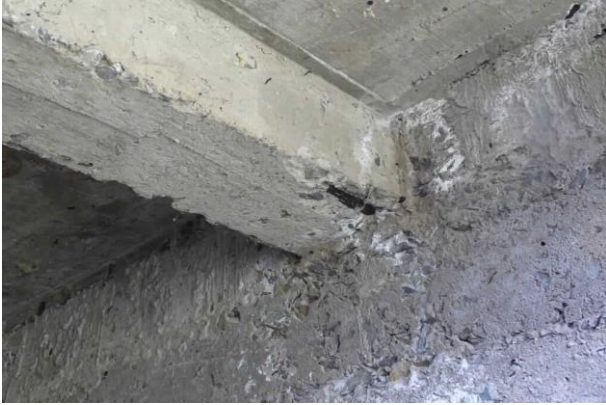
<p data-bbox="791 600 1399 631">Spall with exposed reinforcement at underside of girder</p>
Condition state 4 -Description	Photo
<ul style="list-style-type: none"> • Flexural cracking and shear cracking may be medium sized with moderate cracking along the beam deck joint. • Vertical shrinkage cracks and cracking at built-in supports may be medium in size. • Longitudinal cracking may be medium along the bottom of the beams due to reinforcement corrosion and there may be large spalls with delaminated cover concrete. • Exposed reinforcement may have heavy corrosion with moderate section loss in areas. The beams may have medium cracking in the bearing areas at the ends of the beams.

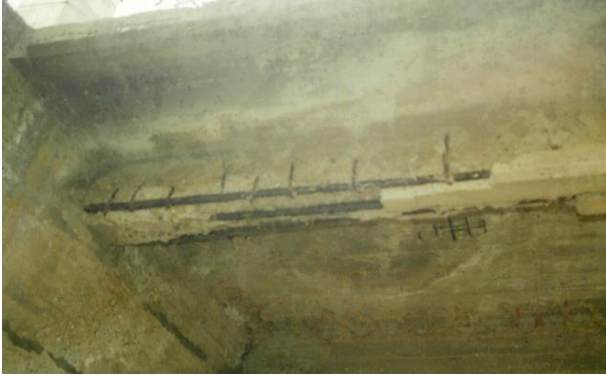
<p data-bbox="791 1149 1399 1211">Heavy spalling along underside of beam with heavy corrosion of reinforcement</p>

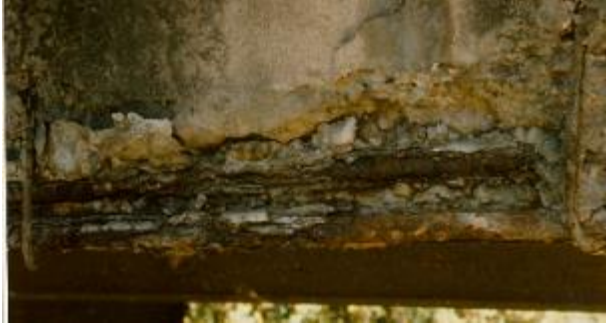
<p data-bbox="791 1709 1399 1771">Severe spalling and heavy corrosion with significant loss of section</p>

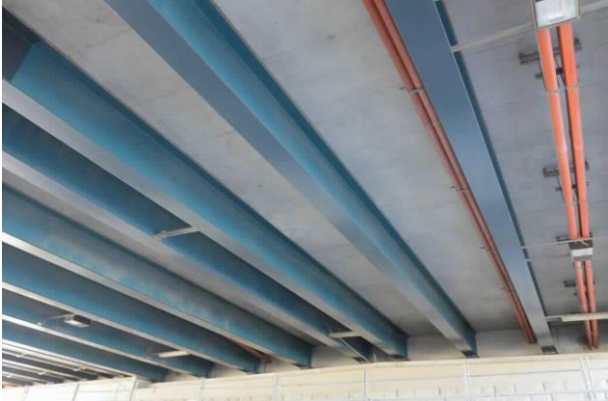
<p>Steel girders in good condition</p>	
Condition state 2 -Description	Photo	
<ul style="list-style-type: none"> Light spot rusting of the paint or galvanising system to the surface area is occurring and the paint system is losing effectiveness. No corrosion of the section has occurred. All welds, bolts or rivets are in good condition with no movement of plates or sections in the component.

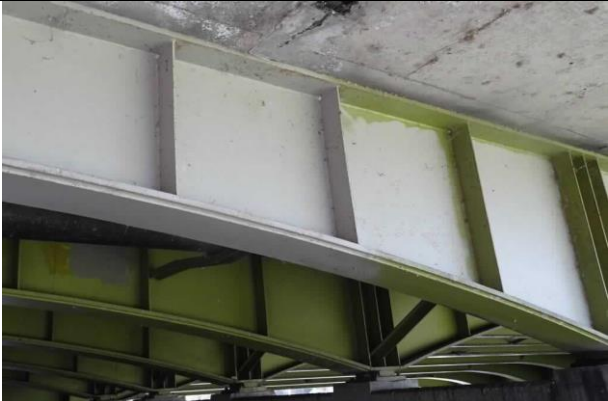
<p>Paint starting to show rust in top and bottom flange areas</p>

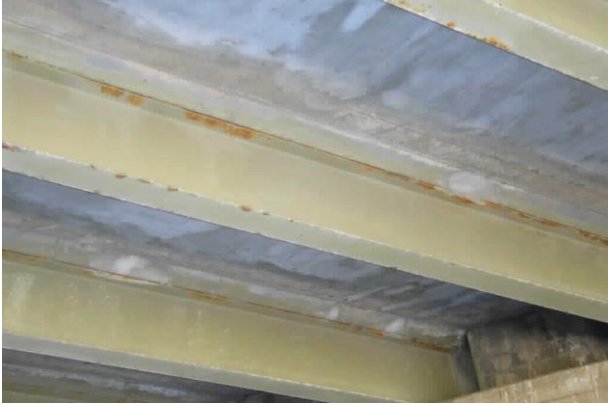
<p>Rusted flanges and webs</p>
<p>Condition state 4 -Description</p> <ul style="list-style-type: none"> • The paint or galvanising system has completely broken down with surface pitting in locations. • Active corrosion may be occurring in isolated areas but no loss of section area has occurred which would affect the strength of the member. • Nuts and bolts may be corroded but are still tight and no cracking of welds has occurred. • Riveted plates may have very minor movements of 1 to 2 mm but rivets are generally sound. 	<p>Photo</p>

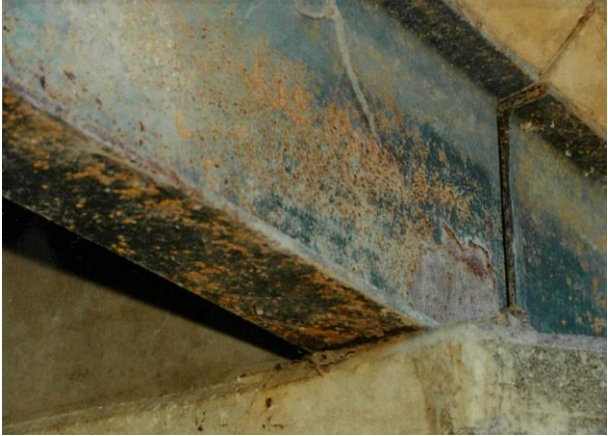
<p>Pitting corrosion of girder especially at end</p>

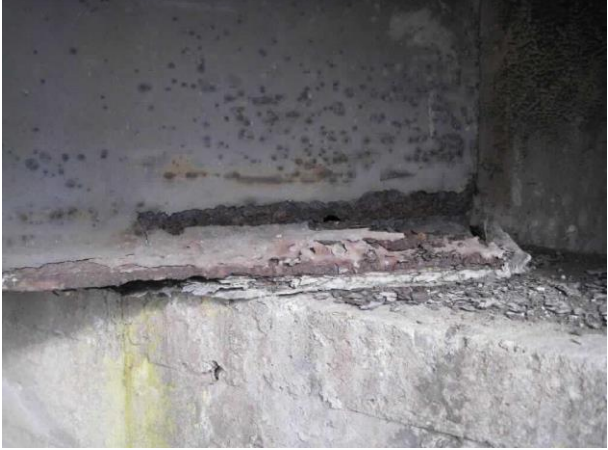
<p>Severe corrosion of girder at ends, with significant flange loss and perforation of web</p>

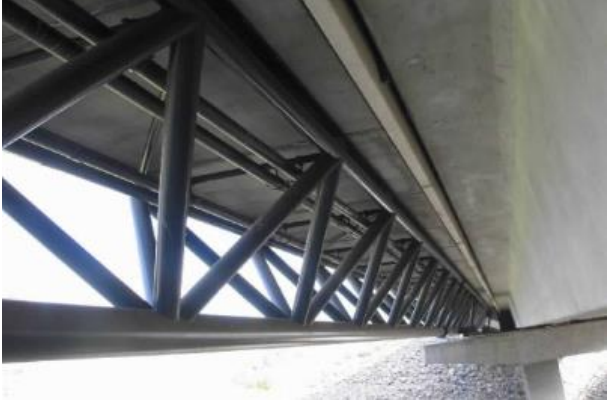
<p data-bbox="791 842 1401 875">Steel deck truss in good condition</p>	
Condition state 2 -Description	Photo	
<ul style="list-style-type: none"> Rust spotting of the paint system is occurring and the paint system is losing effectiveness. No corrosion or section loss has occurred. Welds or bolts are in good condition with no cracking, corrosion or loose bolts. Isolated pigeon droppings in bottom chords of truss

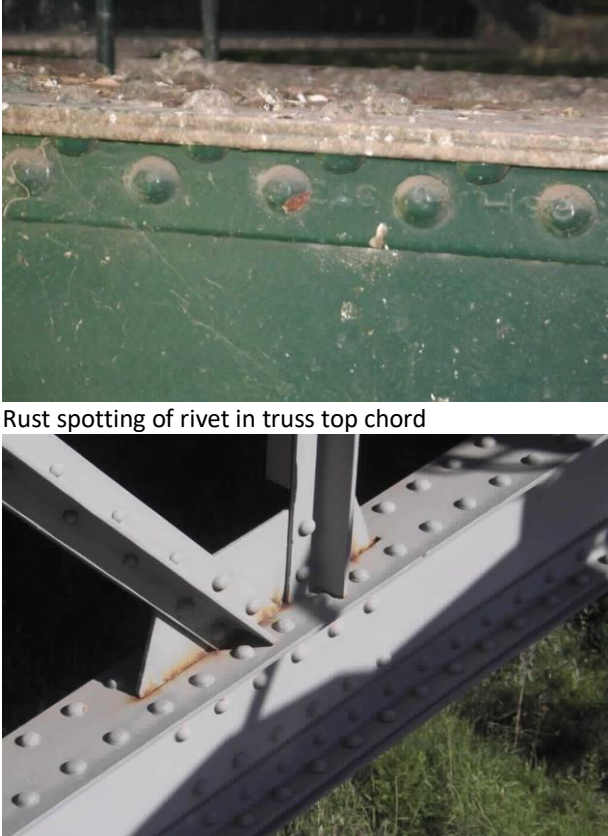
<p data-bbox="791 1312 1401 1346">Rust spotting of rivet in truss top chord</p> <p data-bbox="791 1742 1401 1774">Rust spots bottom truss chord</p>

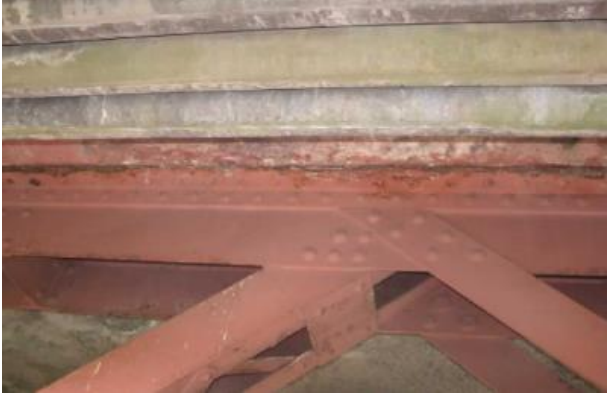
<p data-bbox="791 584 1401 613">Corrosion and rivets missing in top chord of truss</p>
Condition state 4 -Description	Photo
<ul style="list-style-type: none"> • Active corrosion is occurring in isolated areas, but no loss of area is occurring to affect the strength of the member as a whole. • Paint system has broken down with surface pitting present in a number of locations. • Nuts and bolts may be corroding but are still tight and no cracking of welds has occurred.

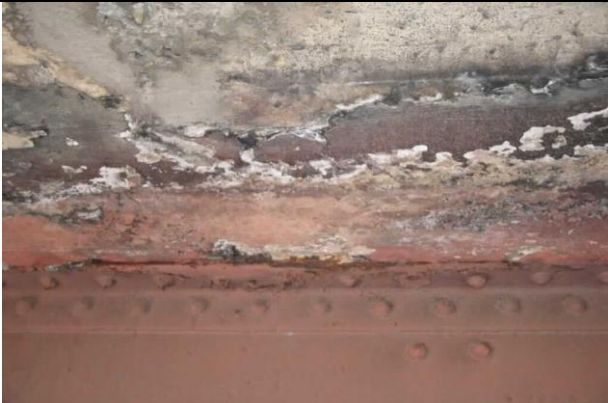
<p data-bbox="791 1048 1401 1081">Corrosion of flange of top chord of truss</p>

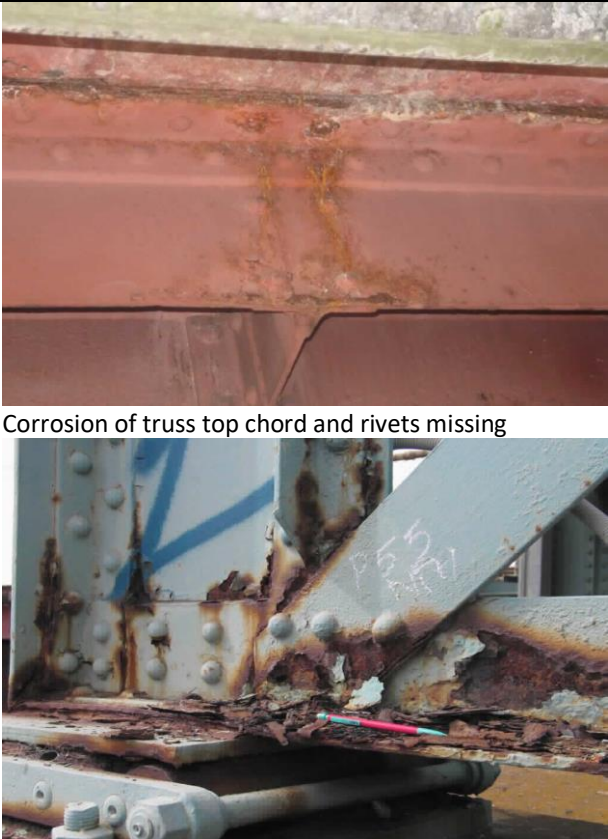
<p data-bbox="791 1518 1401 1552">Corrosion of truss top chord and rivets missing</p> <p data-bbox="791 1951 1401 1977">Heavy corrosion and pitting of truss at support</p>

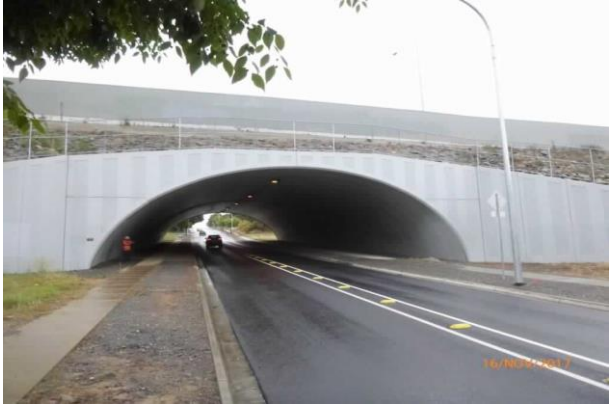
<p>Precast concrete arch in good condition.</p>	
<p>Condition state 2 -Description</p> <ul style="list-style-type: none"> • The component may have slight cracking and spalling due to corroding reinforcement, or simply a construction joint opening up. • There may be patchy scaling of the concrete surface with an increase in white efflorescence powder on the surface. • Shape, line and level of the arch units should be good and straight. • The footing may have minor cracking and spalling due to corroding reinforcement, but no cracking due to movement or differential settlement. 	<p>Photo</p>

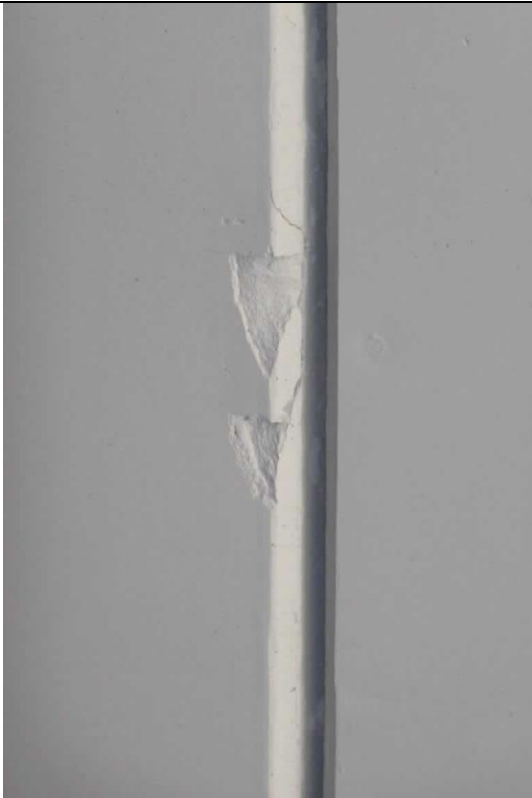
<p>Chipping in edge of precast unit</p>

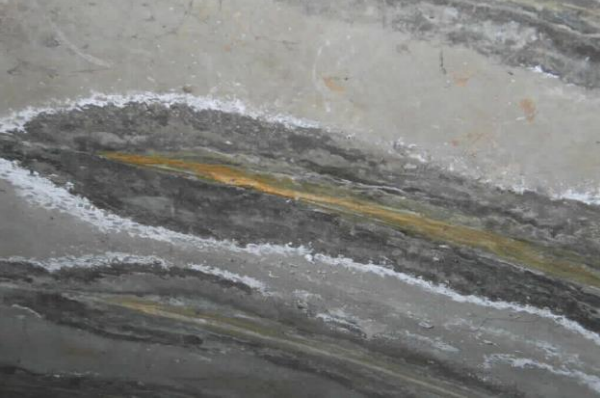
<p data-bbox="794 598 1310 629">Efflorescence due to leaking construction joints</p>
Condition state 4 -Description	Photo
<ul style="list-style-type: none"> The component may have medium cracking and spalling due to corroding reinforcement. Scaling and efflorescence may be prevalent. The arch may be beginning to lose shape with a flat spot at the top due to movement of a footing, or there may be minor cracking due to differential movement of the foundations. 	<p data-bbox="794 768 938 799">Not available</p>

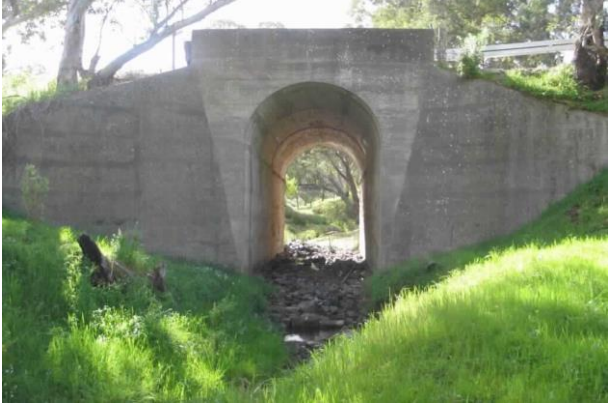
<p data-bbox="791 846 1404 880">Cast-in-situ concrete arch in good condition</p>	
Condition state 2 -Description	Photo	
<ul style="list-style-type: none"> The component may have slight cracking and spalling due to corroding reinforcement, or there may be a fine horizontal crack in the portal wall at the thickening, due to earth pressures on the walls or simply a construction joint opening up. There may be patchy scaling of the concrete surface with an increase in white efflorescence powder on the surface.

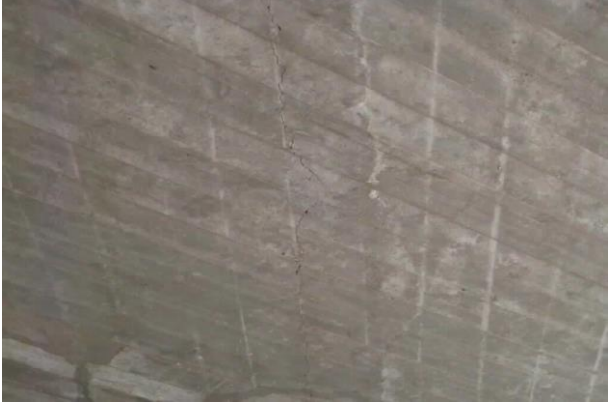
<p data-bbox="791 1317 1404 1344">Minor crack along arch centreline</p>

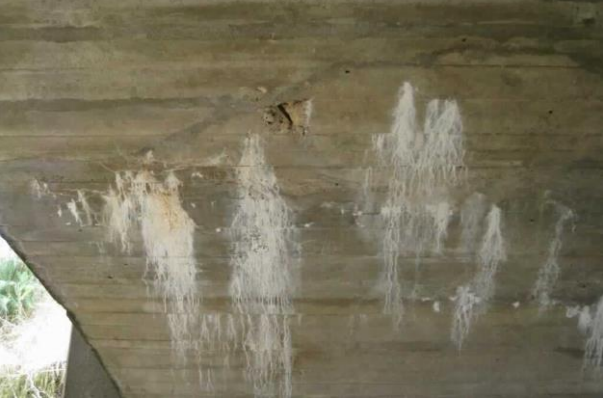
<p data-bbox="794 600 1399 622">Deck spall and efflorescence on arch soffit</p>
Condition state 4 -Description	Photo
<ul style="list-style-type: none"> The component may have moderate cracking and spalling due to corroding reinforcement or there may be a medium size horizontal crack in the portal wall at the thickening. In arches there may be leakage, staining and spalling at the arch/side wall joint due to wet fill inside the arch. Scaling and efflorescence may be prevalent. The arch may be beginning to lose shape with a flat spot at the top due to movement of a footing, or there may be cracking due to slight differential movement of the foundations.

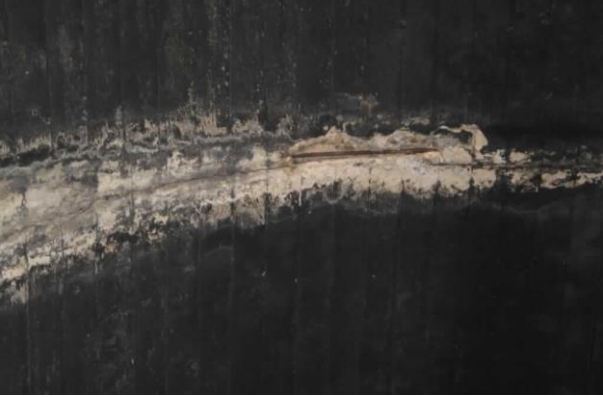
<p data-bbox="794 1070 1399 1093">Exposed reinforcement and spalling in the arch soffit</p>

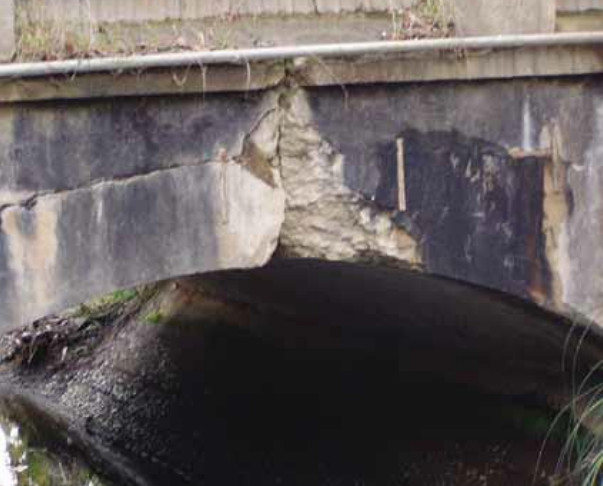
Condition state 5 -Description	Photo
<ul style="list-style-type: none"> There may be heavy cracking and spalling due to corroding reinforcement or horizontal cracking in the portal wall at the thickening. Scaling and efflorescence may be prevalent and leakage at the arch/side wall joint may be excessive. The arch may have lost shape with a large flat spot due to movement of a footing, or there may be heavy cracking due to differential settlement of the foundations. Accident damage may be severe and having a definite effect on the structure.

<p data-bbox="794 1742 1399 1765">Concrete arch cracked and broken at crown (VicRoads)</p>

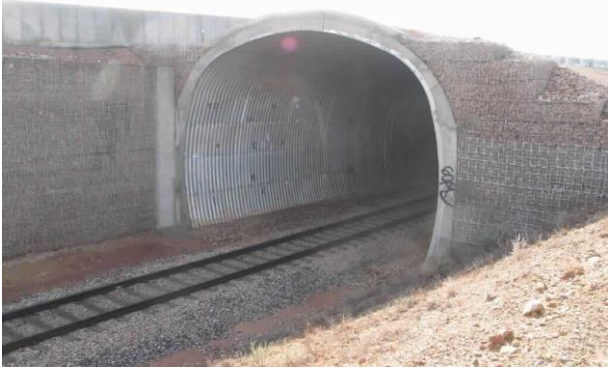
17S - Arches – steel		Units
<p>This component includes all large corrugated multi-plate arches, Superspans, Nova spans or multi-plate underpasses used to pass road or rail traffic through. Smaller units or units used specifically to allow water or cattle traffic through shall be considered as culverts.</p>		<p>m² of exposed surface area</p>
Condition state 1 -Description	Photo	
<ul style="list-style-type: none"> • The component shows no corrosion of the metal. • Any concrete at the base of the arch is in good condition with no cracking or spalling. • There is no evidence of plate buckling or seam shearing. • All bolts connecting the multi-plates are in good condition and are tight. • No distortion of arch shapes with attendant change in dimensions is evident. • There is no damage to the component from vehicular traffic.

<p>Corrugated steel arch in good condition</p>	
Condition state 2 -Description	Photo

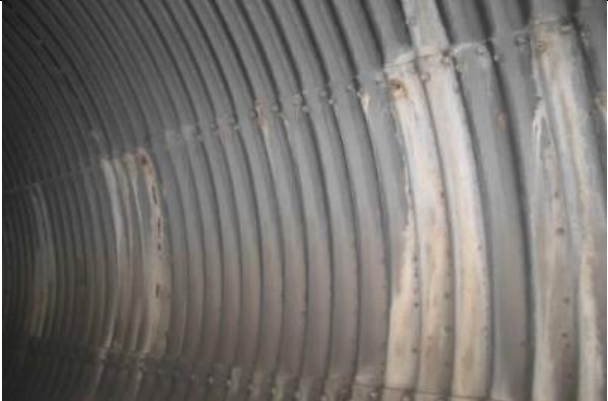
<ul style="list-style-type: none"> • The component may show light spot rusting. • All bolts are tight with no movement of the plates. • There is no damage to the component from vehicular impact. • Any concrete at the base of the arch may have minor cracking or spalling due to corroding reinforcement but there should be no cracking due to settlement of the foundations. • No distortion of the arch shape is discernible; however, there may be a slight change in dimensions.

<p>Corrosion at isolated locations due to seepage through bolt holes</p>

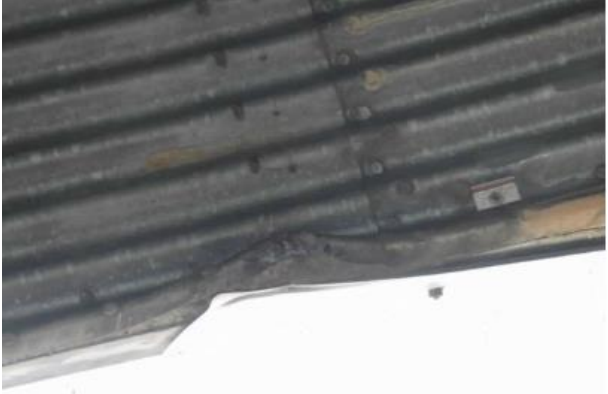
Condition state 3 -Description	Photo
<ul style="list-style-type: none"> • The component may show minor spot rusting. • All bolts are tight with no movement of the plates. • Accident damage from vehicles is minor and does not affect the structure. • Any concrete at the base of the arch may have moderate cracking or spalling due to corroding reinforcement or it may have fine cracking due to minor differential settlement of the foundations. • No distortion of the arch shape is discernible; however, there may be a minor change in dimensions.

<p data-bbox="791 591 1299 620">Impact damage but not affecting the structure</p>
Condition state 4 -Description	Photo
<ul style="list-style-type: none"> • The component may show rusting and areas of minor corrosion. Some bolts may be a little loose and some plates may have slipped slightly. • The plate around some bolts may be damaged or torn allowing distortion to occur. • The arch span may have increased by in size since last inspection. • The arch may be developing a small flat spot due to movement of a footing. • Accident damage from vehicles is moderate with insignificant effect to the structure. • Any concrete at the bottom of the arch may have medium cracking and spalling due to corroding reinforcement or it may have minor cracking due to differential settlement of the foundations.

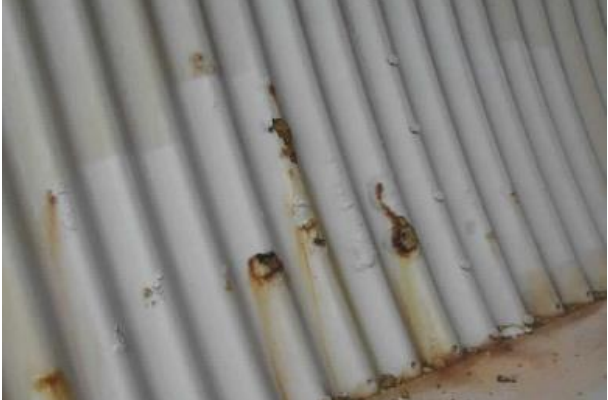
<p data-bbox="791 1180 1193 1209">Rusting and areas of minor corrosion</p>
