Road Structures Inspection Manual

Part 4A: Condition State Guidelines and Photographs

Bridges

RAS Document No: RAMA-ST-PRC-048
Knet Document No: 14888945
Document version: 1.3 (08/05/2020)

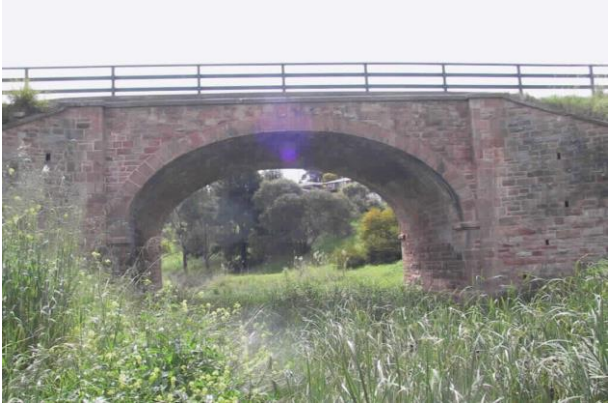
<p>170 - Arches – other</p> <p>This component includes all arch bridges constructed of masonry or red brick which have earth fill inside. The condition of the road surface should be considered under a separate item and not included as part of this item. The arch sidewalls however should be included as part of this item.</p>		<p>Units</p> <p>m² of exposed surface area</p>
<p>Condition state 1 -Description</p> <ul style="list-style-type: none"> • The component shows little or no deterioration with no cracking of mortar or loss of mortar between the blocks. • There may be small areas of dampness and efflorescence. 	<p>Photo</p>

<p>Masonry arch in good condition</p>	
<p>Condition state 2 -Description</p> <ul style="list-style-type: none"> • There may be minor cracking of the mortar or minor loss of mortar between the blocks, but not sufficient to affect the strength of the arch. • The shape of the arch is still good and there is no cracking or bulging of the sidewalls. • There may be large areas of dampness and efflorescence. 	<p>Photo</p>

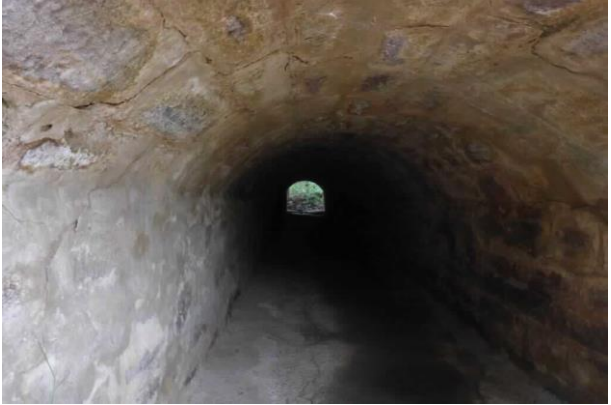
<p>Circumferential cracking between blocks</p>

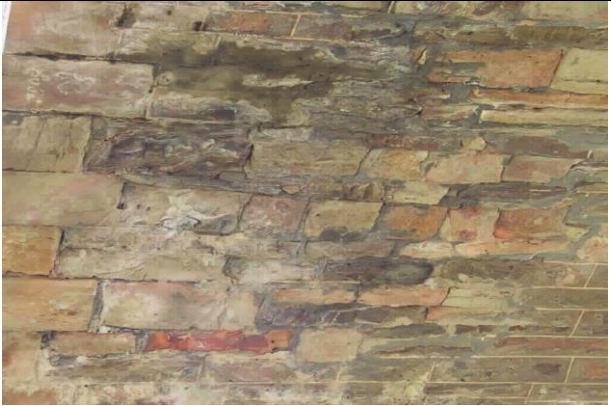
<p>Condition state 3 -Description</p> <ul style="list-style-type: none"> • There may be minor cracking or loss of mortar between blocks which has a minor effect on the strength of the arch, but not of sufficient magnitude to cause concern. • Some soffit blocks may have started to slip marginally due to the loss of mortar. • Minor settlements, movements, loss of arch shape, or cracking may be present, but not of sufficient magnitude to cause concern. 	<p>Photo</p>

<p>Fretted mortar and weathering of stone in crown</p>

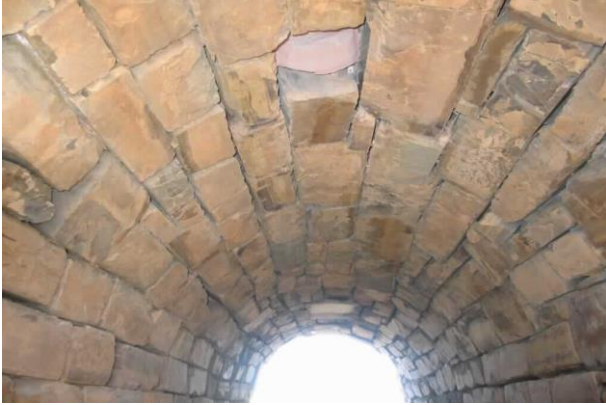
Condition state 4 -Description	Photo
<ul style="list-style-type: none">• There may be moderate cracking or loss of mortar between blocks which has a moderate effect on the strength of the arch.• Some soffit blocks may have slipped slightly due to the loss of mortar.• Moderate settlements, movements, loss of arch shape, or cracking and minor bulging of the sidewalls may be present, but not of sufficient magnitude to cause concern.

<p data-bbox="791 595 1399 658">Loose and missing mortar, with stone missing in arch soffit</p>
Condition state 5 -Description	Photo
<ul style="list-style-type: none">• There may be severe cracking or loss of mortar between blocks which has a significant effect on the strength of the arch.• Some soffit blocks may have slipped significantly and some blocks may have cracked through or edges broken off.• Abutments or piers may have settled or moved significantly causing a loss of shape of the arch.• Differential settlement of the foundations may have also caused heavy cracking along the arch soffit.• Earth pressure on the sidewall may have caused heavy cracking, movement or large bulging of the blocks to occur.

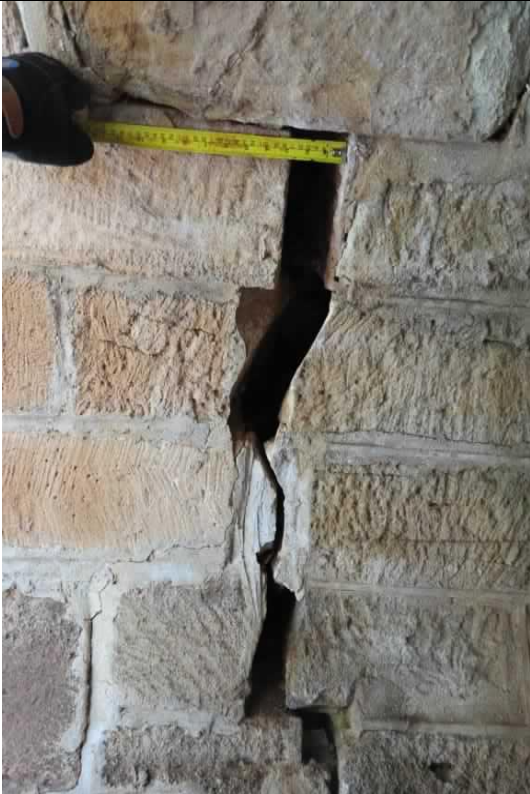
<p data-bbox="791 1482 1323 1543">Large crack and heavy mortar loss in masonry arch side wall</p>

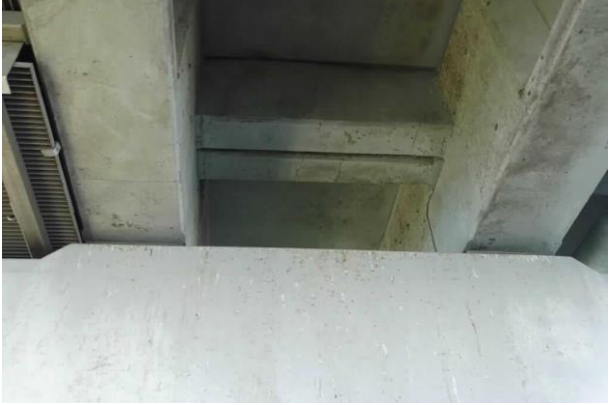
18C - Diaphragms / bracing – cast in-situ concrete		Units
<p>This component includes cast in-situ reinforced concrete end of deck stiffening and deep diaphragms between “I” and “T” beams. In monolithic cast-in-situ flat slab bridges this component includes the deck thickening beam at the pier supports.</p>		<p>m² of exposed surface area</p>
Condition state 1 -Description	Photo	
<ul style="list-style-type: none"> • The components are in good condition with only very minor fine cracking visible. • There may be minor dampness or efflorescence powder visible in a few locations.

<p>Diaphragm with minor fine cracking</p>	
Condition state 2 -Description	Photo	
<ul style="list-style-type: none"> • There may be a few minor cracks or spalls due to corroding reinforcement. • End of deck stiffener may be damp and stained due to excessive moisture penetration of the deck joints, and efflorescence powder may be visible in numerous areas. • In monolithic structures there may be slight cracking of the tops of the columns or at the bearing areas of expansion type piers.

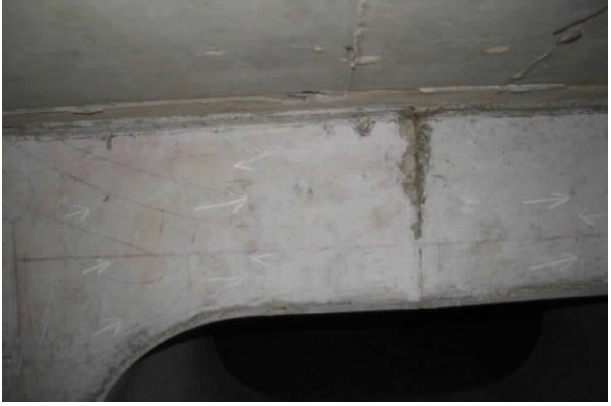
<p>Minor cracks in diaphragm</p>

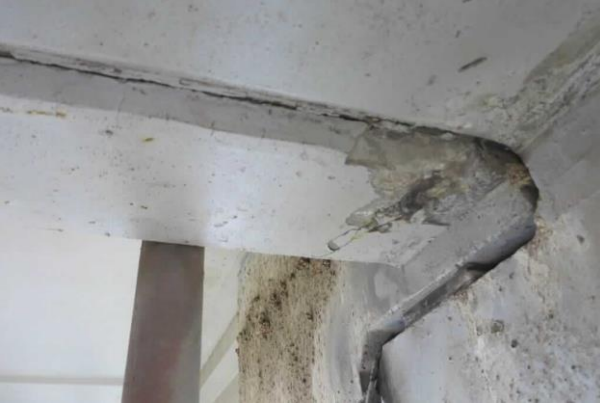
<p>Condition state 3 -Description</p> <ul style="list-style-type: none"> • There may be moderate cracks or spalls due to corroding reinforcement. • End of deck stiffener may be damp and stained due to excessive moisture penetration of the deck joints, and efflorescence powder may be more prevalent in numerous areas. • In monolithic structures there may be minor cracking of the tops of the columns or at the bearing areas of expansion type piers. 	<p>Photo</p>

<p>Spalled diaphragm over pier</p>
<p>Condition state 4 -Description</p> <ul style="list-style-type: none"> • Medium cracking and spalling may be present along with possible delaminated areas due to corroding reinforcement. • Exposed reinforcement may have moderate section loss in isolated areas. • Local spalling or cracking may have occurred as a result of obstructions being trapped in expansion joint gaps or insufficient gap provision for free expansion. • In monolithic structures there may be medium cracking or spalling in the bearing areas of expansion type piers, or at the column/diaphragm joint of fixed type piers. 	<p>Photo</p>

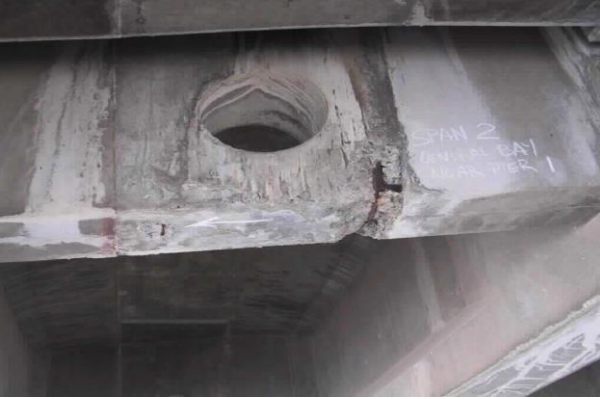
<p>Medium spalling and exposure of corroded reinforcement in diaphragm</p>

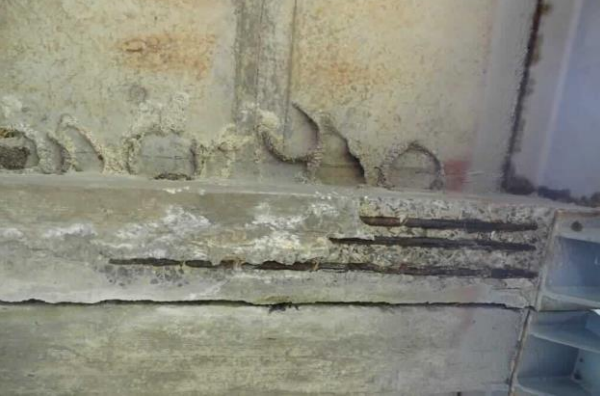
<p>Condition state 5 -Description</p> <ul style="list-style-type: none"> • Severe cracking, spalling or large delaminated areas exist with heavily corroded steel visible with more severe loss of section of reinforcement. • Entire sections of end diaphragms may have spalled as a result of obstructions trapped in expansion joint gaps or insufficient gaps for free expansion. • Monolithic structures may have heavy spalling in the bearing areas with loss of bearing area greater than 40%. 	<p>Photo</p>

<p>Severely spalled diaphragm over column support with heavily corroded steel reinforcement</p>

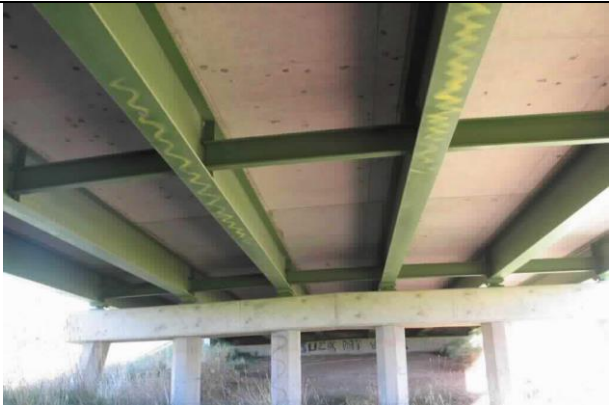
18S - Diaphragms / bracing – steel		Units
<p>This component includes all stiffening devices for the ends of the deck and between steel girders and includes wind bracing of large girder bridges. The diaphragms may have stud connectors into the deck to support and stiffen the ends of the deck. Bracing may be simple steel rods, straps or small angles crossing between the girders, or be heavy channel connectors between the beam webs. Wind bracing may be by steel angles or steel rods.</p>		m ² of exposed surface area
Condition state 1 -Description	Photo	
<ul style="list-style-type: none"> The paintwork is generally sound with only minor chalking, peeling or curling, but no exposure of the metal. All welds, bolts and rivets are in good condition. Distance between adequate bracing is no more than 5 or 6 metres unless the RSJs have a composite reinforced concrete deck.

Steel bracing between beams in good condition

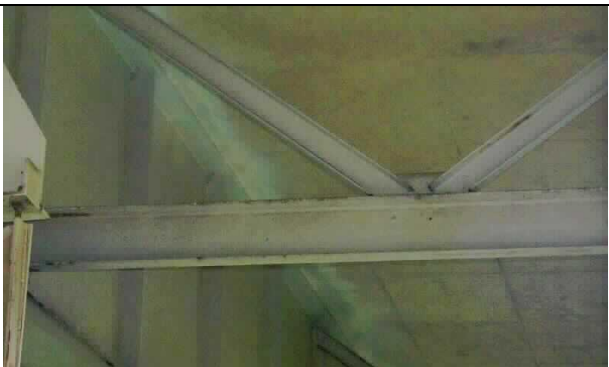
Condition state 2 -Description	Photo	
<ul style="list-style-type: none"> Light spot rusting of the paint system is occurring and the system starting to lose effectiveness. No corrosion has occurred as yet. No cracking of welds has occurred, but there may be some minor rusting of nuts or bolts. Bracing may be too far apart to adequately stiffen girders, or bracing may be too light if deck is not solid.

Light rusting on steel channel bracing

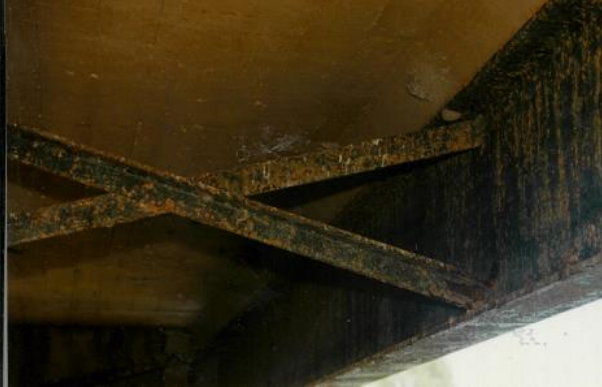
Condition state 3 -Description	Photo
<ul style="list-style-type: none"> • Spot rusting of the paint system is increasing and the system is no longer effective. • Light corrosion has occurred. No cracking of welds has occurred, but there may be some moderate rusting of nuts or bolts. • Bracing may be too far apart to adequately stiffen girders, or bracing may be too light if deck is not solid.

<p data-bbox="794 577 1398 611">Cross bracing is rusty with light corrosion</p>
Condition state 4 -Description	Photo
<ul style="list-style-type: none"> • The paint system has broken down with corrosion and pitting in areas. • Nuts and bolts may be corroded with minor loss of tension in bolt. • Welds may be cracked with minor loss of effectiveness. • Bracing is far too light or inadequate, offering little effect in stiffening of the superstructure, especially if deck is not concrete. • Lateral bowing of girders may be evident under load.

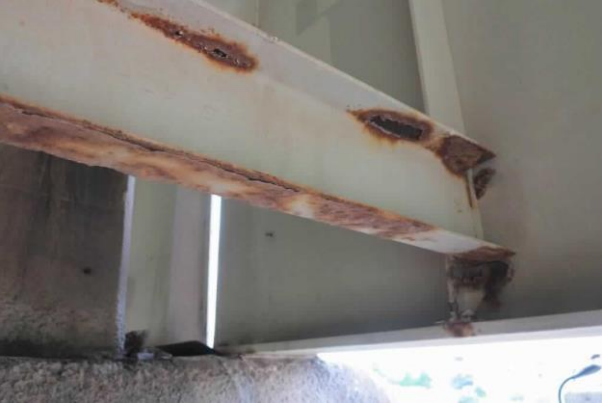
<p data-bbox="794 1048 1398 1081">Corroded cross bracing</p>

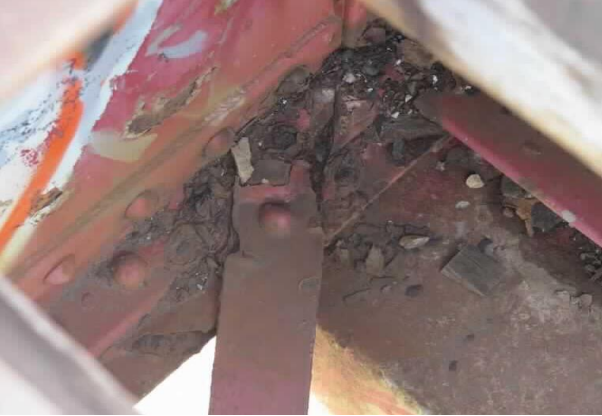
Condition state 5 -Description	Photo
<ul style="list-style-type: none"> • Corrosion is well advanced, having a definite detrimental effect on the strength of the element. • Braces are inadequate or have broken loose or buckled and the girders are bowing noticeably under load. • There may be no transverse distribution of wheel loads and the girders are acting independently. • Bolts or rivets may be missing. Splice joint bolts may be loose (can be loosened by a spanner). • The paint system has completely broken down.

<p data-bbox="794 1529 1398 1617">Heavy corrosion to cross bracing</p>

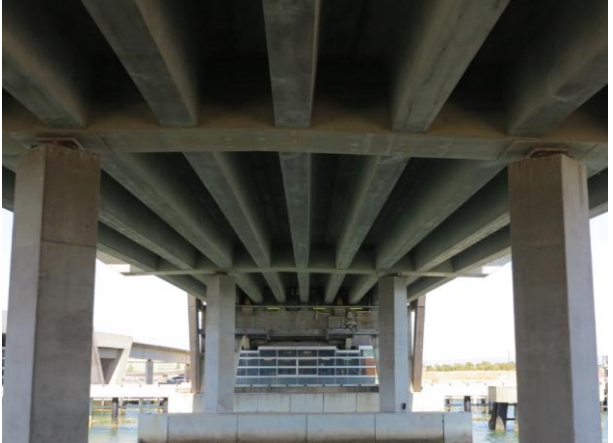
<p>19C - Load bearing diaphragms – cast in-situ concrete</p> <p>This component defines the load bearing diaphragms constructed using reinforced or prestressed concrete which are integral with the superstructure beams and visible to the inspector. These diaphragms are used as a means of joining precast beams to provide continuity over the pier supports, and the diaphragm is used to support the beams on the pier or columns below. Those load bearing diaphragms built-in to box girders or voided slab bridges and are not visible should be considered as part of the superstructure and are not to be included in this component.</p>		<p>Units</p> <p>m² of exposed surface area</p>
<p>Condition state 1 -Description</p> <ul style="list-style-type: none"> • The load bearing diaphragm is in good condition with only minor cracking due to corroding reinforcement. • The crossheads should have no flexural or shear cracking. 	<p>Photo</p>

<p>T-girders joined by load bearing diaphragms for continuity over the piers</p>

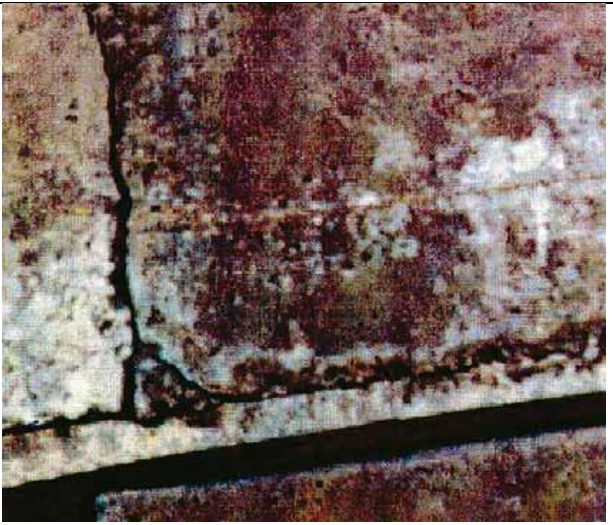
<p>Condition state 2 -Description</p> <ul style="list-style-type: none"> • The load bearing diaphragms may have minor cracking and spalling due to corroding reinforcement. • There may be some very fine flexural or shear cracks. No stressing strands should be exposed. • Minor cracking at prestressing anchorages may be evident. 	<p>Photo</p>

<p>Cracking between precast girder (left) and cast-in-situ diaphragm (right), with separation of the girder from the common steel bearing plate (VicRoads)</p>

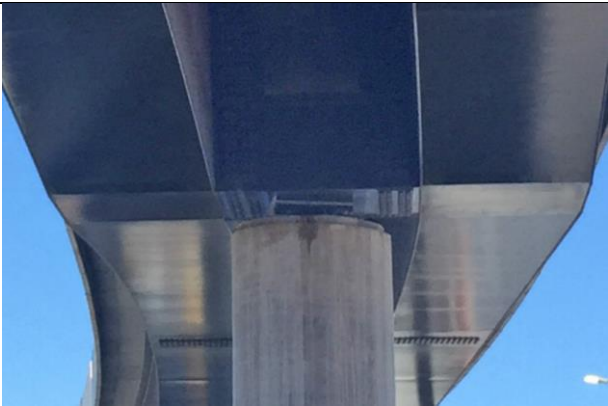
19S - Load bearing diaphragms – steel		Units
<p>This component defines those load bearing diaphragms constructed using steel which are integral with the superstructure and visible to the inspector. These diaphragms are used as a means of joining the steel girders or boxes to provide continuity over the pier supports, and the diaphragm is used to support and distribute the loads to the pier or columns below. If the load bearing diaphragm is built-in to the steel box and is not externally visible to the inspector, it should be considered as part of the superstructure and not included in this component.</p>	<p>m² of exposed surface area</p>	
Condition state 1 -Description	Photo	
<ul style="list-style-type: none"> The load bearing diaphragm is in good condition with no deterioration of the welds or bolts. The paint system is in good condition with only minor chalking, peeling or curling, but with no exposure of the metal.

<p>Steel diaphragm in good condition</p>

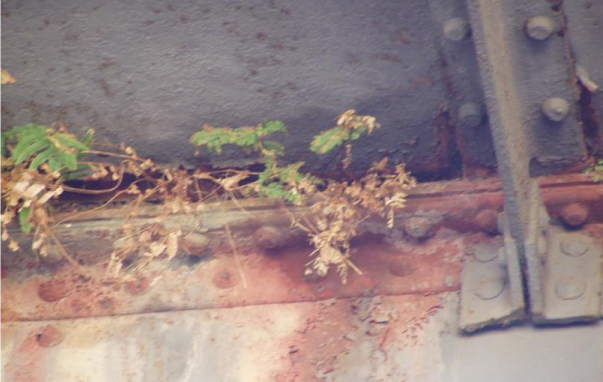
Condition state 3 -Description	Photo
<ul style="list-style-type: none"> • The paint system has broken down with minor surface rusting to the area and minor corrosion and pitting in areas. • No cracking of welds has occurred, but there may be some moderate rusting of nuts or bolts.

<p data-bbox="794 584 1257 611">Minor corrosion on diaphragms (VicRoads)</p>
Condition state 4 -Description	Photo
<ul style="list-style-type: none"> • The paint system has broken down with moderate surface rusting to the area and moderate corrosion and pitting in areas. • Nuts and bolts may be corroded with moderate loss of tension in the bolt. • Welds may be cracked with minor loss of effectiveness. 	Not available
Condition state 5 -Description	Photo
<ul style="list-style-type: none"> • Corrosion is well advanced having a detrimental effect on the strength of the component. • The paint system has completely broken down with corrosion and pitting in areas. 	Not available

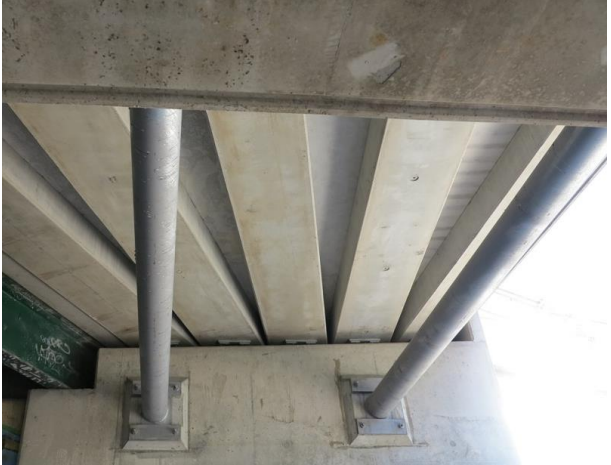
<p>Steel props in very good condition</p>	
Condition state 2 -Description	Photo	
<ul style="list-style-type: none"> • Spot rusting to the surface area is occurring and the paint system is losing effectiveness. • No corrosion of the section has occurred. • There is no deformation of the steel props.

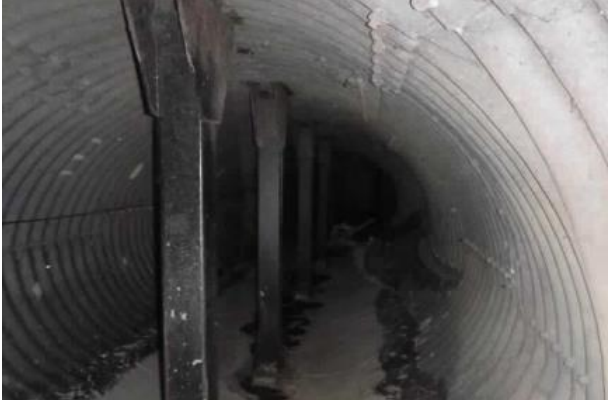
<p>Steel propping in good condition</p>

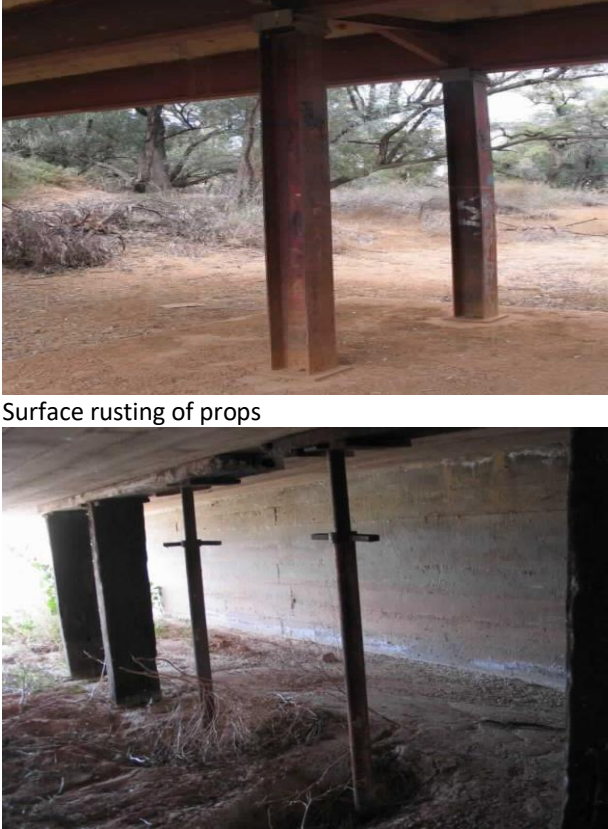
<p data-bbox="791 595 1054 629">Surface rusting of props</p> <p data-bbox="791 1025 1209 1059">Acrow props with light debris build up</p>
Condition state 4 -Description	Photo
<ul style="list-style-type: none"> • The paint or galvanising system has completely broken down with surface pitting in locations. • Active corrosion may be occurring in areas but no loss of section area has occurred which would affect the strength of the propping. • Nuts and bolts may be corroded but are still tight and no cracking of welds has occurred.

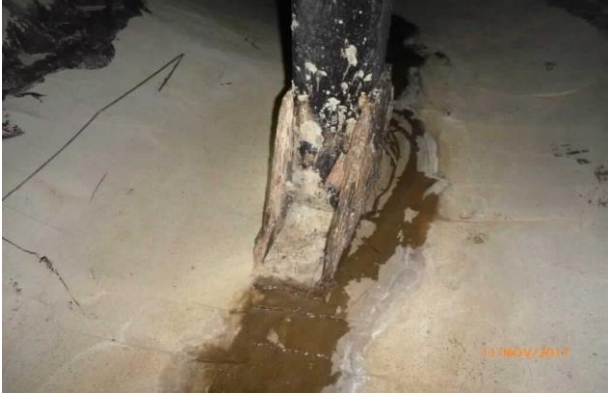
<p data-bbox="791 1496 1070 1529">Corrosion at base of prop</p>

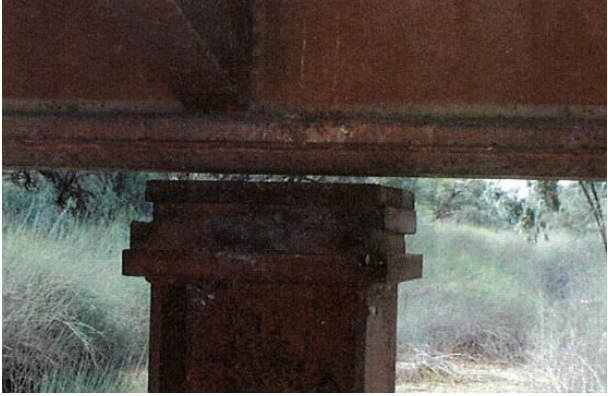
<p data-bbox="791 1966 1382 2000">Prop is not supporting girder, with 10mm gap evident</p>

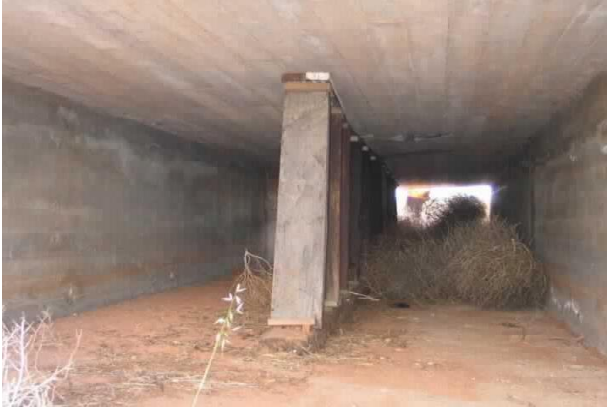
Timber propping in good condition	
Condition state 2 -Description <ul style="list-style-type: none"> • Props are generally in good condition but may have minor deterioration but not affecting strength. • There is no deformation of the props. 	Photo

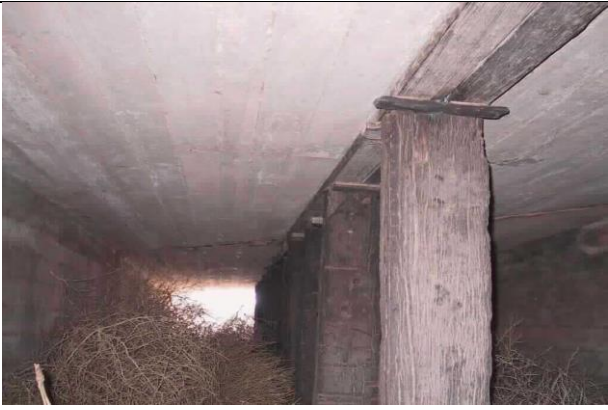
Props with minor deterioration but not affecting structural integrity

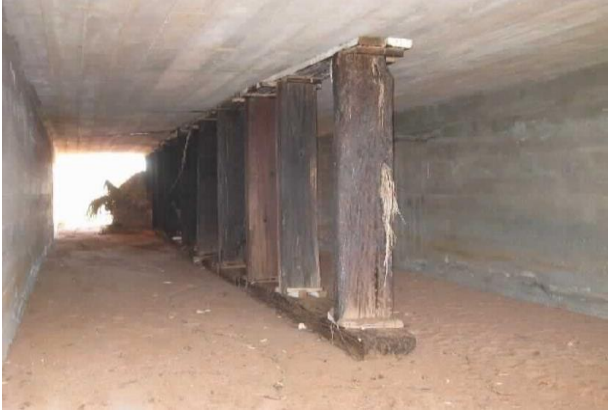
<p>Timber propping in overall fair condition</p>
<p>Condition state 4 -Description</p> <ul style="list-style-type: none"> • Props (or packing) may be loose and not engaged with the deck. • There may be slight deformation of the propping. • Props could have major splitting and/or large areas of rot that may impact on strength if not treated. • Remediation and/or replacement required before next inspection. 	<p>Photo</p>

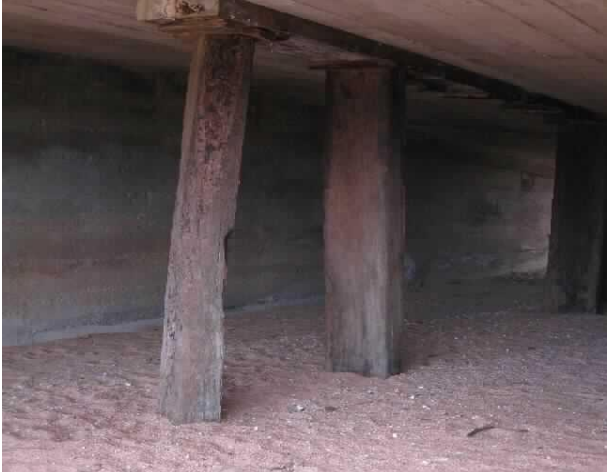
<p>Timber prop starting to fail</p>
<p>Condition state 5 -Description</p> <ul style="list-style-type: none"> • Props have significant deterioration and without treatment or replacement in the short term will affect the load carrying capacity of the structure. • Props may be missing. 	<p>Photo</p>

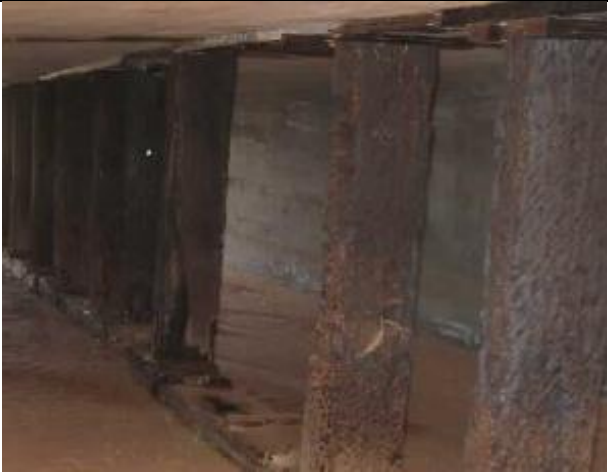
<p>Missing prop</p>

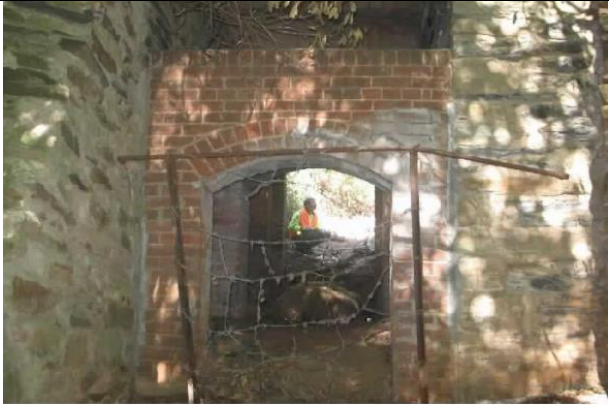
<p>Brick buttress in good condition</p>	
<p>Condition state 2 -Description</p> <ul style="list-style-type: none"> • Props are generally in good condition but may have minor deterioration but not affecting strength. • There may be a number of fine cracks in the mortar joints but no cracking of the blocks or there may be minor loss of mortar of no concern. 	<p>Photo</p>

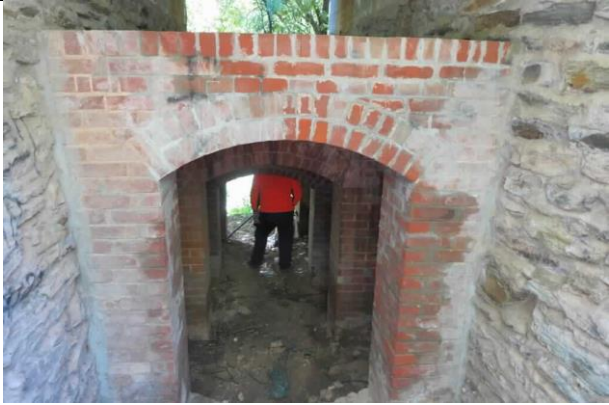
<p>Brick buttress showing previous repairs but still in good condition</p>

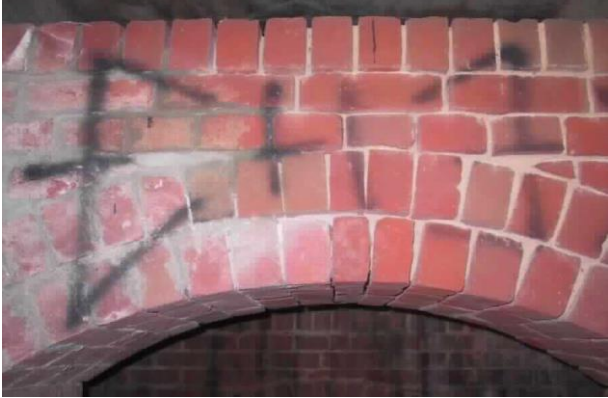
<p data-bbox="791 593 1401 622">Typical mortar loss in brick buttress</p>
Condition state 4 -Description	Photo
<ul style="list-style-type: none"> • Moderate cracking of mortar or loss of mortar may be evident. • Level of deterioration may have a minor effect on strength. 	Not available
Condition state 5 -Description	Photo
<ul style="list-style-type: none"> • Severe cracking or loss of mortar is occurring. • Without treatment in the short term will affect the load carrying capacity of the structure 	Not available

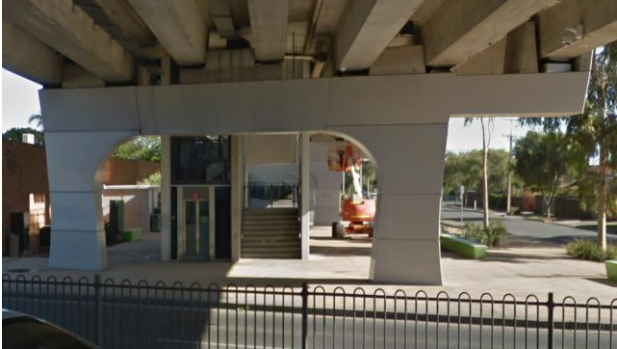
<p>Precast concrete crosshead in good condition</p>	
<p>Condition state 2 -Description</p> <ul style="list-style-type: none"> The crossheads may have a few minor fine cracks or minor spalls due to corroding reinforcement. No stressing strands should be exposed in any spall. There should be no moment cracking in the stressed crossheads. Reinforced crossheads may have fine moment cracking. 	<p>Photo</p>

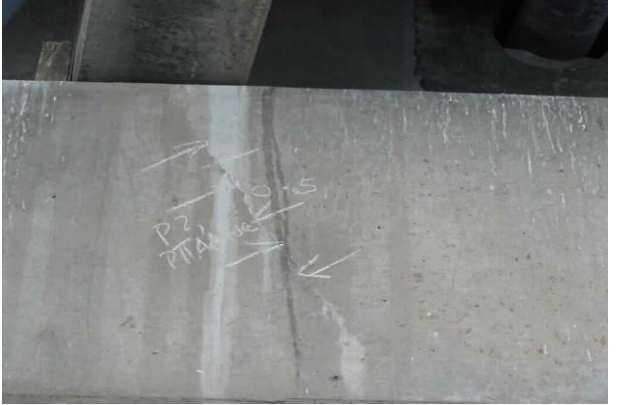
<p>Precast concrete crosshead with minor cracking beneath beam</p>

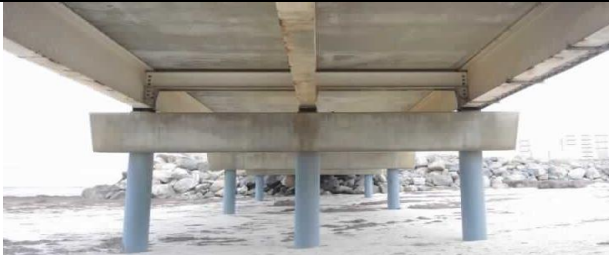
Crosshead in good condition	
Condition state 2 -Description	Photo	
<ul style="list-style-type: none"> The crossheads may have minor spalling due to corroding reinforcement or due to beam friction and bearing directly on the crosshead edges. Some minor fine cracks due to moment or shear may exist.

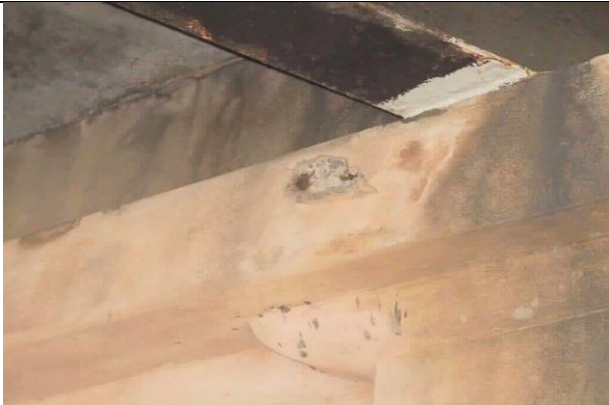
Minor spall in pier crosshead

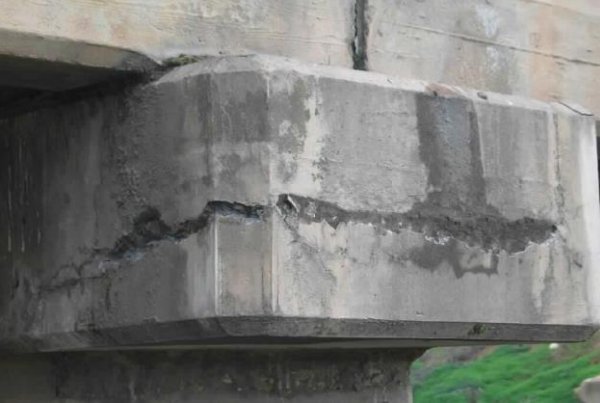
<p data-bbox="794 593 1396 622">Moderate spalling at end of crosshead</p>
Condition state 4 -Description	Photo
<ul style="list-style-type: none"> Medium sized cracks, spalls and possible delaminations may exist with exposed corroding reinforcement having moderate loss of section. Flexural cracking may be medium sized but any shear cracks should only be fine.

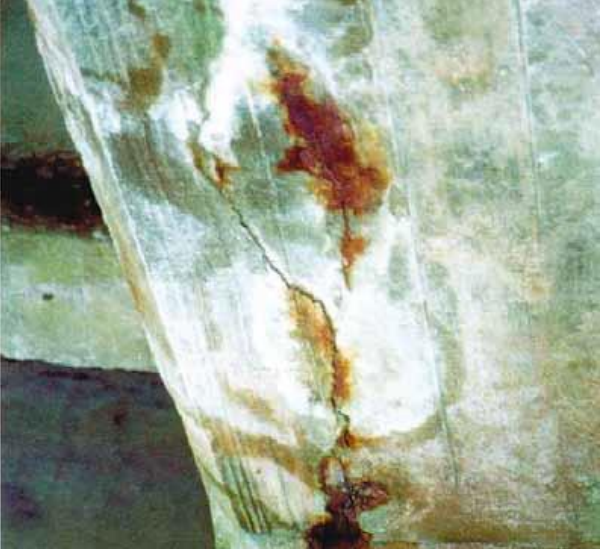
<p data-bbox="794 1209 1396 1272">Severe cracking and rust staining in crosshead (VicRoads)</p>
Condition state 5 -Description	Photo
<ul style="list-style-type: none"> Severe cracking, spalling or large delaminations may exist with heavily corroded steel reinforcement. Moment cracking may be severe whilst shear cracks may be moderate sized.

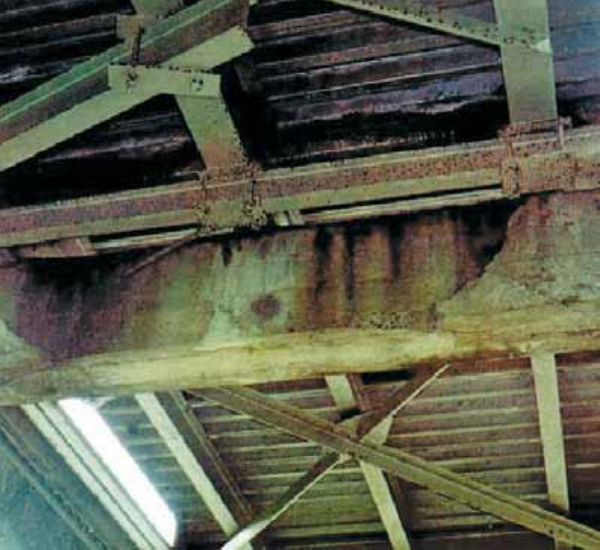
<p data-bbox="794 1859 1396 1888">Heavy shear cracking in crosshead (VicRoads)</p>

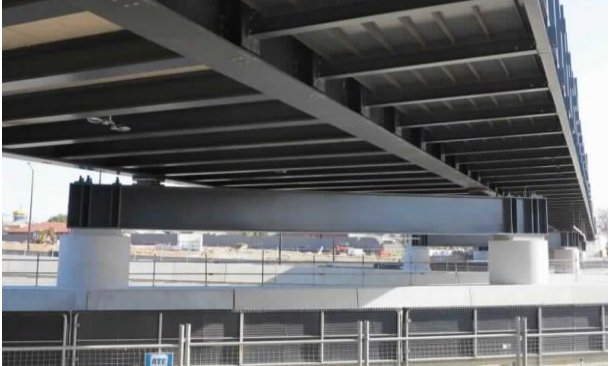
<p data-bbox="791 792 1406 824">Steel crosshead in very good condition</p>	
Condition state 2 -Description	Photo	
<ul style="list-style-type: none"> • Light spot rusting is occurring to the surface area and the paint system is losing effectiveness. • No corrosion has occurred as yet. Welds are in good condition but there may be light rusting of nuts or bolts.

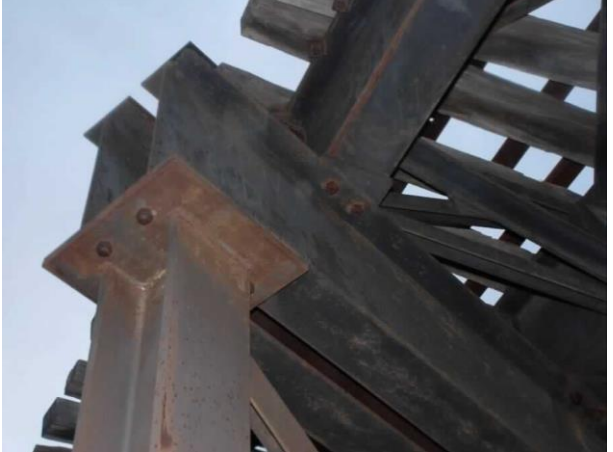
<p data-bbox="791 1312 1406 1406">Steel crosshead with light rusting but no corrosion of the steel. Bolts also lightly rusted. (Pier column also has surface rusting)</p>

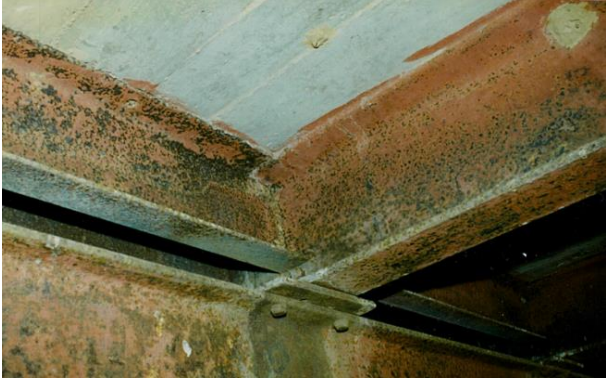
<p>Surface rust but no pitting; welds still ok</p>
<p>Condition state 4 -Description</p> <ul style="list-style-type: none"> • The paint system has broken down, and moderate surface rusting to the area and minor pitting corrosion is occurring. • Nut and bolts may have moderate corrosion with only minor loss of tension in the bolt. • Welds may have faint cracking with only minor loss of effectiveness. • Crossheads may be too light to carry the loads imposed on them and may have minor bows or buckles in them. 	<p>Photo</p>

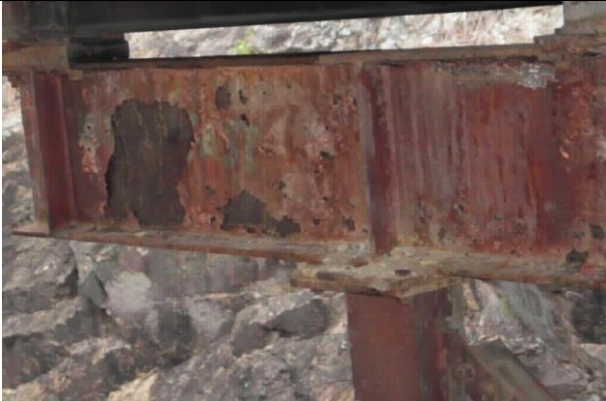
<p>Advanced corrosion of crosshead</p>
<p>Condition state 5 -Description</p> <ul style="list-style-type: none"> • Corrosion is well advanced having a definite detrimental effect on the strength of the component. • Connecting bolts or nuts may have corroded severely, broken loose or are missing. • Crosshead size may be inadequate with large bows or buckling occurring. • The paint system has completely broken down. 	<p>Photo</p> <p>Not available</p>

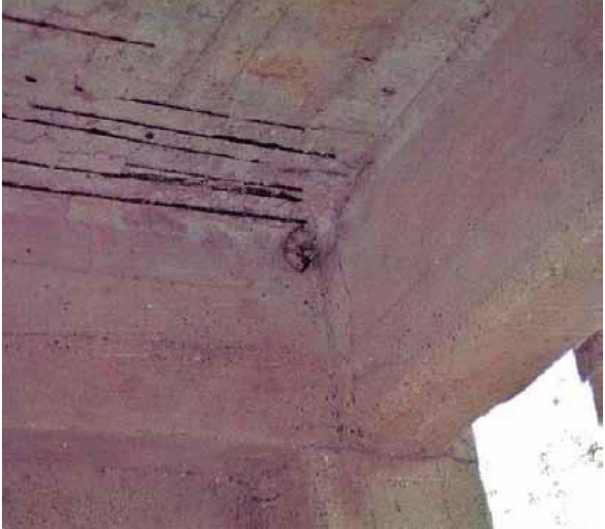
<p>Integral crosshead in good condition with no cracking or staining, though beam and deck are cracked and spalled. Construction joint at underside of beam is beginning to enlarge (VicRoads)</p>	
<p>Condition state 2 -Description</p> <ul style="list-style-type: none"> • There may be a few minor cracks or spalls due to corroding reinforcement but no structural cracking is visible. • There may be fine cracks at the construction joints at the undersides of the beams. 	<p>Photo</p>

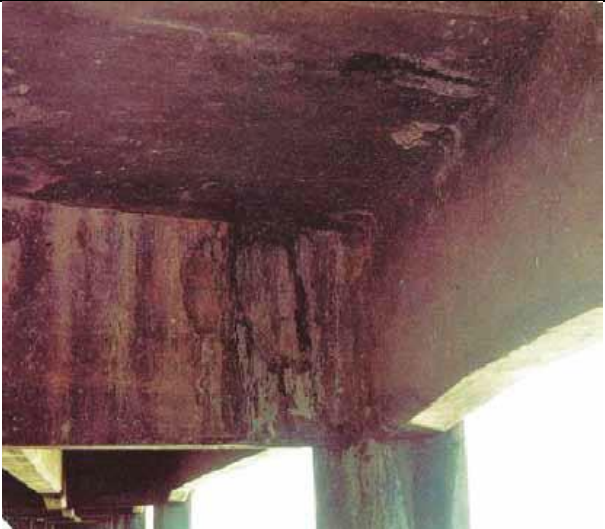
<p>Moisture and staining of crosshead due to crack at deck/crosshead joint (VicRoads)</p>

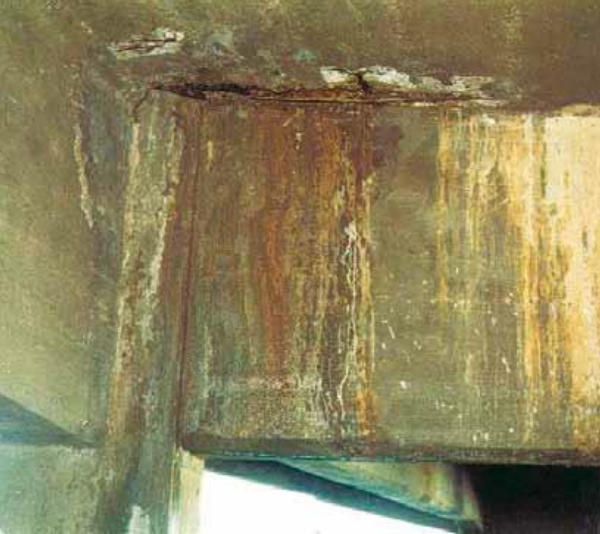
Condition state 3 -Description	Photo
<ul style="list-style-type: none"> • Moderate cracking and spalling may exist due to corroding reinforcement and there may be minor cracking beneath supported beams. • There may be minor loss of section of reinforcement due to corrosion. • Fine cracking may exist at the crosshead/deck joint with evidence of light moisture staining and/or efflorescence visible. 	Not available
Condition state 4 -Description	Photo
<ul style="list-style-type: none"> • Medium cracking and spalling may exist due to corroding reinforcement and there may be fine cracking beneath supported beams. • There may be moderate loss of section of reinforcement due to corrosion. • Minor cracking may exist at the crosshead/deck joint with moisture staining and/or efflorescence visible.

<p data-bbox="794 1120 1396 1182">Heavy staining, cracking and spalling at deck/crosshead joint (VicRoads)</p>

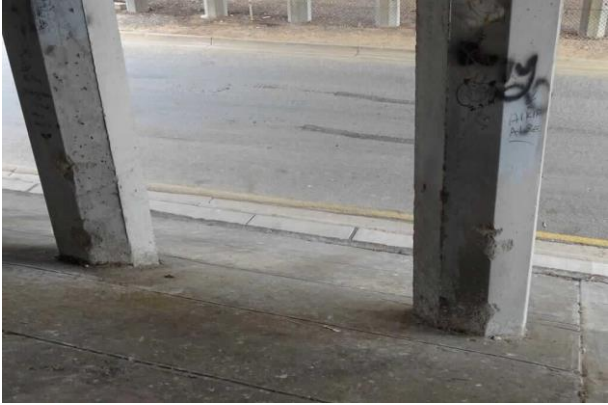
<p>Condition state 3 -Description</p> <ul style="list-style-type: none"> • Moderate cracking and spalling due to corroding reinforcement may be visible with minor loss of section of the bars. • Exposed stressing strands should only have light corrosion. • Minor flexural cracking may be evident especially if bracing or ties are ineffective or non-existent. • The footings, if visible, may have minor cracking or spalling. 	<p>Photo</p>

<p>Spalls on pier columns</p>
<p>Condition state 4 -Description</p> <ul style="list-style-type: none"> • Medium cracking and spalling due to corroding reinforcement may be visible with moderate loss of section of the bars. • Exposed stressing strands should only have minor corrosion. • Flexural cracking may be moderate sized especially if bracing or ties are ineffective or non-existent. • The footings, if visible, may have medium cracking or spalling. 	<p>Photo</p> <p>Not available</p>

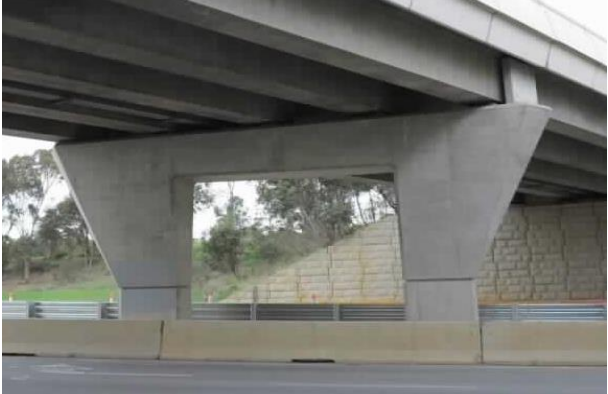
23C - Column or pile extensions – cast in-situ concrete		Units
<p>This component includes all cast-in-situ columns or cast-in-situ extensions on top of driven piles. This component should also encompass footings, ties or braces, which may be used to stiffen the columns or piles and to distribute loads.</p>	<p>m² of exposed surface area</p>	
Condition state 1 -Description	Photo	
<ul style="list-style-type: none"> • The piles or columns show only minor fine cracking due to reinforcement corrosion. • There should be no flexural cracking in the piles or columns. • The piles are adequately braced with unsupported height less than 3.5 metres. • Footings, if visible, are in good condition.

<p data-bbox="791 835 1401 869">Reinforced concrete columns in good condition</p>	
Condition state 2 -Description	Photo	
<ul style="list-style-type: none"> • The piles or columns have fine cracking or minor spalling due to corroding reinforcement. • Fine flexural cracking may be visible. • The piles or columns may not be effectively braced, or the footings, if visible, may have fine cracking or spalling.

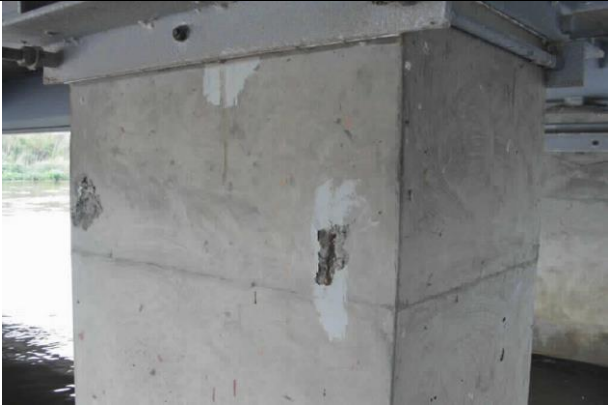
<p data-bbox="791 1305 1401 1335">Minor spalling of reinforced concrete column</p>

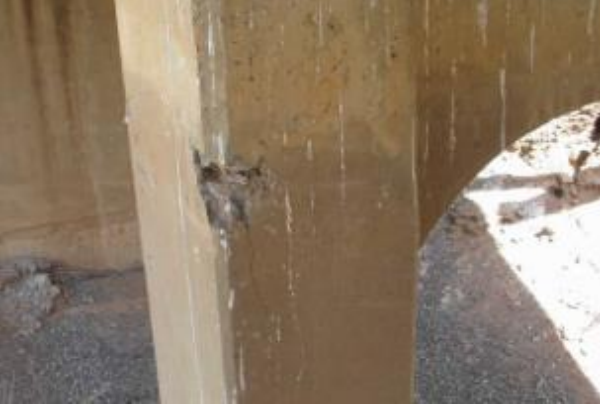
Condition state 3 -Description	Photo
<ul style="list-style-type: none"> • The piles or columns have moderate cracking or spalling due to corroding reinforcement with minor loss of section in the steel bars. • Minor flexural cracking may be evident especially if bracing or ties are ineffective or non-existent. • The footings, if visible, may have minor cracking or spalling.

<p data-bbox="794 600 1396 629">Spalling on pier column</p>
Condition state 4 -Description	Photo
<ul style="list-style-type: none"> • The piles or columns have medium cracking or spalling due to corroding reinforcement with moderate loss of section in the steel bars. • Flexural cracking may be moderate sized, especially if the bracing or ties are ineffective or non-existent. • Footings, if visible, may have medium cracking or spalling.

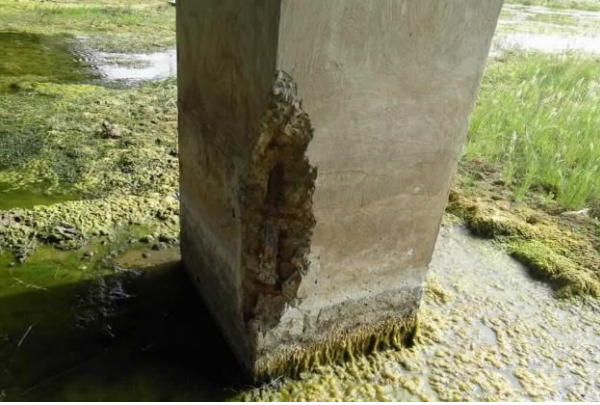
<p data-bbox="794 1070 1396 1099">Major spalling at base of column</p>
Condition state 5 -Description	Photo

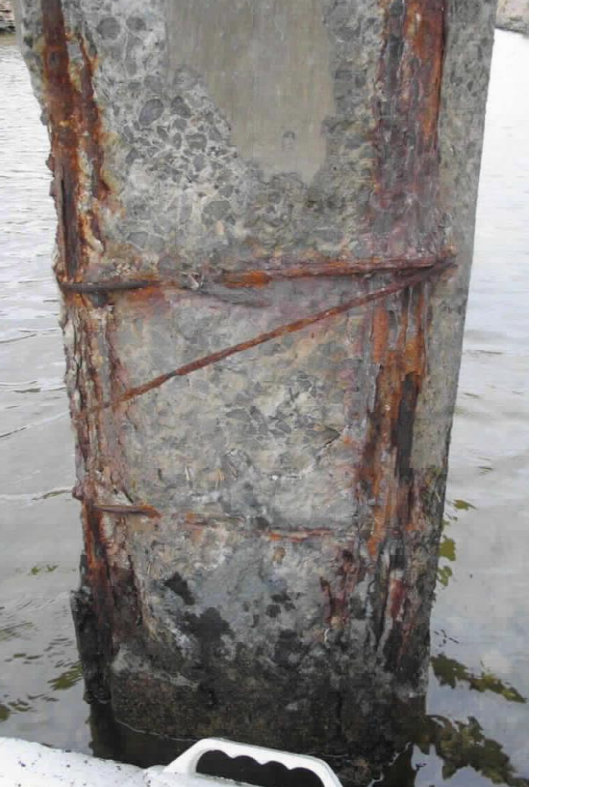
<ul style="list-style-type: none"> • Severe cracking or spalling due to corroding reinforcement may be visible with advanced corrosion of the steel bars with more severe loss of section of reinforcement. • Flexural cracking may be severe with bracing or ties totally ineffective or missing. • Footing, if visible, may have severe cracking or spalling.

<p data-bbox="794 1921 1396 1973">Column with heavy spalling and advanced corrosion of reinforcement</p>

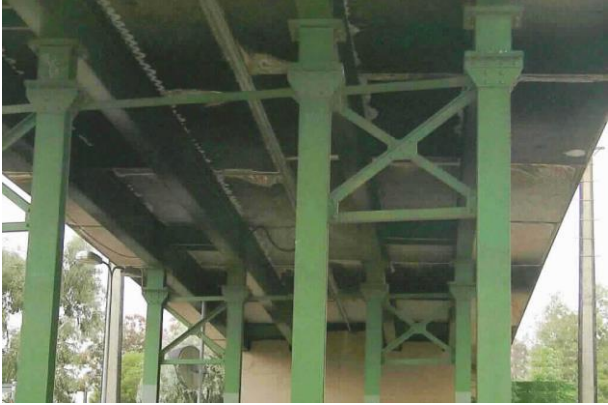
Condition state 1 -Description	Photo
<ul style="list-style-type: none"> The paintwork is generally in good condition with only minor chalking, curling or peeling, but no metal exposure. The piles are adequately braced and all connections are in good condition.

<p data-bbox="791 846 1401 909">Steel columns in good order with no rust spotting of the paintwork</p>
Condition state 2 -Description	Photo
<ul style="list-style-type: none"> Painted steelwork has light spot rusting to the surface area and the protective coating is losing effectiveness. The piles or columns may not be effectively braced or the connections may be slightly loose or corroded. The footings, if visible, may have fine cracking or spalling. Unpainted steel piles may be rusted.

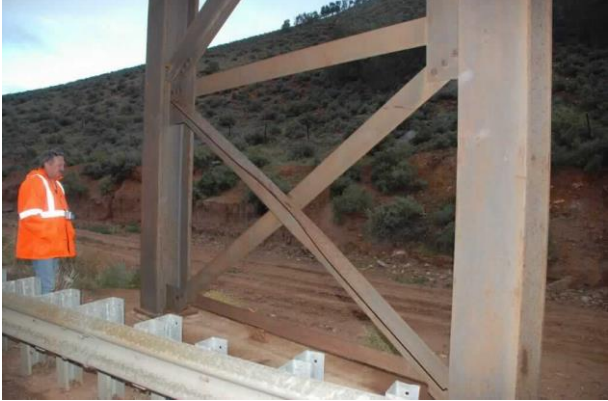
<p data-bbox="791 1346 1401 1379">Pier brace buckling and light rusting of surface</p>
Condition state 3 -Description	Photo
<ul style="list-style-type: none"> Steelwork has minor corrosion and the paint system is no longer effective with minor surface area rusting. Light surface pitting may be evident but section loss is minimal. Bracing may be ineffective or non-existent and connections may have minor corrosion. If footings are visible they may have minor cracking and spalling.

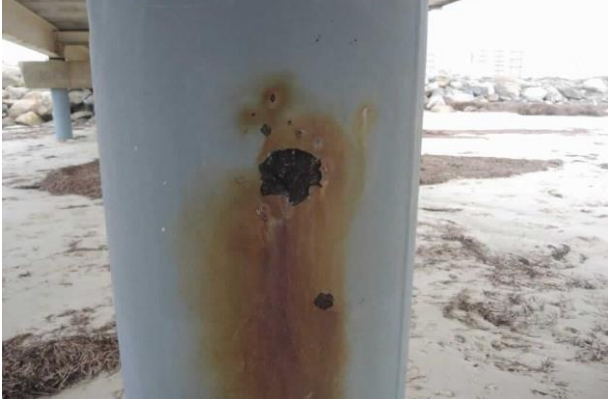
<p data-bbox="791 1816 1401 1841">Corrosion on steel column</p>

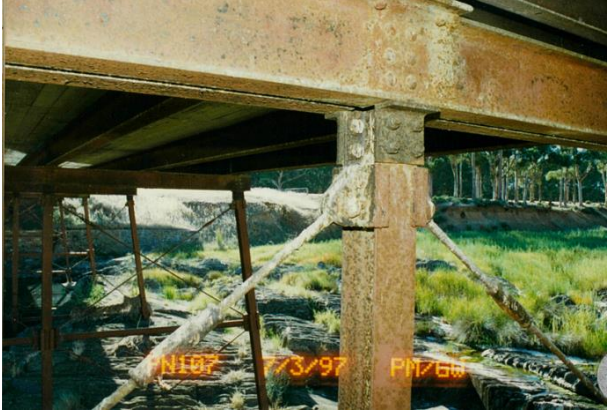
<p>Condition state 4 -Description</p> <ul style="list-style-type: none"> • Steelwork has medium corrosion and the paint system has failed with moderate surface area rusting. • Surface pitting may be evident but section loss is only minor. Bracing may be ineffective or non-existent and connections may be heavily corroded or loose. • If footings are visible they may have medium cracking and spalling or some loss of support. 	<p>Photo</p>

<p>Corrosion at pier top and bracing tie/turnbuckle</p>
<p>Condition state 5 -Description</p> <ul style="list-style-type: none"> • Steelwork is heavily corroded with moderate loss of section. • Footings may be heavily cracked and spalled or may have substantial loss of bearing support. • Connections may be very loose or bracing may be missing or totally ineffective. • The paint system has completely failed. 	<p>Photo</p>

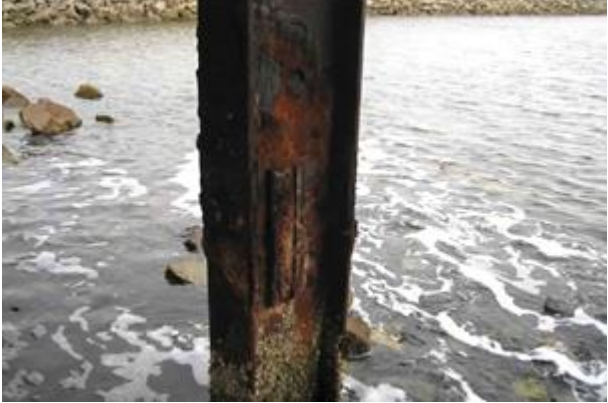
<p>Heavy corrosion of column</p>
