Road Structures Inspection Manual

Part 4A: Condition State Guidelines and Photographs

Bridges

RAS Document No: RAMA-ST-PRC-048
Knet Document No: 14888945
Document version: 1.3 (08/05/2020)

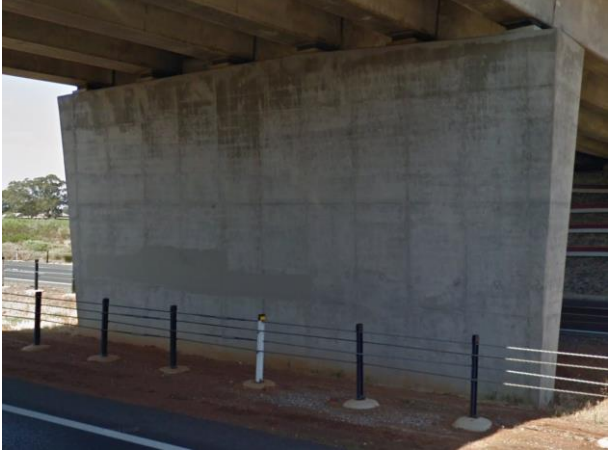
Condition state 1 -Description	Photo
<ul style="list-style-type: none"> The wall is in good condition with only fine cracking due to corroding reinforcement. Footings, if visible, are in good condition with only fine cracking. There is no cracking due to differential settlement of the foundations.

<p data-bbox="791 1115 1082 1144">Pier wall in good condition</p>
<ul style="list-style-type: none"> The wall may have fine cracking and minor spalling due to corroding reinforcement. Footings, if visible, may have fine cracking or spalling due to corroding reinforcement or differential settlement of foundations. Tops of the walls may have fine cracking due to friction or edge loading of beams.

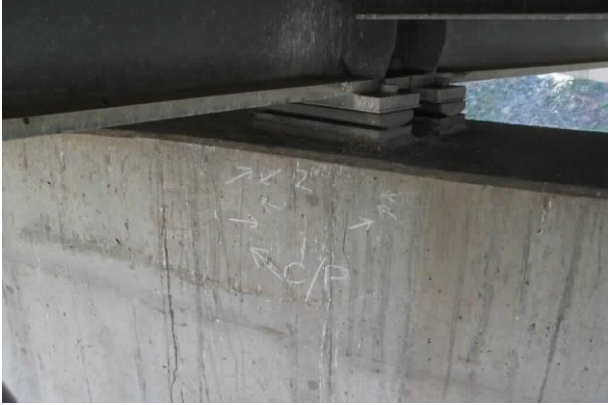
<p data-bbox="791 1585 1118 1615">Pier crack under fixed bearing</p>
<ul style="list-style-type: none"> Moderate cracking and spalling may be visible with minor loss of reinforcement section. Footings, if visible, may have minor cracking or spalling due to reinforcement corrosion or differential settlement of foundations. Top of walls may have minor cracking or spalling due to friction or edge loading of beams.

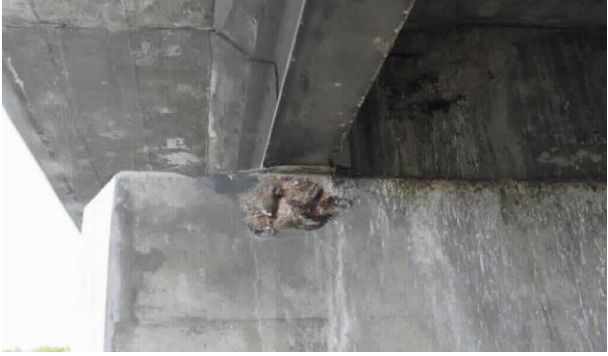
<p data-bbox="791 2007 1034 2036">Pier spall under girder</p>

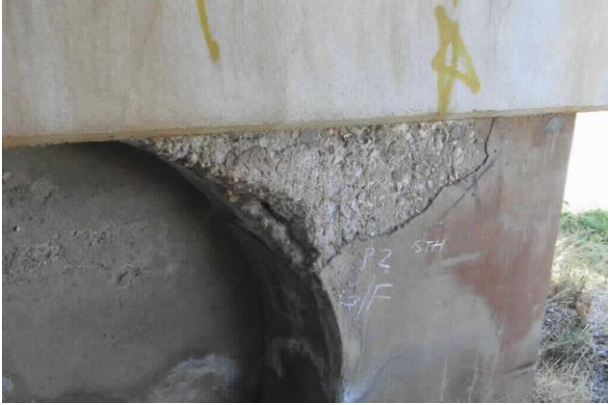
<p>Condition state 4 -Description</p> <ul style="list-style-type: none"> • Medium cracking and spalling may be visible with moderate loss of reinforcement section. • Footings, if visible, may have moderate cracking or spalling due to reinforcement corrosion or differential settlement of foundations. • Top of walls may have moderate cracking or spalling due to friction or edge loading of beams. 	<p>Photo</p>

<p>Fretting and spalling of pier</p>
<p>Condition state 5 -Description</p> <ul style="list-style-type: none"> • Severe cracking or spalling may be visible with advanced corrosion of the reinforcement with more severe loss of section. • Footings, if visible, may have severe cracking or spalling due to reinforcement corrosion or differential settlement of the foundations. • Tops of walls may have severe cracking and spalling due to friction or edge loading of the beams. 	<p>Photo</p>

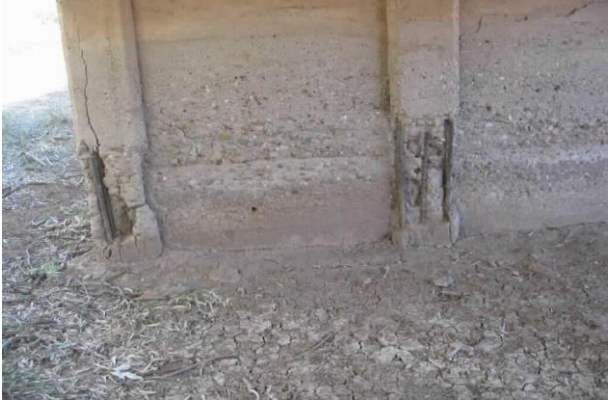
<p>Severe spalling of pier wall, with advanced corrosion of reinforcement</p>

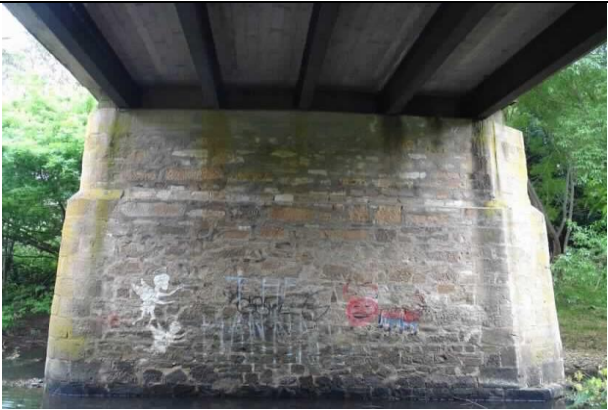
<p>240 - Pier wall – other</p> <p>This component describes all wall types other than concrete and includes stone masonry walls, red brick walls or grouted rubble walls. The component does not include any reinforced concrete cap on top of the walls. If bluestone blocks are used to cap the walls, those blocks could be considered in this component. Foundations, if visible, should be included in this component.</p>		<p>Units</p> <p>m² of exposed surface area</p>
<p>Condition state 1 -Description</p> <ul style="list-style-type: none"> • The wall is in good condition with only a few very minor fine cracks in the mortar between the bricks, stones or blocks. • There is no cracking due to differential settlement of the foundations. There should be no loss of mortar between the blocks. 	<p>Photo</p>

<p>Masonry pier in good condition</p>	
<p>Condition state 2 -Description</p> <ul style="list-style-type: none"> • The wall may have a number of fine cracks in the mortar between brick or blocks, but no cracking of the masonry. • There may be slight loss of mortar of no concern. • There may be fine cracking due to differential settlement of the foundations. 	<p>Photo</p>

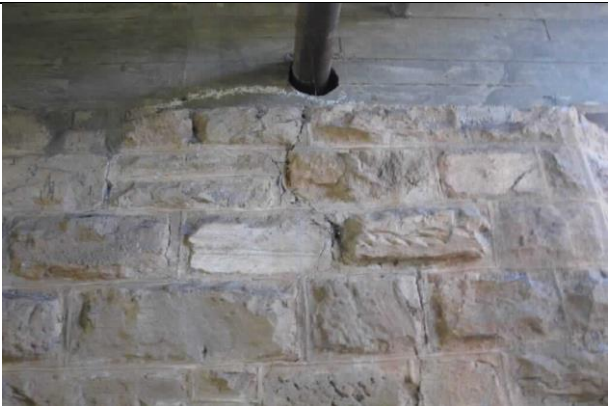
<p>Cracking between blocks with slight mortar loss</p>

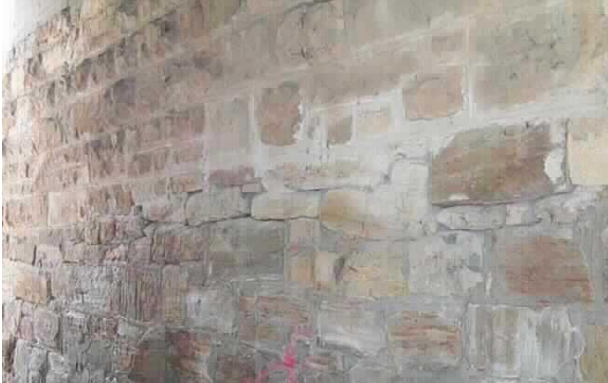
<p>Condition state 3 -Description</p> <ul style="list-style-type: none"> • Minor cracking of the mortar between the blocks may be occurring or minor mortar loss may be occurring due to water wash. • There should be, however, be only minor mortar loss beneath any masonry capping blocks. • Moderate cracking may exist due to differential settlement of the foundations. 	<p>Photo</p>

<p>Fretted stonework with minor mortar loss</p>
<p>Condition state 4 -Description</p> <ul style="list-style-type: none"> • Moderate cracking of the mortar between the blocks may be occurring or moderate mortar loss may be occurring due to water wash. • There should be, however, be only minor mortar loss beneath any masonry capping blocks. • Medium cracking may exist due to differential settlement of the foundations. 	<p>Photo</p>

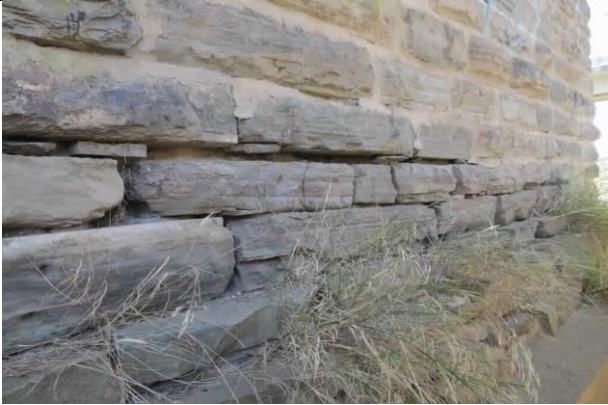
<p>Moderate loss of mortar at base of pier</p>
<p>Condition state 5 -Description</p> <ul style="list-style-type: none"> • The mortar and blocks may have severe cracking through them. • Mortar loss may be severe requiring pressure repointing. • Loss of mortar below masonry capping blocks may be moderate. • Differential settlement of the foundations may have caused severe cracking. 	<p>Photo</p>

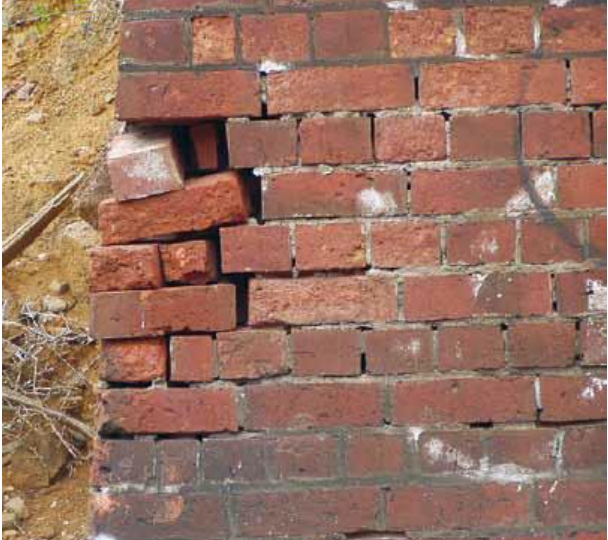
<p>End of pier wall lost all mortar (VicRoads)</p>

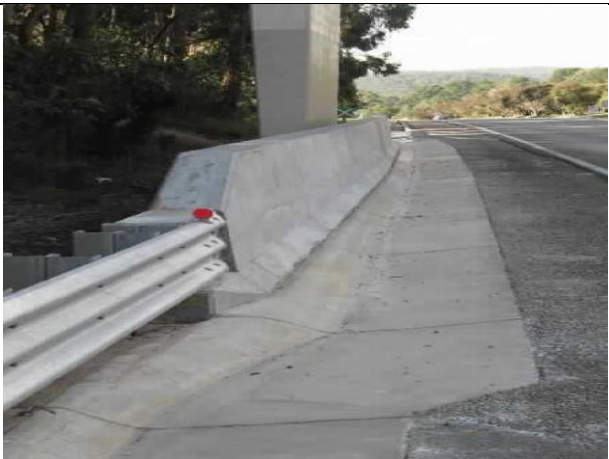
26P - Pier protection – precast concrete This component describes all precast concrete barriers that are installed to protect vulnerable substructure elements such as piers and abutments, from errant vehicles (including ships and barges where the bridge crosses a river).		Units m² of exposed surface area
Condition state 1 -Description <ul style="list-style-type: none"> • The component shows only minor deterioration and the connections between units and anchorages are in good condition. • There may be discolouration, efflorescence, and/or superficial cracking but without effect on strength and/or serviceability. • No accident damage is evident. 	Photo

<p>Concrete barrier pier protection, in good condition</p>	
Condition state 2 -Description <ul style="list-style-type: none"> • There may be minor cracking and spalling due to corroding reinforcement. • Connections between units and anchorages should be in good condition. • Accident damage should be minor and of no consequence. • There has been no displacement of units from their installed position. 	Photo

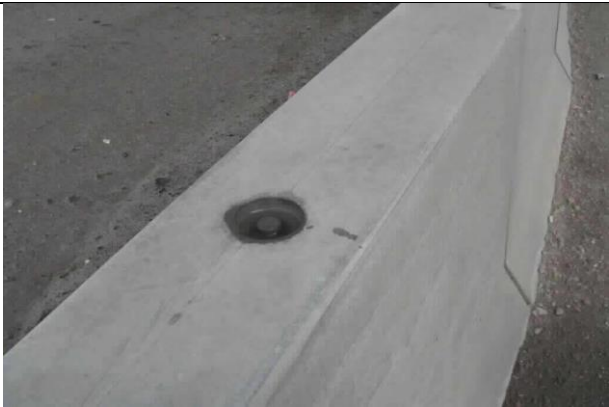
<p>Barrier in good condition but lifting recesses not filled</p>

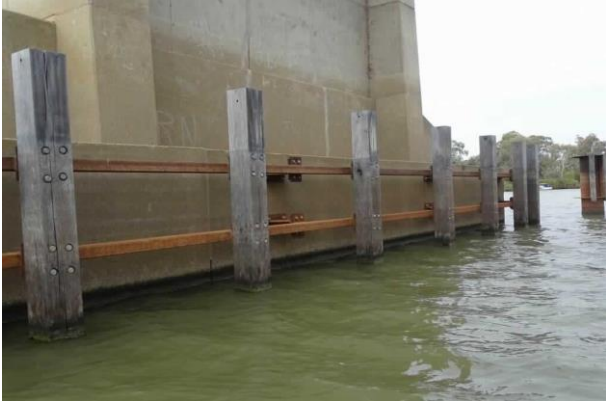
<p>Condition state 3 -Description</p> <ul style="list-style-type: none"> • Minor spot rusting has formed to the surface area and the paint system is no longer effective. • Posts may have some rust and light corrosion, or minor cracking in the concrete, but bolting or joint support is still tight. • Accident damage has only a minor effect on strength or serviceability of the barrier. 	<p>Photo</p>

<p>Light corrosion on fender rails</p>
<p>Condition state 4 -Description</p> <ul style="list-style-type: none"> • The paint system may have broken down and there is surface pitting in a number of locations on the rails and/or posts but there is minimal effect on strength or serviceability • Posts may also have corroding areas, loose hold down bolts or medium concrete cracking with some spalling. • Bolts holding down rails or rail joint support may be a little loose. • Accident damage has a moderate effect on strength or serviceability of the barrier, with some deformation and/or minor displacement of members. • Any stabilising or deflection limiting devices may minor cracking. 	<p>Photo</p>

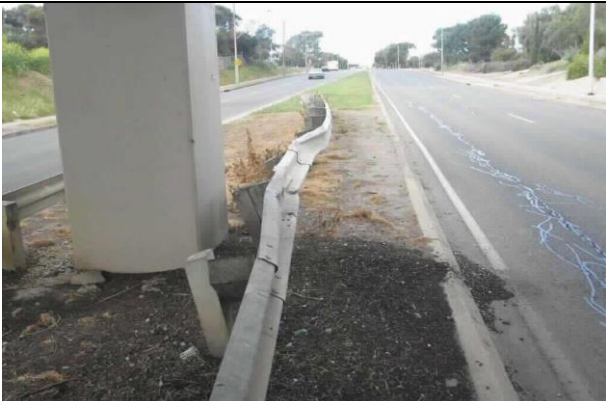
<p>Deformation and displacement of posts due to impact damage</p>

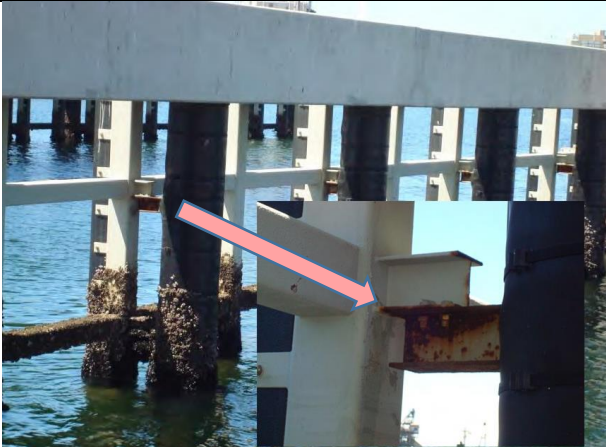
<p>Condition state 5 -Description</p> <ul style="list-style-type: none"> • Corrosion is advanced with loss of section affecting both strength and serviceability. • Posts may be badly corroded, become quite loose in their grouted anchorage or bolting, or heavily cracked and spalled concrete. • Bolts holding down rails or rail joint support may be a loose or missing. • Accident damage is severe with major deformation and displacement of members heavily affecting the strength and serviceability of the barrier. • Any stabilising or deflection limiting devices may be broken or have become detached. 	<p>Photo</p>

<p>Large extent of paint loss and heavy corrosion on outrigger members of steel fendering</p>

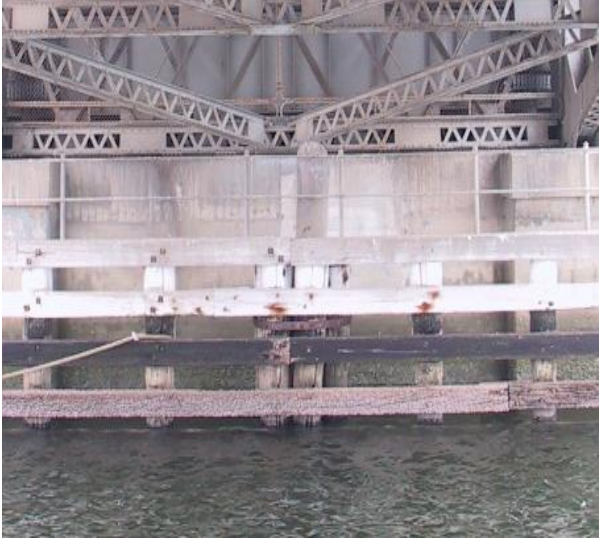
26T - Pier protection – timber		Units
<p>This component describes all timber barriers that are installed to protect vulnerable substructure elements such as piers and abutments, from errant vehicles including ships and barges. This component includes also the supporting posts and connecting bolts.</p>		<p>m² of exposed surface area</p>
Condition state 1 -Description	Photo	
<ul style="list-style-type: none"> • The component shows only minor deterioration and all the bolting is tight. • No accident damage is visible.

<p data-bbox="791 981 1394 1010">Timber fendering in front of pier in good condition</p>	
Condition state 2 -Description	Photo	
<ul style="list-style-type: none"> • The component shows signs of minor decay, splitting or cracking but does not affect the strength or serviceability. • Bolting of the posts and rails is generally tight. • Accident damage is only minor with no effect on strength or serviceability.

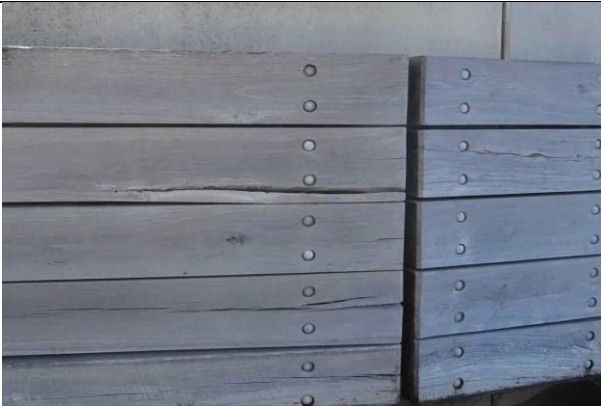
<p data-bbox="791 1447 1394 1478">Minor splitting in timber fender</p>

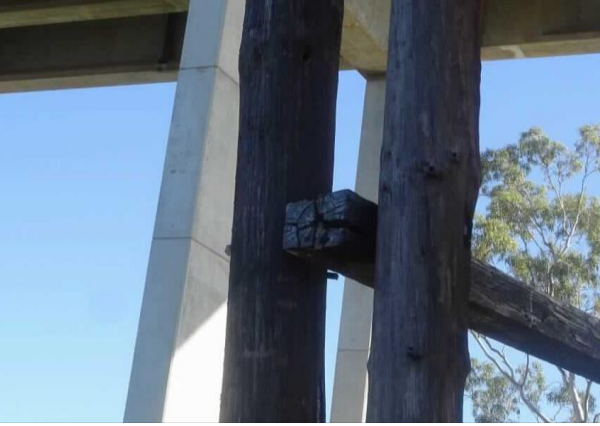
Condition state 3 -Description	Photo
<ul style="list-style-type: none"> Moderate decay, splitting cracking or crushing may be present affecting the strength and serviceability of the barrier to a minor extent. Bolting may be loose and/or corroded in some areas. Accident damage may have a minor effect on the strength or serviceability of the barrier.

<p data-bbox="794 616 1396 645">Splitting end of channel fender horizontal member</p>
Condition state 4 -Description	Photo
<ul style="list-style-type: none"> Medium decay, splitting cracking or crushing may be present affecting the strength and serviceability of the railing to a moderate extent. Bolting may have moderate corrosion and be loose in a number of areas. Accident damage may have a moderate effect on the strength or serviceability of the barrier, with some deformation and/or minor displacement of members. Any stabilising or deflection limiting devices may have minor cracking.

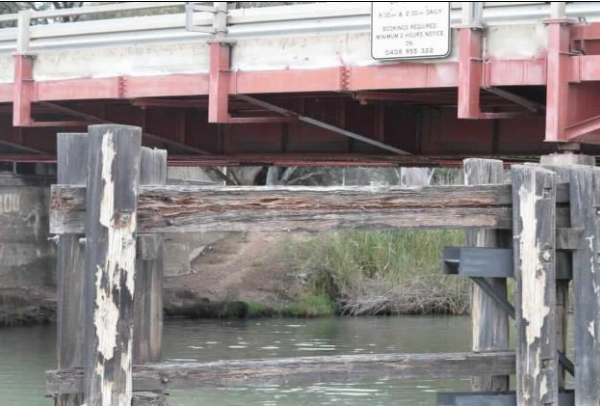
<p data-bbox="794 1086 1396 1153">Termite damage to fender rails</p>

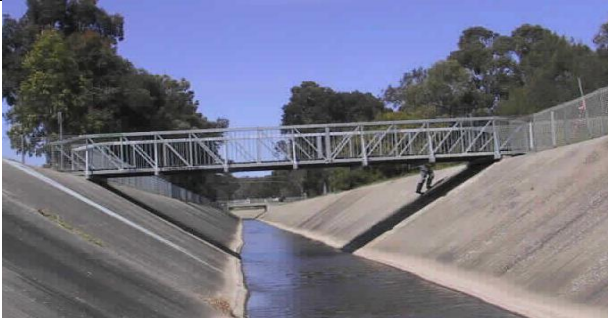
<p>27S - Through truss – steel</p> <p>This component includes all steel or wrought iron trusses that are above the deck level of the roadway. The component includes all truss chords (top and bottom), verticals, crossbraces, windbracing or arch braces. This component does not include the floor beams supporting the roadway.</p>		<p>Units</p> <p>m² of exposed surface area</p>
<p>Condition state 1 -Description</p> <ul style="list-style-type: none"> • The steelwork is in good condition with no rust spotting of the paint system, though there may be minor chalking, peeling or curling. • There is no accident damage to the trusses or bracing. All welds, bolts and rivets are in good condition with no corrosion, cracking or looseness. 	<p>Photo</p>

<p>Steel trusses in good condition</p>	
<p>Condition state 2 -Description</p> <ul style="list-style-type: none"> • Rust spotting of the paint system is occurring. No corrosion or section loss has occurred. • All welds or bolts are in good condition with no cracking, corrosion or loose bolts. • Minor accident damage of no consequence. 	<p>Photo</p>

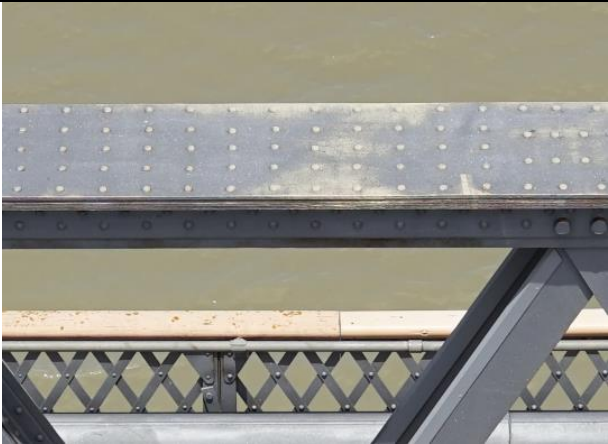
<p>Minor rusting of top chord</p>

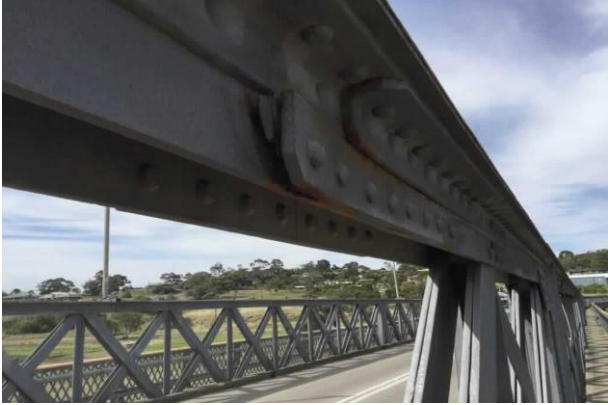
<p>Condition state 3 -Description</p> <ul style="list-style-type: none"> • Surface rust or minor pitting has formed or is forming and the paint system is no longer effective. There is no measurable loss of section • All welds, bolts and rivets are in sound condition with only superficial surface corrosion • There are no cracks in the steel • There may be minor deformations that do not affect the integrity of the component. 	<p>Photo</p>

<p>Top plate element separating from top chord</p>
<p>Condition state 4 -Description</p> <ul style="list-style-type: none"> • Active corrosion is occurring in isolated areas, but no loss of a whole area is occurring to affect the strength of the member as a whole. • Paint system has broken down with surface rusting and pitting present in a number of locations. • Nuts and bolts may be corroding but are still tight. Welds may have non-continuous hairline cracks. • Riveted plates may have very minor movement of 1 mm to 2 mm but rivets are generally sound. • Accident damage to truss or overhead bracing is evident and has minor effect on the stiffness of the trusses. 	<p>Photo</p>

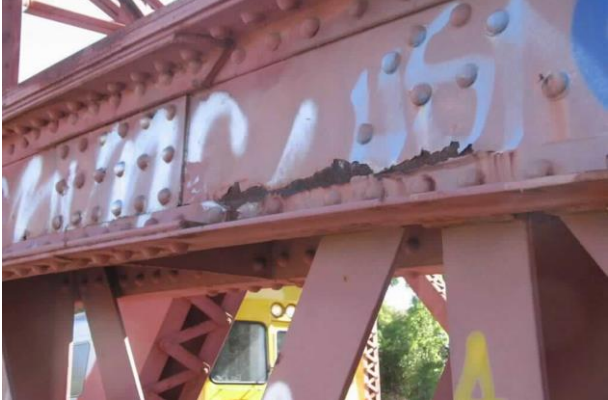
<p>Corrosion in truss top chord</p>

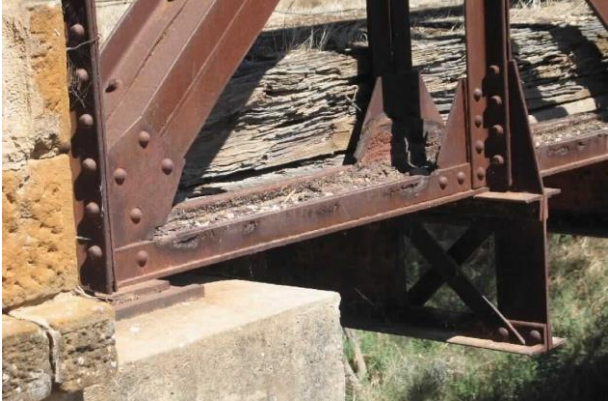
<p>Condition state 5 -Description</p> <ul style="list-style-type: none"> • Corrosion is well advanced and some loss of section has definitely occurred which may have a detrimental effect on the strength of the member, i.e. a flange badly corroded over much of its length. • Welds may be cracked. Nuts or bolts are severely corroded and possibly no longer functioning to full capacity. • Accident damage to trusses or overhead bracing is evident and has major effect on strength of the trusses. 	<p>Photo</p>

<p>Heavy corrosion in bottom chords</p>

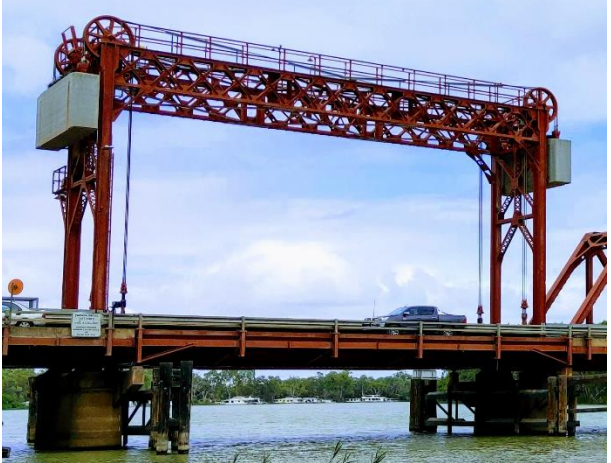
28S - Cables / hangers (not embedded in concrete) – steel		Units
<p>This component includes all steel cables or hangers used to support the deck. The cables may be galvanised, painted, coated or wrapped in grease with a protective outer wrapper, but are not embedded in concrete.</p>		<p>Each</p>
Condition state 1 -Description	Photo	
<ul style="list-style-type: none"> • There is no evidence of rusting or corrosion and any paint system or protective wrapping is in good condition. • There are no signs of distress at anchors, sockets or saddles.

<p>Lifting span cables in good condition</p>	
Condition state 2 -Description	Photo	
<ul style="list-style-type: none"> • The cables or hangers may show signs of rust and any paint system or protective wrapping is in fair condition. • There are no signs of distress at anchors or sockets but the saddles may be rusty and in need of lubrication.

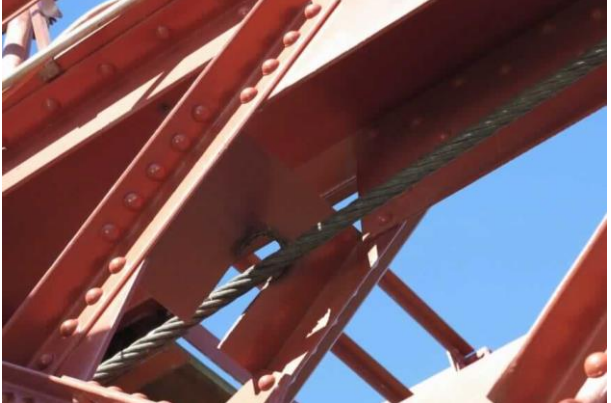
<p>Oxy cut cable guide plate not painted</p>

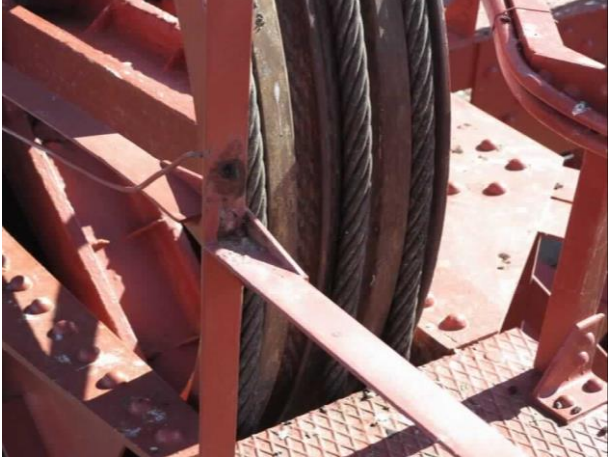
Condition state 3 -Description	Photo	
<ul style="list-style-type: none"> • The cables or hangers may show light rust • The protective wrapping may be broken or in poor condition. • Anchors may have fine cracking, sockets may be a little loose or saddles may have fine cracks in the metal.

<p>Light rusting of cable spool</p>

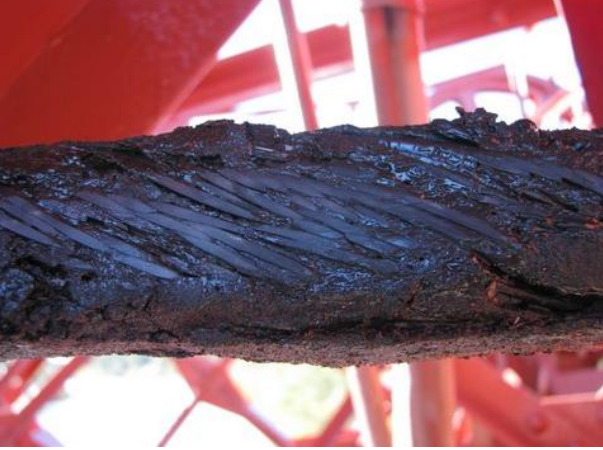
Condition state 4 -Description	Photo
<ul style="list-style-type: none">• The cables or hangers may be rusty with signs of minor corrosion.• Any paint system, coating or protective wrapping has been lost or is in very poor condition.• Anchors may have minor cracking, sockets may be slightly loose or saddles may have minor cracks in the metal.• The cables may have slacked off slightly or the hangers are slipping on the cable.• Cables may be beginning to abrade but there are no wire breakages.

<p data-bbox="794 651 1011 674">Worn lift span cable</p>
Condition state 5 -Description	Photo
<ul style="list-style-type: none">• The cables or hangers are badly corroded or the hangers are loose and are sliding along the cables.• The cables may have slacked noticeably.• Anchorages may have severely cracked or anchorages have moved or slipped.• Sockets may have loosened or saddles are badly damaged.• Cables may be severely abraded with a number of broken wires.

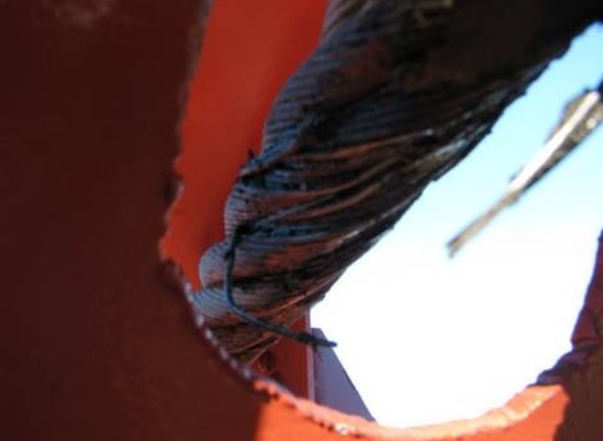
<p data-bbox="794 1167 1251 1189">Heavily worn lift cable with broken strand</p>

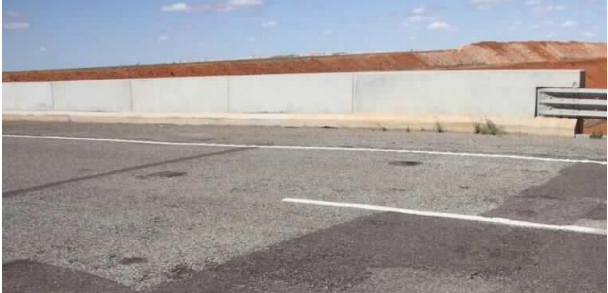
29C - Traffic barriers – concrete (precast or cast in-situ)		Units
<p>This item defines all types and shapes of barriers where the principal component is concrete. It includes any RC terminals, steel safety rails or traffic barriers mounted on top and holding down bolts.</p>		<p>Linear metres</p>
Condition state 1 -Description	Photo	
<ul style="list-style-type: none"> • The component shows only minor deterioration and the end connections or anchorage to the deck are in good condition. • There may be discolouration, efflorescence, and/or superficial cracking but without effect on strength and/or serviceability. • Steel rails are in good condition with no rust spotting and bolted and welded connections show no signs of deterioration. • No accident damage is evident.

<p data-bbox="791 719 1401 752">Precast concrete barrier in very good condition</p>	
Condition state 2 -Description	Photo	
<ul style="list-style-type: none"> • The rails may have minor flexural cracks or minor cracking and spalling due to corroding reinforcement. • Rail connections and anchorages should be in good condition. • Minor cracking and spalling of posts or joining concrete may be visible. • Steel railing on top of the parapets may have rust spotting but connections should still be tight. There are no cracked welds • Accident damage should be minor and of no consequence.

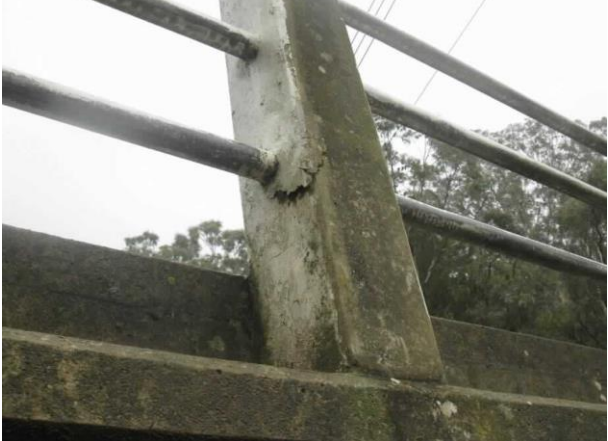
<p data-bbox="791 1375 1401 1406">Minor spalling of post</p>

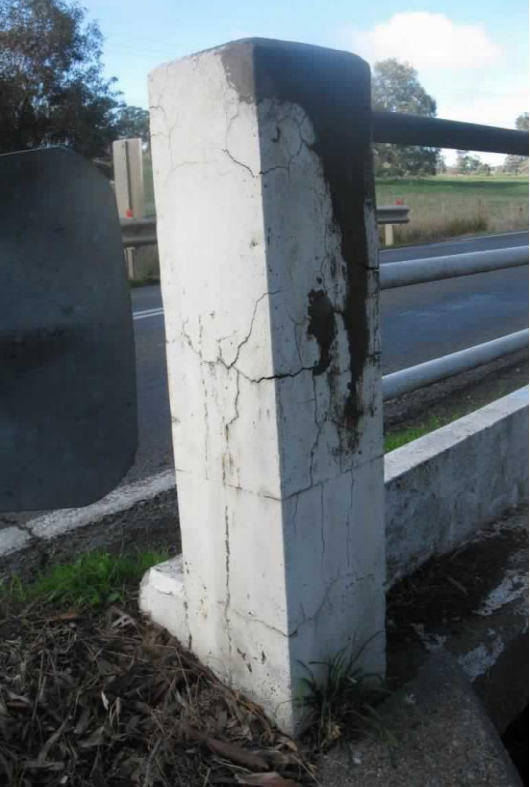
Condition state 3 -Description	Photo
<ul style="list-style-type: none"> • The rails may have moderate flexural cracks or minor cracking and spalling due to corroding reinforcement. • Rail connections and anchorages should be in fair condition. • Moderate cracking and spalling of posts or joining concrete may be visible. • Steel railing on top of the parapets may have minor rust spotting but connections should still be tight. There are no cracked welds • Accident damage has only a minor effect on strength or serviceability.

<p data-bbox="794 987 1262 1010">Moderate cracking in concrete barrier post</p>
Condition state 4 -Description	Photo
<ul style="list-style-type: none"> • The posts and rails may have medium cracking and spalling due to corrosion of reinforcement. • Rail connections may be slightly loose and post or parapet anchorages may have minor fine cracking due to vehicle impact. • Steel railing on top of parapets may be corroded or have loose bolting. • Accident damage has a moderate effect on strength or serviceability. • There may be minor rotation of the end posts

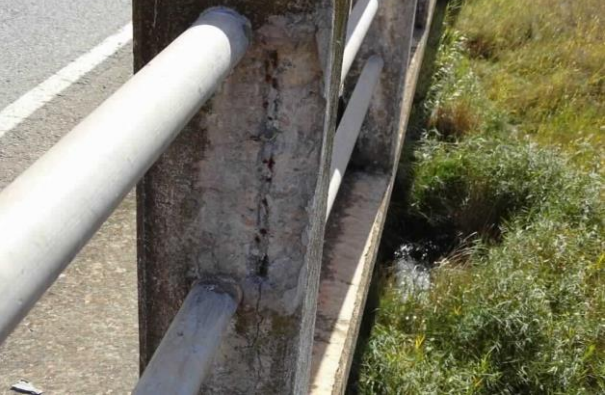
<p data-bbox="794 1458 1241 1480">Medium spalling of concrete barrier post</p>

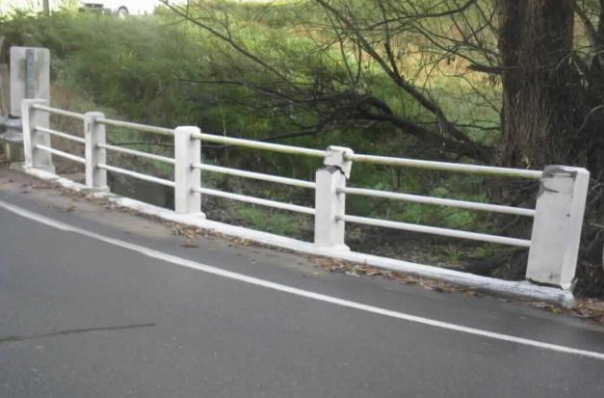
Condition state 5 -Description	Photo
<ul style="list-style-type: none">• The posts and rails may have severe cracking and spalling affecting their strength and serviceability.• Rails may be loose or have broken away at their connections. Severe cracking or spalling of the parapets or their anchorages may affect their strength and serviceability.• Corrosion may be well advanced in the steel barrier, bolts may be loose or rails may have broken free from their mountings. The anchorage area of the steel barrier posts may be cracked and spalled.• Accident damage is severe with part of the railing missing or demolished.• End posts may show signs of significant impact or rotation.

<p data-bbox="793 598 1252 627">Severe collision damage to concrete posts</p>

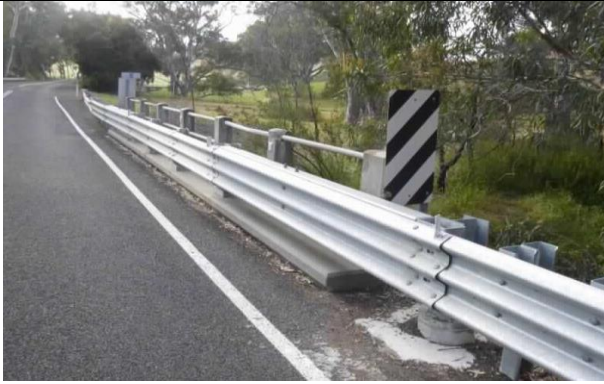
Condition state 1 -Description	Photo
<ul style="list-style-type: none"> • The paint or galvanising is generally in good condition with no rusting or corrosion. • The posts supporting the rails are in good condition with no corrosion of steel or cracking of concrete. • No accident damage is visible.

<p data-bbox="790 1041 1396 1064">Steel thrie beam barrier in very good condition</p>
Condition state 2 -Description	Photo
<ul style="list-style-type: none"> • Light spot rusting has formed to the surface area and the paint system is losing effectiveness. • Posts may have spot rusting or fine cracking in the concrete, but bolting or joint support is tight. • Any accident damage or vandalism is minor and of no consequence.

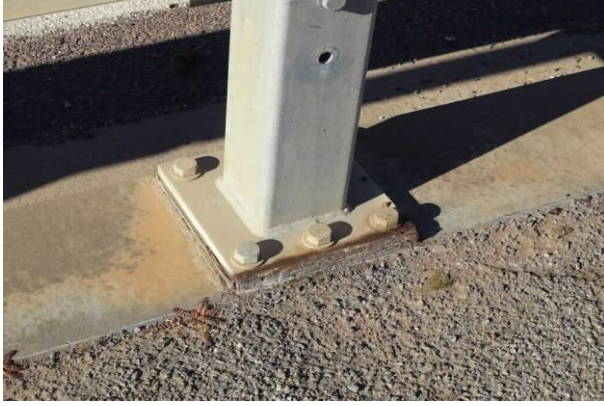
<p data-bbox="790 1512 1396 1534">Light rusting on barrier post base plate</p>
Condition state 3 -Description	Photo
<ul style="list-style-type: none"> • Minor spot rusting has formed to the surface area and the paint system is no longer effective. • Posts may have some rust and light corrosion, or minor cracking in the concrete, but bolting or joint support is still tight. • Accident damage has only a minor effect on strength or serviceability of the railing.

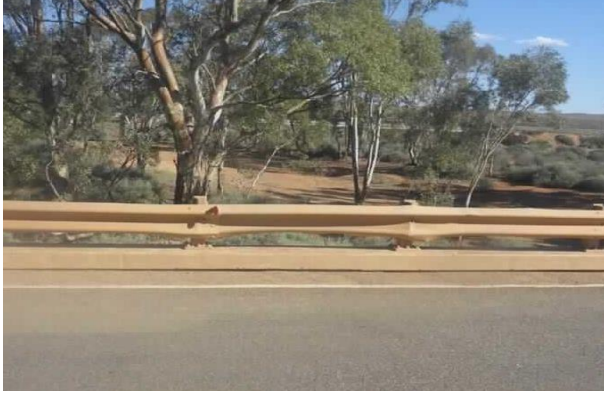
<p data-bbox="790 1971 1396 1995">Minor accident damage to steel w-beam barrier</p>

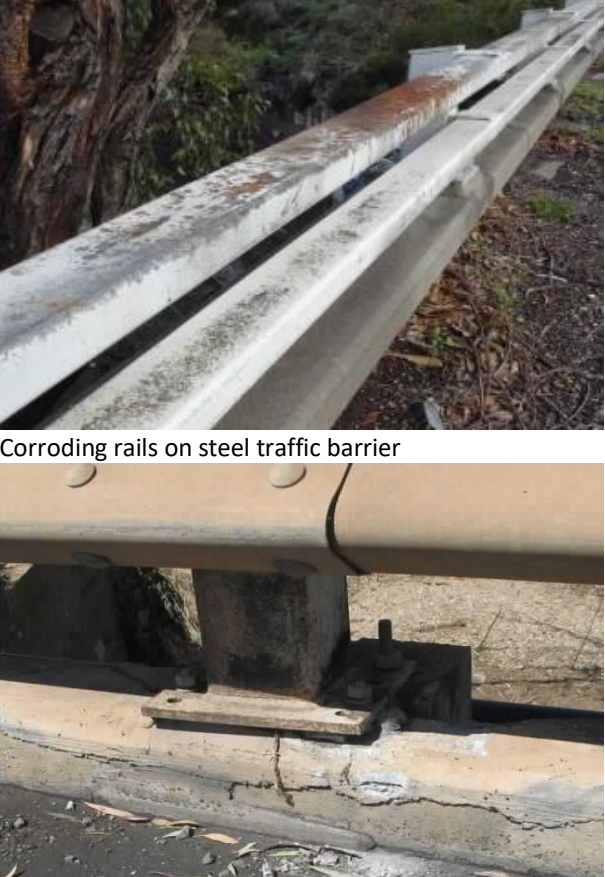
Condition state 4 -Description	Photo
<ul style="list-style-type: none"> • The paint system may have broken down and there is surface pitting in a number of locations on the rails and/or posts but there is minimal effect on strength or serviceability • Posts may also have corroding areas, loose hold down bolts or medium concrete cracking with some spalling. • Bolts holding down rails or rail joint support may be a little loose. • Accident damage has a moderate effect on strength or serviceability of the railing.

<p>The top photograph shows a close-up of a steel traffic barrier rail with significant surface rust and pitting. The bottom photograph shows a concrete barrier post with a metal anchor bolt that is loose and protruding from the concrete, which shows some cracking.</p> <p>Corroding rails on steel traffic barrier</p> <p>Barrier post anchor bolts loose</p>
Condition state 5 -Description	Photo

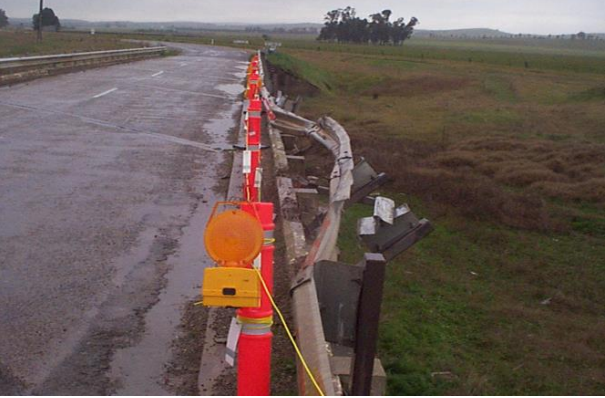
<ul style="list-style-type: none"> • Corrosion is advanced with loss of section affecting both strength and serviceability. • Posts may be badly corroded, become quite loose in their grouted anchorage or bolting, or heavily cracked and spalled concrete. • Rails may have broken away at their joints. • Accident damage is severe with loss of railing.

<p>The photograph shows a long stretch of a road with a w-beam railing. A significant portion of the railing has been crushed and broken away, leaving a large gap. Debris is scattered on the road surface. A yellow and red traffic cone is visible in the foreground near the damaged area.</p> <p>Severe damage to w-beam railing</p>

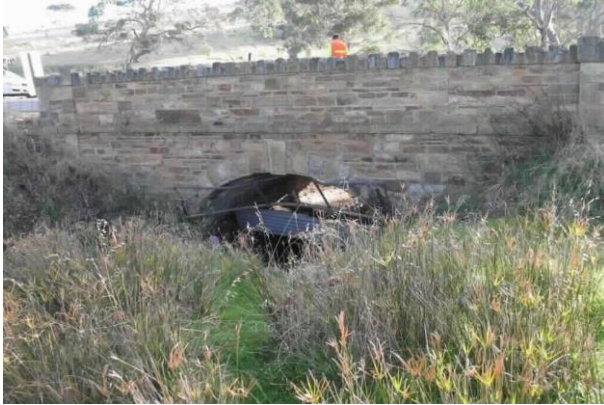
290 - Traffic barriers – other		Units
<p>This component defines all types of shapes and materials other than those already covered. Included in this component are masonry parapets, aluminium rails with steel tensioning cables inside, GWI pipe, post and rails, wire mesh fencing panels, wire or chain cables. The component covers any posts required to support the railing system or cables.</p>		<p>Linear metres</p>
Condition state 1 -Description	Photo	
<ul style="list-style-type: none"> • The component shows only minor signs of deterioration with minor cracking between masonry blocks or rusting of steelwork. • No accident damage is visible.

<p>Masonry wall in good condition</p>	
Condition state 2 -Description	Photo	
<ul style="list-style-type: none"> • Minor cracking, spalling, loss of mortar between masonry blocks, surface or spot rusting has occurred but having little or no effect on strength or serviceability. • Accident damage is very minor with no effect on strength or serviceability.

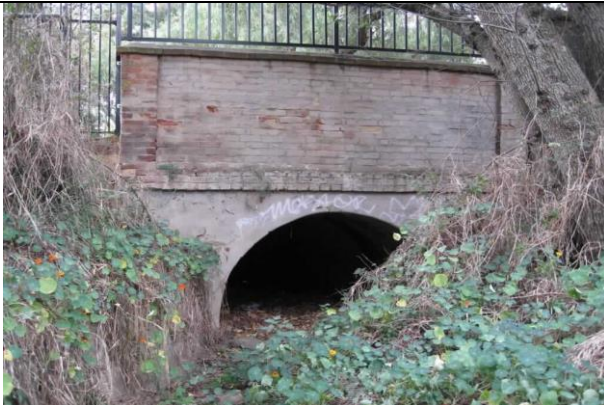
<p>Bricks starting to fret</p>

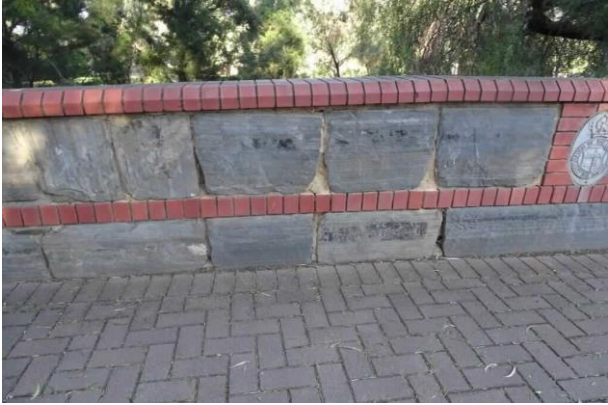
<p>Condition state 3 -Description</p> <ul style="list-style-type: none"> Moderate cracking, spalling, loss of mortar between masonry block, or corrosion of metal is occurring but having a minor effect on strength or serviceability. Accident damage may have a minor effect on the strength or serviceability of the railing. 	<p>Photo</p>

<p>Mortar loss between blocks</p>
<p>Condition state 4 -Description</p> <ul style="list-style-type: none"> Medium cracking, spalling, loss of mortar between masonry block, or corrosion of metal is occurring but having a moderate effect on strength or serviceability. Accident damage may have a moderate effect on the strength or serviceability of the railing. 	<p>Photo</p>

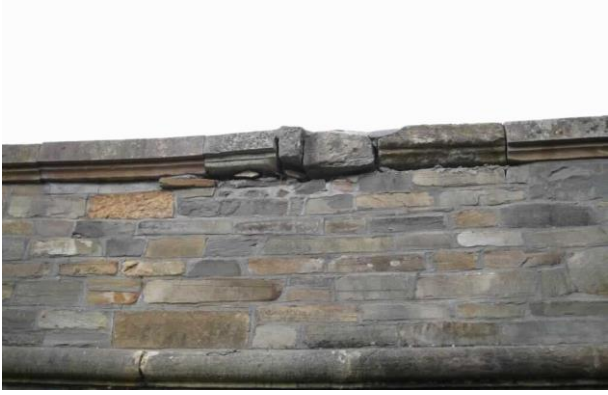
<p>Loose headstone in masonry barrier</p>
<p>Condition state 5 -Description</p> <ul style="list-style-type: none"> Severe cracking, spalling, loss of mortar or corrosion has a large effect on rail strength or serviceability. Accident damage is major affecting the strength or serviceability of the railing. 	<p>Photo</p>

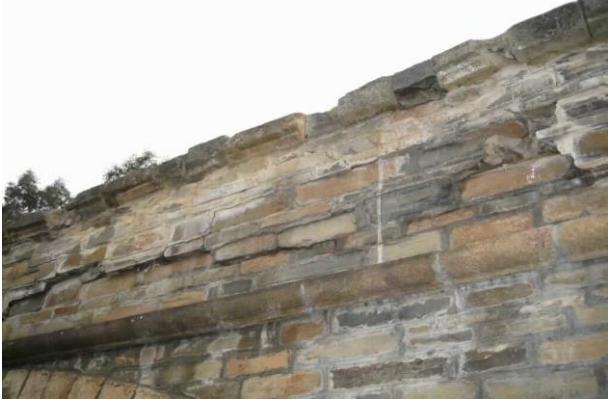
<p>Heavy impact has dislodged majority of stone</p>

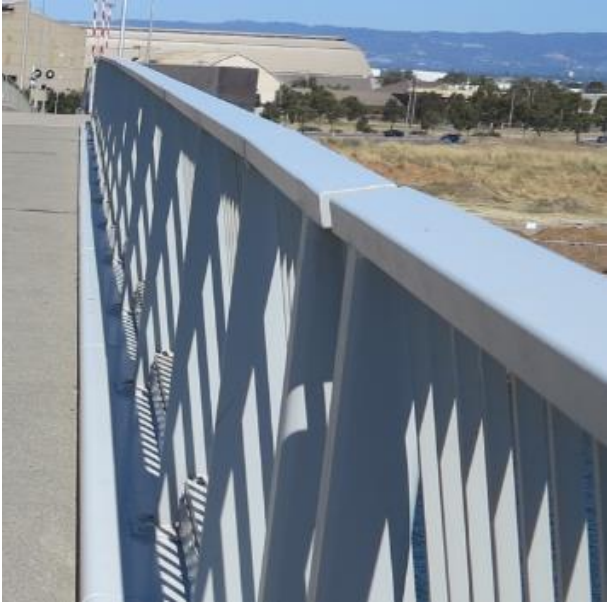
30S - Pedestrian barrier / fence – steel		Units
<p>This component defines all types of steel pedestrian barrier / railing and includes rails formed from tubes, rolled hollow sections, rolled shapes or beams. Also included in this component are the post and endposts, which support the railing and any pedestrian grilles attached to the component.</p> <p>This component does not include pedestrian mesh fencing with GWI posts and rails, which is included in Component No 270.</p>		<p>Linear metres</p>
Condition state 1 -Description	Photo	
<ul style="list-style-type: none"> • The paint or galvanising is generally in good condition with no rusting or corrosion. • The posts supporting the rails are in good condition with no corrosion of steel or cracking of concrete. • No accident damage is visible.

<p data-bbox="791 1144 1401 1178">Steel pedestrian barrier in good condition</p>	
Condition state 2 -Description	Photo

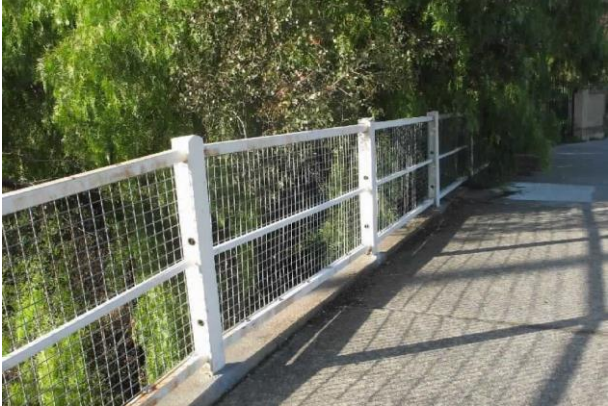
<ul style="list-style-type: none"> • Light spot rusting has formed to the surface area and the paint system is losing effectiveness. • Posts may have spot rusting or fine cracking in the concrete, but bolting or joint support is tight. • Any accident damage or vandalism is minor and of no consequence.

<p data-bbox="791 1615 1401 1644">Railing is showing spot rust throughout</p>

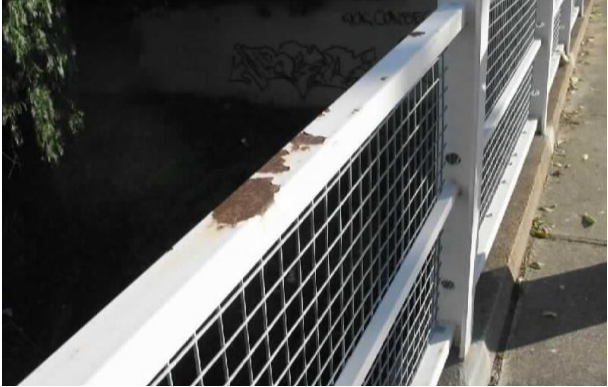
<p>Condition state 3 -Description</p> <ul style="list-style-type: none"> • Minor spot rusting has formed to the surface area and the paint system is no longer effective. • Posts may have some rust and light corrosion, or minor cracking in the concrete, but bolting or joint support is still tight. • Accident damage has only a minor effect on strength or serviceability of the railing. 	<p>Photo</p>

<p>Rusting and light corrosion</p>
<p>Condition state 4 -Description</p> <ul style="list-style-type: none"> • The paint system may have broken down and there is surface pitting in a number of locations on the rails and/or posts but there is minimal effect on strength or serviceability • Posts may also have corroding areas, loose hold down bolts or medium concrete cracking with some spalling. • Bolts holding down rails or rail joint support may be a little loose. • Accident damage has a moderate effect on strength or serviceability of the railing. 	<p>Photo</p>

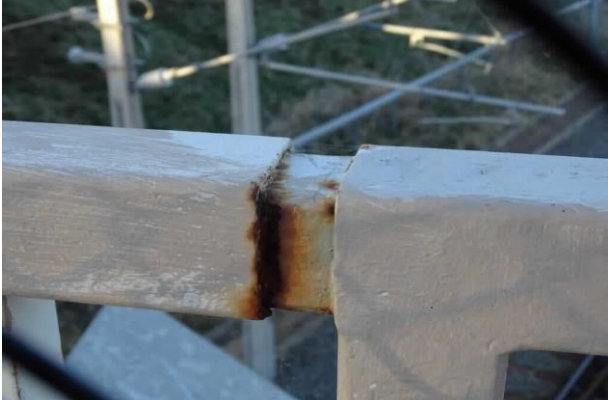
<p>Steel railing showing moderate corrosion</p>

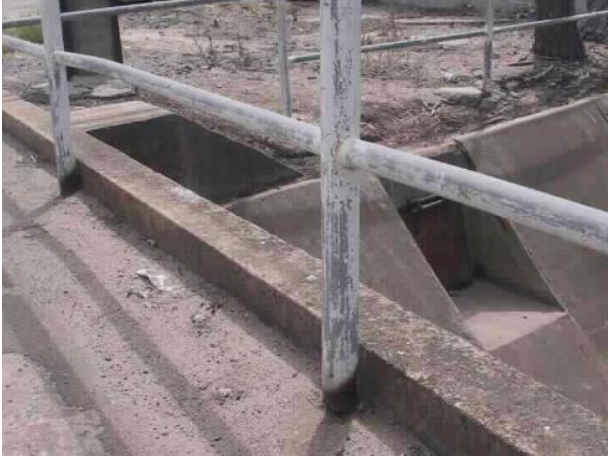
<p>Condition state 5 -Description</p> <ul style="list-style-type: none"> • Corrosion is advanced with loss of section affecting both strength and serviceability. • Posts may be badly corroded, become quite loose in their grouted anchorage or bolting, or heavily cracked and spalled concrete. • Rails may have broken away at their joints. • Accident damage is severe with loss of railing. 	<p>Photo</p>

<p>Section completely corroded through at base</p>

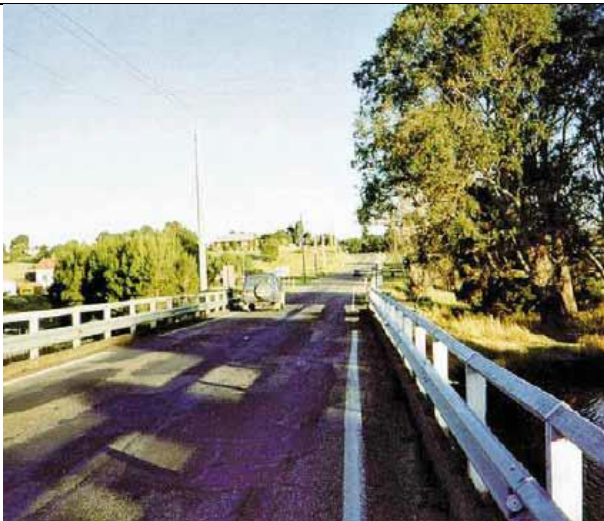
30T - Pedestrian barrier / fence – timber		Units
This component defines those rails constructed using timber either from a sawn section or glued laminated sections. This component includes also the supporting posts.		Linear metres
Condition state 1 -Description	Photo	
<ul style="list-style-type: none"> The component shows only minor deterioration and all the bolting is tight. No accident damage is visible.

<p>Timber railing in good condition with steel rubbing rail in front (VicRoads)</p>	
Condition state 2 -Description	Photo	
<ul style="list-style-type: none"> The component shows signs of minor decay, splitting or cracking but does not affect the strength or serviceability. Bolting of the posts and rails is generally tight. Accident damage is only minor with no effect on strength or serviceability.

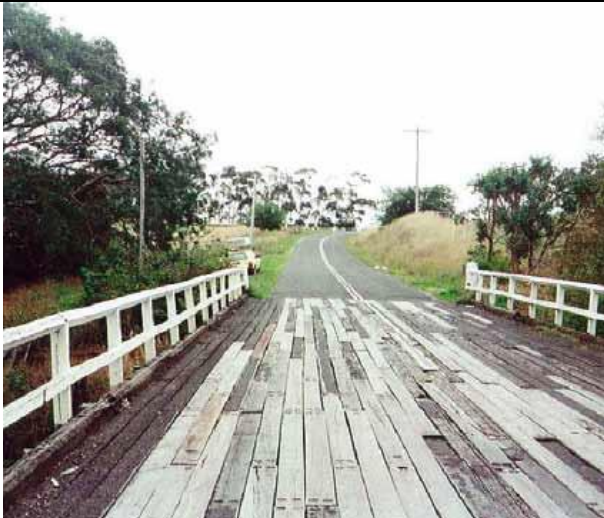
<p>Some posts have splits and some straps holding the top rail are loose (VicRoads)</p>

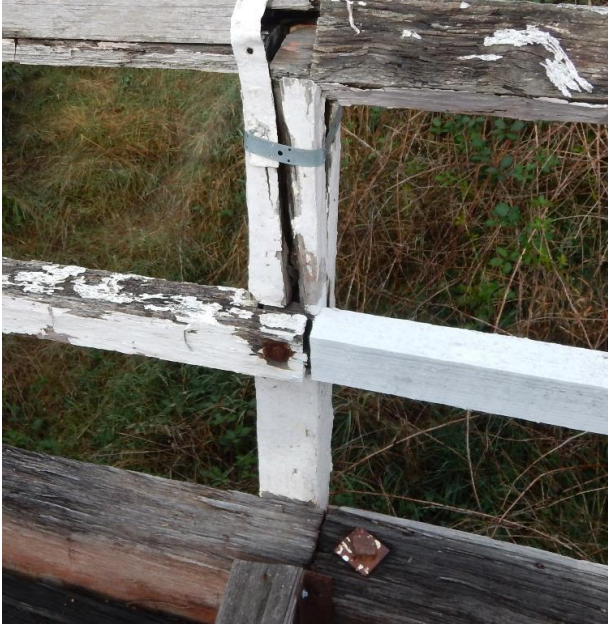
<p>Condition state 3 -Description</p> <ul style="list-style-type: none"> • Moderate decay, splitting cracking or crushing may be present affecting the strength and serviceability of the railing to a minor extent. • Bolting may be starting to loosen in a number of areas. • Accident damage may have a minor effect on the strength or serviceability of the railing. 	<p>Photo</p> <p>Not available</p>
<p>Condition state 4 -Description</p> <ul style="list-style-type: none"> • Significant decay, splitting cracking or crushing may be present affecting the strength and serviceability of the railing to a moderate extent. • Bolting may be loose in a number of areas. • Accident damage may have a moderate effect on the strength or serviceability of the railing. 	<p>Photo</p>

<p>Moderate decay of timber around connecting bolts and railing becoming loose (VicRoads)</p>
<p>Condition state 5 -Description</p> <ul style="list-style-type: none"> • Severe decay splitting cracking or crushing may be present affecting the strength and serviceability of the railing. • Bolting may be quite loose affecting the strength of the railing. • Accident damage is major affecting the serviceability of the railing. 	<p>Photo</p>

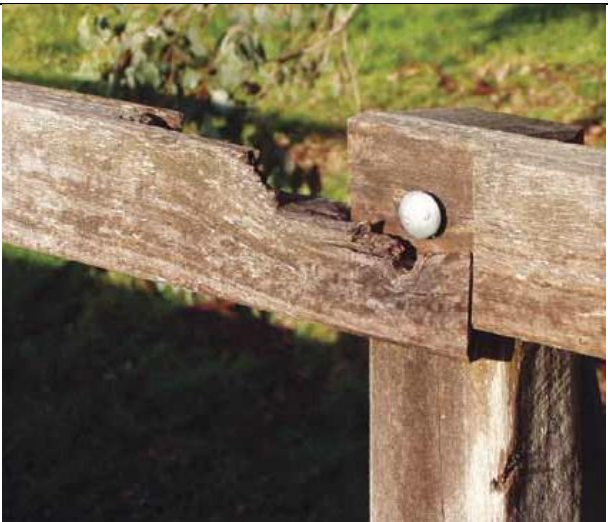
<p>Top rail rotted out at connection (VicRoads)</p>
