Road Structures Inspection Manual

Part 4A: Condition State Guidelines and Photographs

Bridges

RAS Document No: RAMA-ST-PRC-048
Knet Document No: 14888945
Document version: 1.3 (08/05/2020)

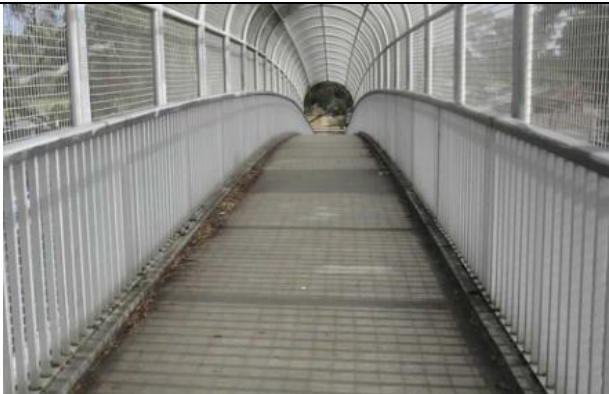
300 - Pedestrian barrier / fence – other		Units
<p>This component defines all types of shapes and materials other than those already covered. Included in this component are masonry parapets, aluminium rails, GWI pipe, post and rails, wire mesh fencing panels, wire or chain cables. The component covers any posts required to support the railing system or cables.</p>		<p>Linear metres</p>
Condition state 1 -Description	Photo	
<ul style="list-style-type: none"> The component shows only minor signs of deterioration with minor cracking between masonry blocks or rusting of steelwork. No accident damage is visible.

Aluminium fence in good condition
Condition state 2 -Description	Photo	
<ul style="list-style-type: none"> Minor cracking, spalling, loss of mortar between masonry blocks, surface or spot rusting has occurred but having little or no effect on strength or serviceability. Accident damage is very minor with no effect on strength or serviceability.

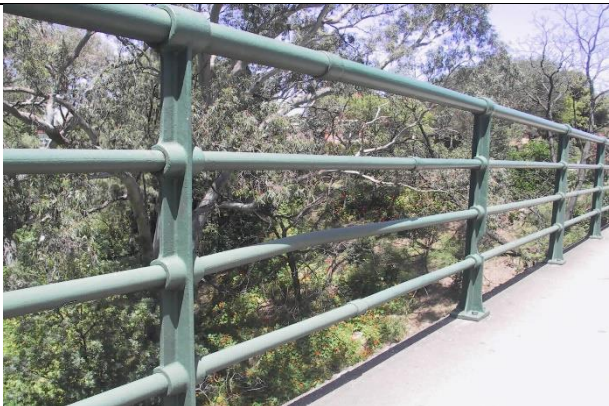
Pipe fence rail bent

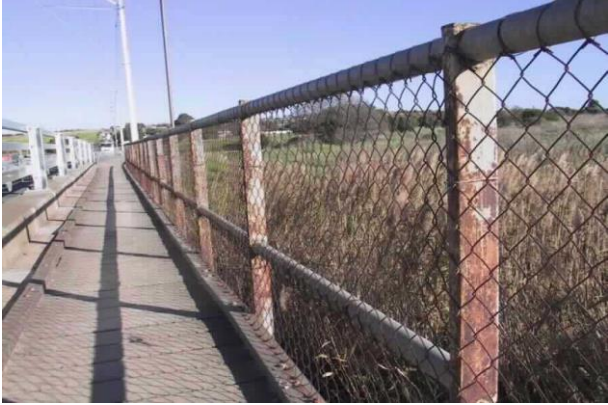
<p>Condition state 3 -Description</p> <ul style="list-style-type: none"> • Moderate cracking, spalling, loss of mortar between masonry block, or corrosion of metal is occurring but having a minor effect on strength or serviceability. • Accident damage may have a minor effect on the strength or serviceability of the railing. 	<p>Photo</p>

<p>Corroded pedestrian handrail and chainwire</p>
<p>Condition state 4 -Description</p> <ul style="list-style-type: none"> • Medium cracking, spalling, loss of mortar between masonry block, or corrosion of metal is occurring but having a moderate effect on strength or serviceability. • Accident damage may have a moderate effect on the strength or serviceability of the railing. 	<p>Photo</p>

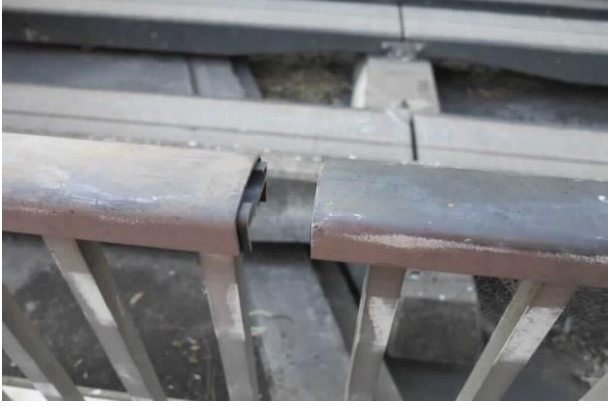
<p>Spigot dislodged from aluminium handrail</p>
<p>Condition state 5 -Description</p> <ul style="list-style-type: none"> • Severe cracking, spalling, loss of mortar or corrosion has a large effect on rail strength or serviceability. • Accident damage is major affecting the strength or serviceability of the railing. 	<p>Photo</p>

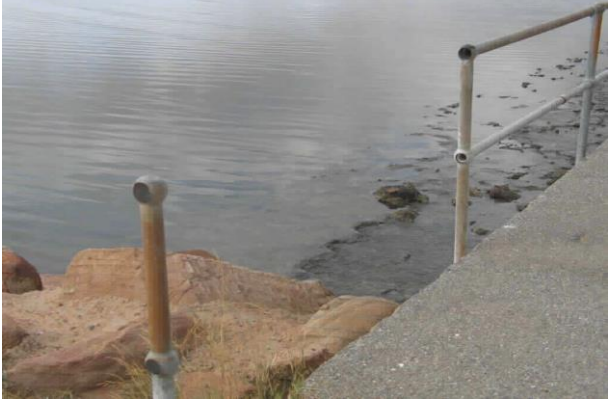
<p>GWI rails missing</p>

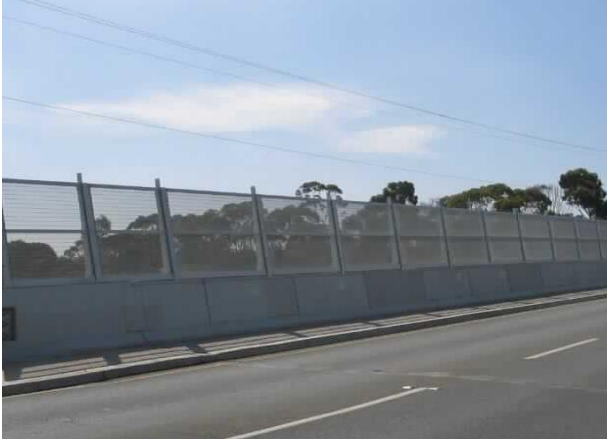
310 - Other barriers and screens – other This component defines other barrier and screen attachments on bridges. This includes safety screens and anti-throw screens.		Units Linear metres
Condition state 1 -Description	Photo	
<ul style="list-style-type: none"> • The screen is in good condition. There is little or no evidence of corrosion. The protective coating, if any, may be chalking, peeling, checking or showing other early evidence of distress but there is no exposure of metal. • The structural connections fixing the screen to the bridge are in good condition.

<p data-bbox="791 869 1187 898">Anti-throw screen in good condition</p>	
Condition state 2 -Description	Photo	
<ul style="list-style-type: none"> • Surface or freckled rust has formed or is forming. The protective coating, if any, is losing effectiveness and there may be exposed metal but there is no loss of section. • The structural connections fixing the attachment to the bridge are in good condition.

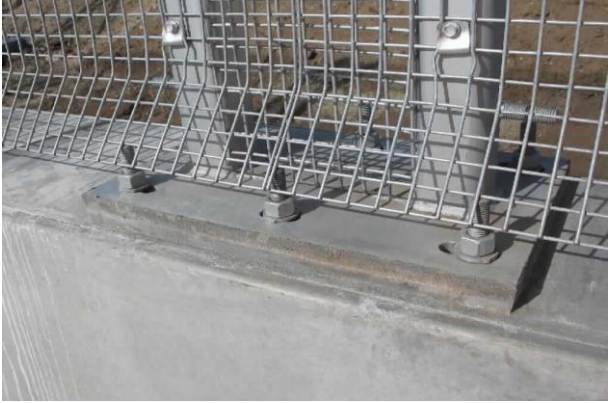
<p data-bbox="791 1339 1321 1364">Safety screen mesh in contact with anchor studs</p>

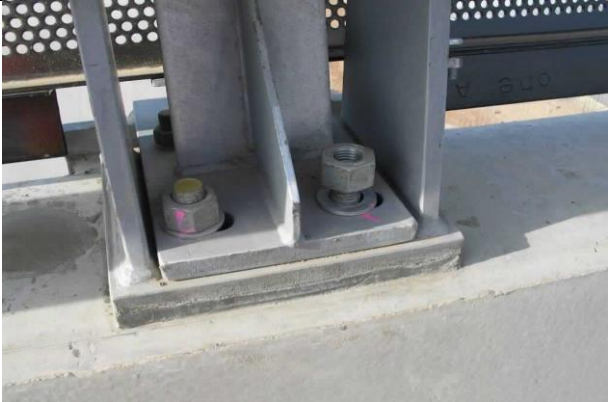
Condition state 3 -Description	Photo	
<ul style="list-style-type: none"> • Surface rust has formed and pitting may be present. The protective coating, if any, is no longer effective and there may be exposed metal but any section loss is minor and does not affect the strength or serviceability of the component. • The structural connections fixing the attachment to the bridge are only in fair condition.

<p data-bbox="791 1805 1155 1830">Loose nut in throw screen mount</p>

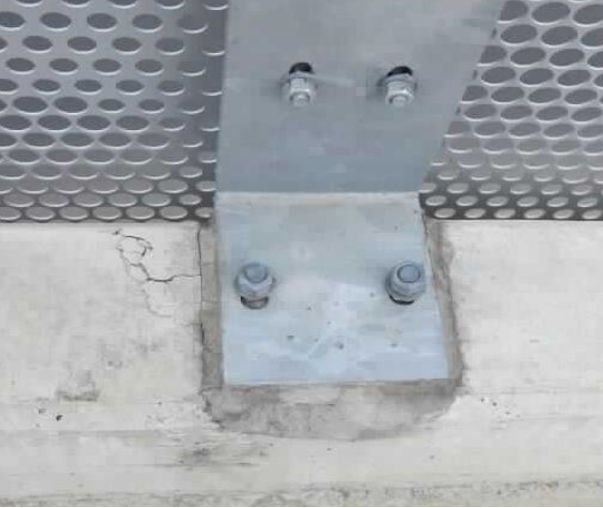
Condition state 4 -Description	Photo
<ul style="list-style-type: none">• Surface pitting is present and there may be moderate section loss that has only a minor effect on the strength or serviceability of the component.• The structural connections fixing the attachment to the bridge are generally in poor condition with minor corrosion to bolts and/or cracking or spalling to mortar pads.

<p data-bbox="794 707 1214 734">Spalling around anti throw screen post</p>
Condition state 5 -Description	Photo
<ul style="list-style-type: none">• Corrosion is advanced. Section loss may be affecting the strength and/or serviceability of the component.• There is doubt about the integrity of the connection(s). There may be advanced corrosion or cracking of the connectors and/or the supporting bridge component.	Not available

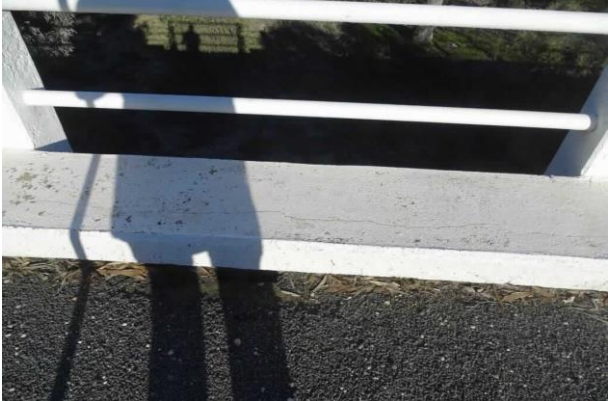
32C - Bridge kerbs – concrete (precast or cast in-situ)		Units
<p>This item defines kerbs that are constructed of either precast or cast in-situ concrete on deck units or deck slabs which form an upstand at the edge of the bridge and/or carriageway. Bridge barriers are normally mounted on these members. Also included are concrete kerbs cast on timber bridge decks, with or without attached barriers.</p>		<p>Linear metres</p>
Condition state 1 -Description	Photo	
<ul style="list-style-type: none"> Kerbs are in good condition with only minor cracking due to shrinkage or corrosion of reinforcement.

<p>Minor cracking</p>	
Condition state 2 -Description	Photo	
<ul style="list-style-type: none"> There is minor cracking or spalling at the joints or on faces due to movement restraint, shrinkage or corrosion of reinforcement. Bolts to timber girders may be slightly loose.

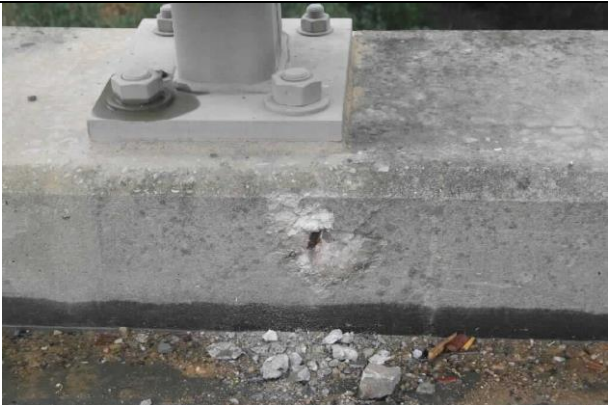
<p>Minor spall in concrete kerb</p>

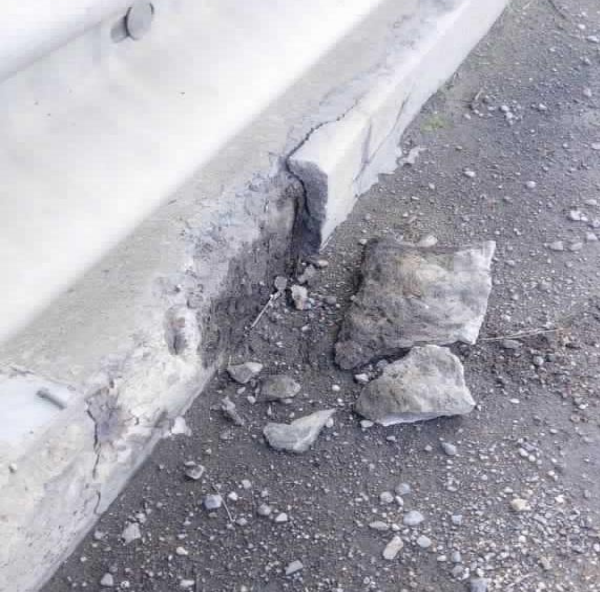
Condition state 3 -Description	Photo
<ul style="list-style-type: none"> • There is moderate cracking or spalling at the joints or on faces due to movement restraint, shrinkage or corrosion of reinforcement. • The reinforcement may have minor loss of section. • There may be minor cracking at the base of barrier posts as a consequence of vehicle impact but containment is not impaired. • Bolts to timber girders may be loose.

<p data-bbox="794 792 991 819">Moderate spalling</p>
Condition state 4 -Description	Photo
<ul style="list-style-type: none"> • There is medium cracking or spalling at the joints or on faces due to movement restraint, shrinkage or corrosion of reinforcement. • The reinforcement may have moderate loss of section. • Some minor flexural cracking may be evident on the top face over piers on continuous joints. • There may be moderate cracking at the base of barrier posts as a consequence of vehicle impact but containment is not impaired. • Bolts to timber girders may be moderately loose.

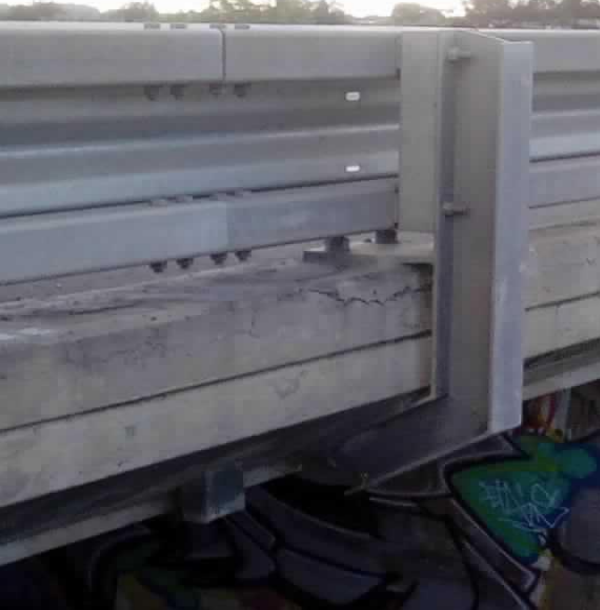
<p data-bbox="794 1476 1267 1503">Major cracking including separation of kerb</p>

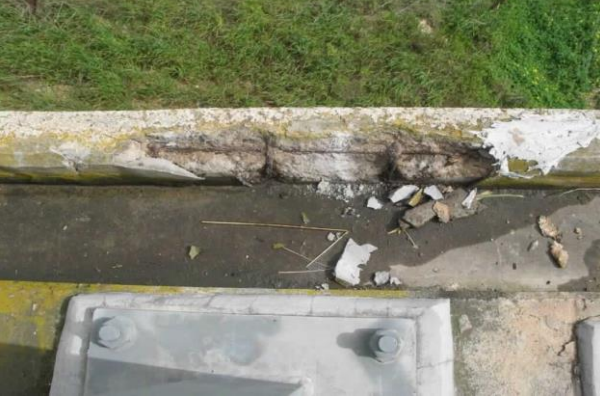
Condition state 5 -Description	Photo
<ul style="list-style-type: none"> • Severe cracking and spalling is evident as a result of movement restraint at joints, corrosion of reinforcement or the effects of vehicle impact on the barrier. • Containment capacity may be reduced to unsafe levels. • The reinforcement may have suffered a more severe loss of section. • Bolts to timber girders may be very loose, severely corroded or missing completely.

<p data-bbox="794 1946 1155 1973">Significant spalling of bridge kerb</p>

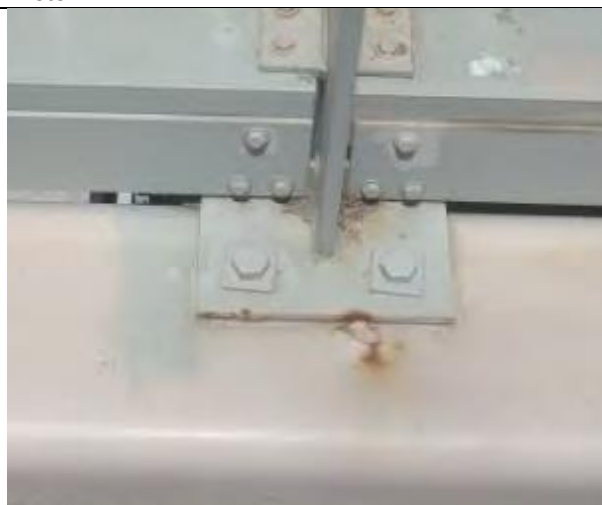
Spot rusting on steel kerb

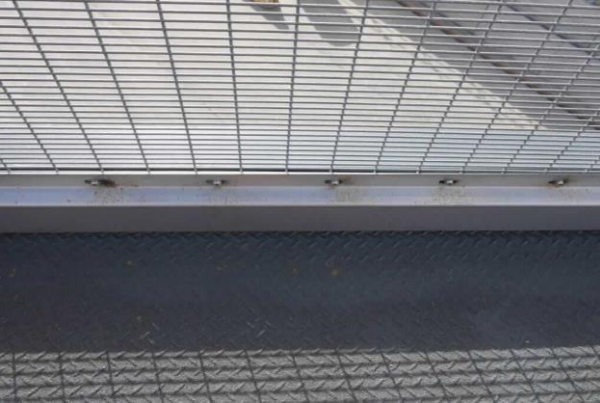
Condition state 3 -Description	Photo
<ul style="list-style-type: none"> The protective system is no longer effective and surface rusting with minor pitting in some areas has occurred on the member. All fixings are tight although rust may be forming. Any accident damage is moderate and has only minor effect on strength or serviceability.

<p data-bbox="794 593 1396 622">Corrosion staining on stainless steel kerbing</p>
Condition state 4 -Description	Photo
<ul style="list-style-type: none"> The protective system may have broken down and there is surface pitting in a number of locations on the member but there is minimal effect on strength or serviceability. There may be some corrosion evident. Fixings may be loose but the kerb is still in the correct location. Fixings may be corroding. Accident damage has moderate effect on strength or serviceability.

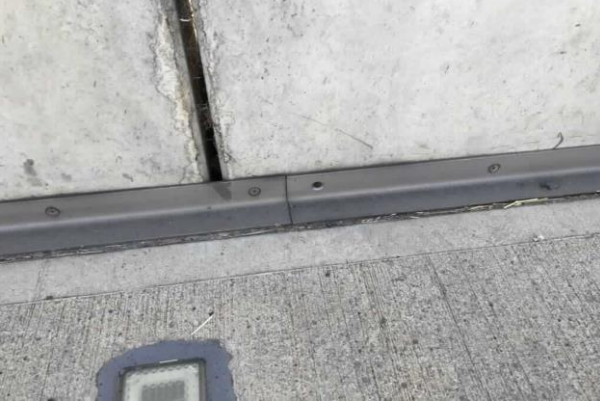
<p data-bbox="794 1064 1396 1093">Fastener missing from steel kerb</p>

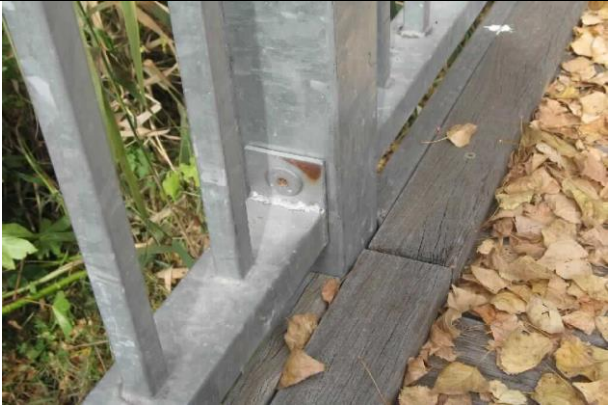
Timber kerb with minor splitting

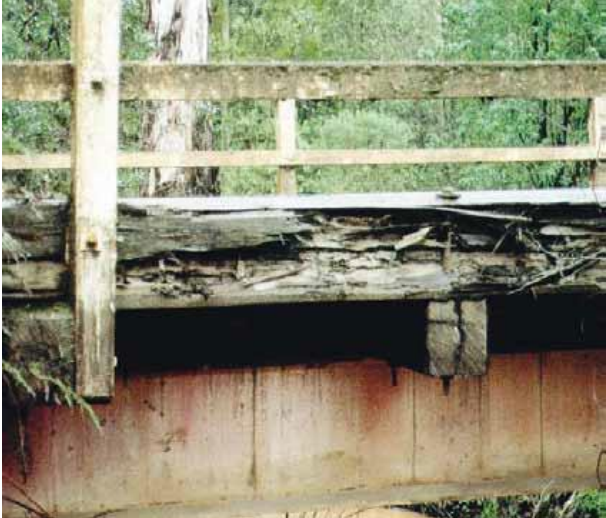
Condition state 3 -Description	Photo
<ul style="list-style-type: none"> Moderate decay, splitting or cracking may be present and starting to affect the strength or serviceability of the member. 	Not available
Condition state 4 -Description	Photo
<ul style="list-style-type: none"> Medium decay, splitting or crushing may be present, affecting the component's serviceability, including containment capacity if barrier attachment capacity is reduced. In most instances, timbers will have loosened considerably. There may be an active termite presence but with only minimal damage sustained. The paint system on the kerb may have broken down. 	Not available
Condition state 5 -Description	Photo
<ul style="list-style-type: none"> Heavy decay, splitting or crushing may be present, affecting the serviceability of the component. Timbers will be loose or may in fact be missing. There may be an active termite infestation causing severe damage. The paint system on the kerb may have broken down. Attachment bolts may be very loose, missing completely or heavily corroded. Unsleeved attachment bolts may be severely corroded due to contact with preservative treatment in stress-laminated decks. With ply kerbs, bolt heads may be punching into the kerb if insufficient washer sizes are used.

<p data-bbox="791 1417 1342 1447">Timber kerb severely eaten by termites (VicRoads)</p>

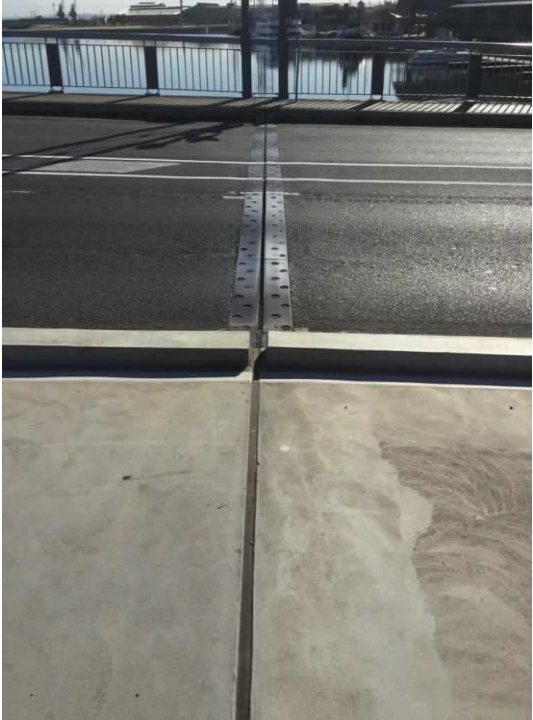
<p>Reinforced concrete kerb and footpath in good condition with no cracking or spalling</p>	
Condition state 2 -Description	Photo	
<ul style="list-style-type: none"> Kerbs may have minor cracking or spalling due to movements or corrosion of steel reinforcement. Footpath slabs may also have slight cracking or spalling due to shrinkage, temperature, relative movement or corroding reinforcement. Minor differential vertical movement between footpath slabs present only minimal danger to pedestrians tripping over.

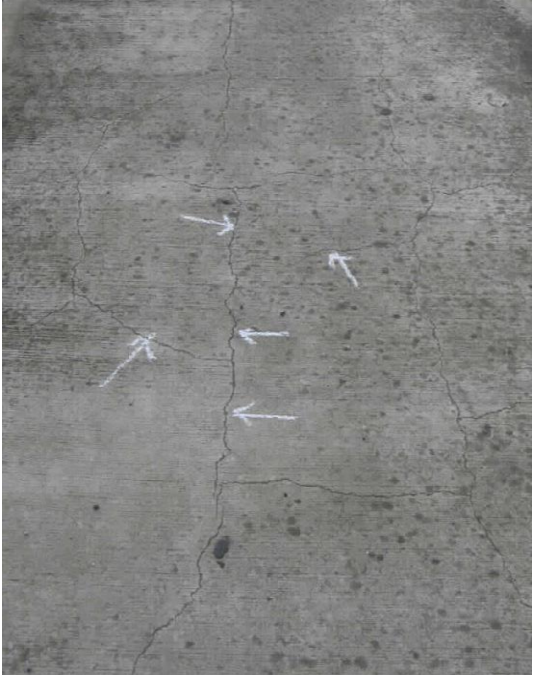
<p>Minor footpath cracking</p>

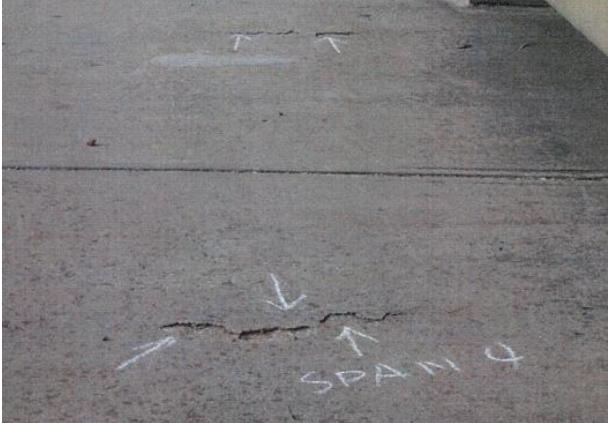
<p>Condition state 3 -Description</p> <ul style="list-style-type: none"> • Kerbs may have moderate cracking or spalling due to movements or corrosion of steel reinforcement. • Footpath slabs may also have minor cracks or spalls due to shrinkage, temperature, relative movement or corroding reinforcement. • Differential vertical movement between footpath slabs may present a minor danger to pedestrians tripping over. 	<p>Photo</p>

<p>Spalling footpath creating minor tripping hazard</p>
<p>Condition state 4 -Description</p> <ul style="list-style-type: none"> • Kerbs and footpaths may have medium cracking and spalling due to movement or steel reinforcement corrosion. • Differential movement between footpath slabs may have caused broken edges and vertical displacements that present a danger of tripping to pedestrians. 	<p>Photo</p>

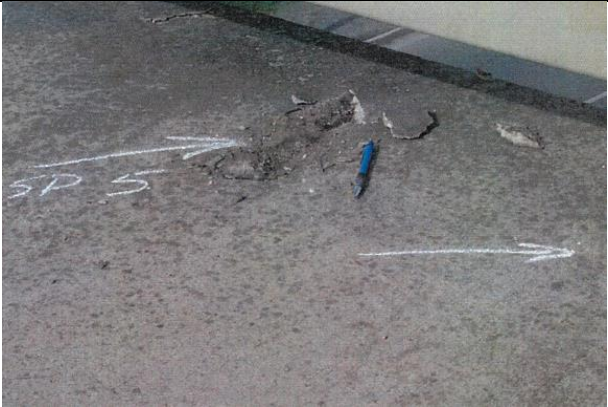
<p>Medium spalling in footpath causing tripping hazard</p>

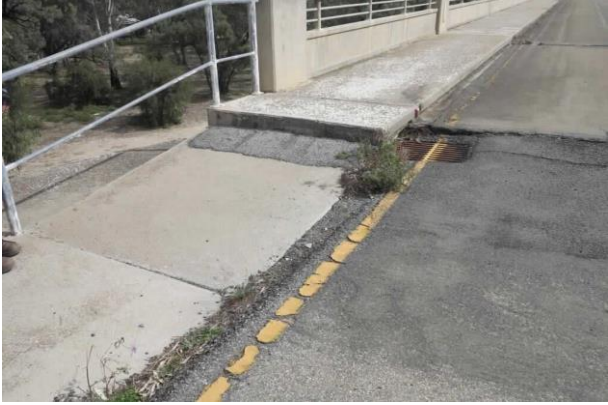
<p>Condition state 5 -Description</p> <ul style="list-style-type: none"> • Kerbs and footpaths may have severe cracking and spalling. • Footpath slabs may be badly broken and uneven in areas or have large vertical displacements causing major danger to pedestrians. 	<p>Photo</p>

<p>Footpath with large vertical displacement</p>

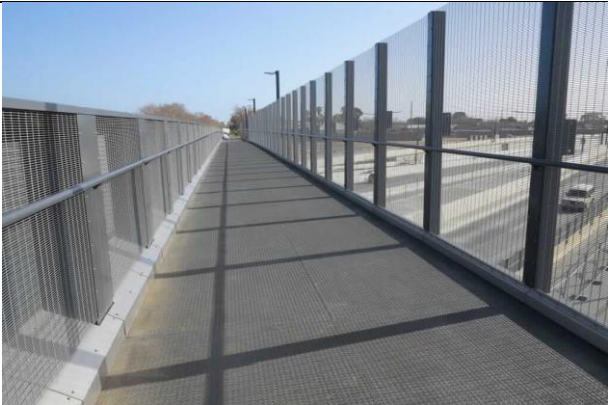
33S - Footpaths – steel This item describes those footpaths which are constructed of steel plates. Any thin layer of surfacing material should be included with this item as it greatly influences the action and rate of deterioration of the steel decking.		Units Linear metres
Condition state 1 -Description <ul style="list-style-type: none"> • The steel is in good condition with no evidence of any corrosion. • The plates are rigidly bolted to supports and are good and tight. • The surfacing is in good condition with no evidence of cracking, pop-outs or delamination. 	Photo

Steel chequer plate footpath in good condition
Condition state 2 -Description <ul style="list-style-type: none"> • Slight pitting of the surface due to corrosion may be evident but there is no loss of section. • Plates remain firmly bolted to supports and are good and tight. • There may be minor cracking of the surfacing. 	Photo Not available

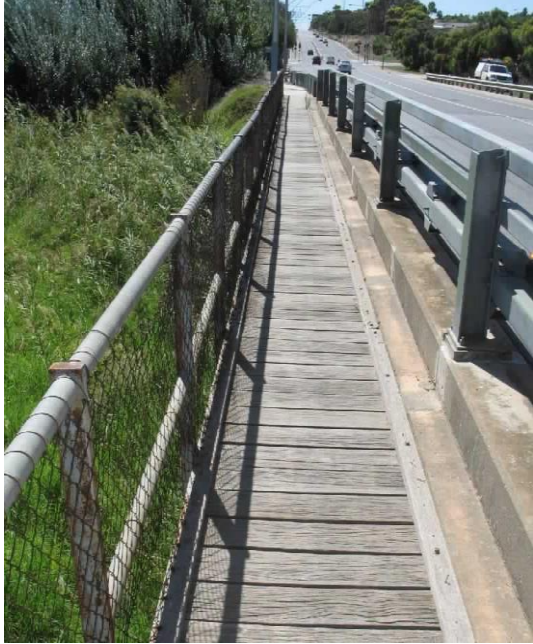
<p>Footpath timber with only minor splitting</p>

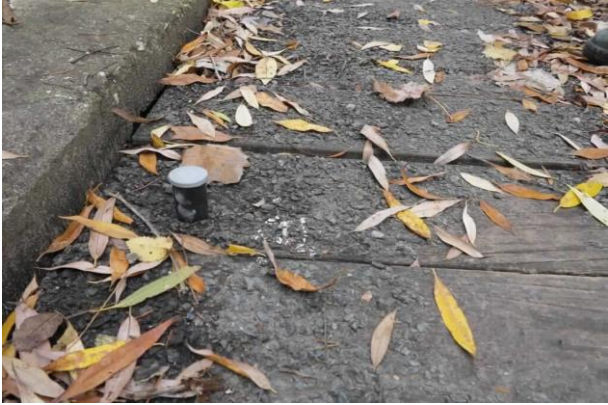
<p>Condition state 3 -Description</p> <ul style="list-style-type: none"> • Moderate decay, splitting or cracking may be present but only having a slight effect on the strength or serviceability of the timber. • Loose planks, small gaps and a few uneven timbers do not cause a danger to pedestrians. • Non-slip surfacing on ply decks may be starting to delaminate. 	<p>Photo</p>

<p>Loose timber plank caused by hold down nail pulling out</p>
<p>Condition state 4 -Description</p> <ul style="list-style-type: none"> • Medium decay, splitting or crushing may be present affecting the components serviceability. • Planks are generally loose and along with gaps and uneven ends of timbers present a danger of tripping to pedestrians. • Advancing delamination of non-slip surfacing on ply decks. 	<p>Photo</p>

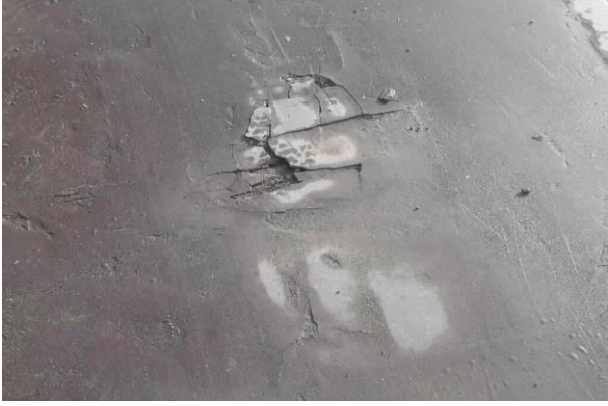
<p>Footpath timber deck surface breaking up</p>
<p>Condition state 5 -Description</p> <ul style="list-style-type: none"> • Severe decay, splitting or crushing may be present affecting the serviceability of the component. • Planks may be broken, missing or very loose presenting a major danger to pedestrians. • Non-slip surfacing on ply decks may be missing in substantial areas. • Acute termite infestation and damage may have occurred. • The exposed ends of ply decking may be badly weathered and delaminated. 	<p>Photo</p> <p>Not available</p>

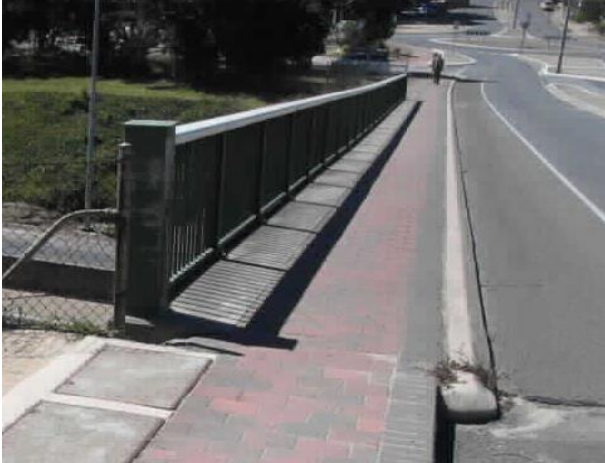
Condition state 1 -Description	Photo
<ul style="list-style-type: none"> The component is in good condition with only minor superficial cracking of the surface, minor rusting of the steel kerb face plate or broken masonry blocks.

<p data-bbox="791 904 1398 936">Brick paving footpath in good condition</p>
Condition state 2 -Description	Photo
<ul style="list-style-type: none"> The asphalt surface may have some minor cracking, but no broken-up areas. Steel kerb face plate may be rusty but no corrosion pitting. Masonry kerb blocks may be cracked or have small edge spalls but still in fair condition.

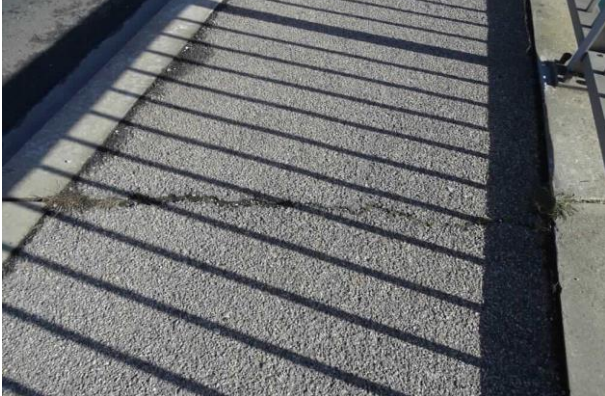
<p data-bbox="791 1370 1398 1391">Cracked asphalt surface</p>

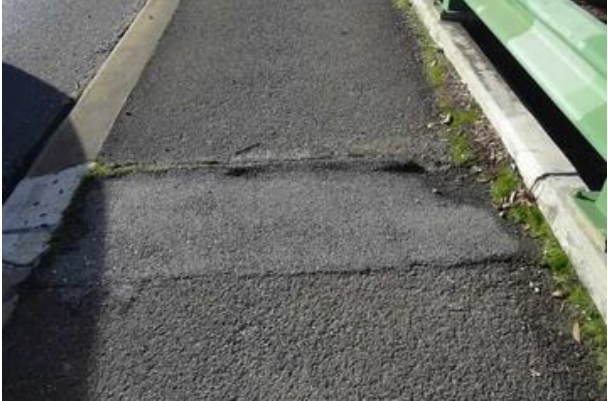
<p>Condition state 3 -Description</p> <ul style="list-style-type: none"> • Asphalt surfacing may have moderate cracking or small broken up areas. • Steel kerb face plate may be rusty with minor corrosion pitting. • Masonry kerb blocks may be cracked or have moderate edge spalls but still basically in fair condition. 	<p>Photo</p>

<p>Settlement in footpath causing minor tripping hazard</p>
<p>Condition state 4 -Description</p> <ul style="list-style-type: none"> • The kerb face plate may have moderate corrosion but still be effectively holding the footway material in place. • Masonry kerb blocks may be severely cracked and broken up but still be effectively holding the footway material in place. • Asphalt surfacing may have medium cracking and a number of broken up areas. 	<p>Photo</p>

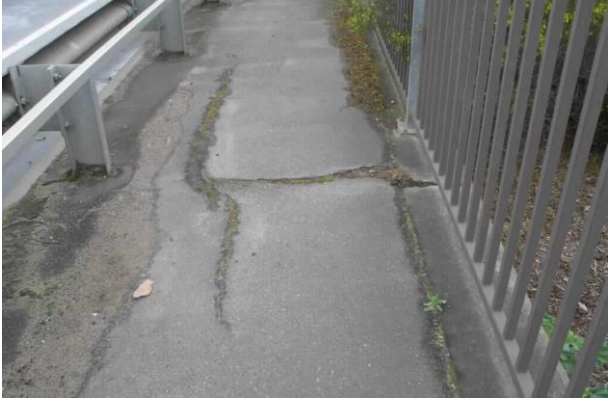
<p>Asphalt surface cracking causing tripping hazard</p>
<p>Condition state 5 -Description</p> <ul style="list-style-type: none"> • Asphalt surface may be severely cracked and broken up in large areas. • Steel kerb face plate may be severely corroded with holes or loss of edges. • Masonry kerb blocks may be completely broken with sections missing. 	<p>Photo</p>

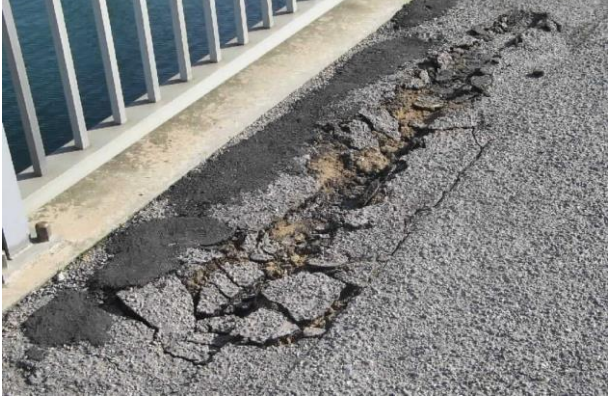
<p>Severely cracked asphalt surface</p>

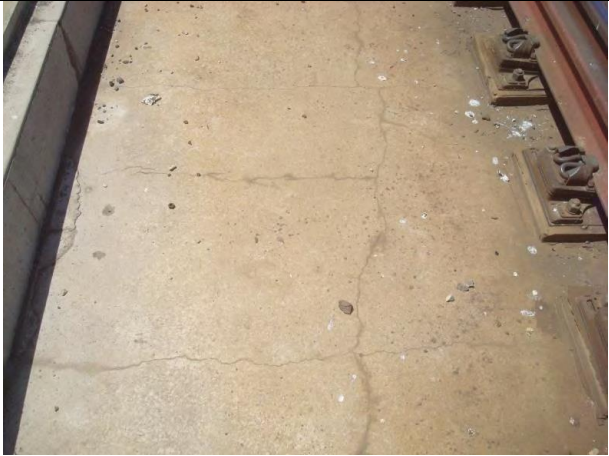
34C - Traffic surface – cast in-situ concrete		Units
<p>This item applies to concrete decks which form the running surface for traffic.</p> <p>This includes the surface of concrete bridges that carry busway tracks, but does not include the busway tracks themselves, these shall be considered under Component No 120P.</p>		<p>m² of exposed surface area</p>
Condition state 1 -Description	Photo	
<ul style="list-style-type: none"> The concrete surface is in good condition and may have minor shrinkage or plastic settlement cracks. The surface texture is pronounced and the aggregate is not worn and there is adequate crossfall or grade to efficiently drain any surface water. All scuppers are clear.

Minor shrinkage cracks in concrete surface	
Condition state 2 -Description	Photo	
<ul style="list-style-type: none"> Shrinkage or plastic settlement cracks are of moderate width and there may be minor cracking and spalling due to corrosion of reinforcement. Some wear or polishing of aggregate is evident but there is only a marginal loss of surface texture and skid resistance. There may be surface irregularities which hold surface water and the ability to shed and drain surface water has been slightly impaired. Some scuppers may be blocked with debris and isolated patches of weed are growing at the kerbs.

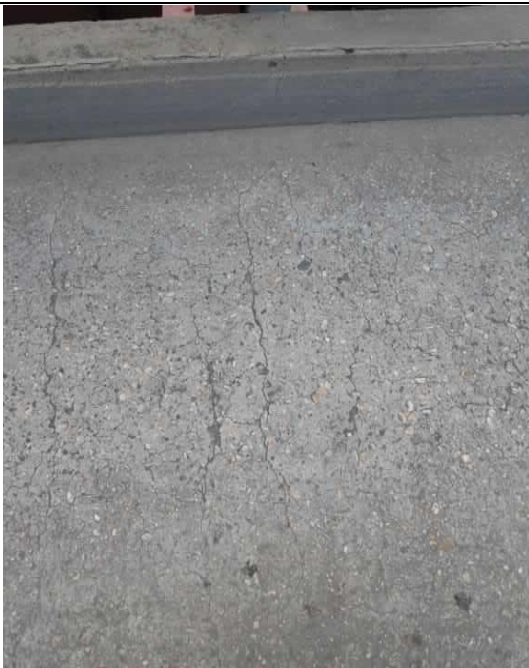
Cracked and slightly worn concrete traffic surface

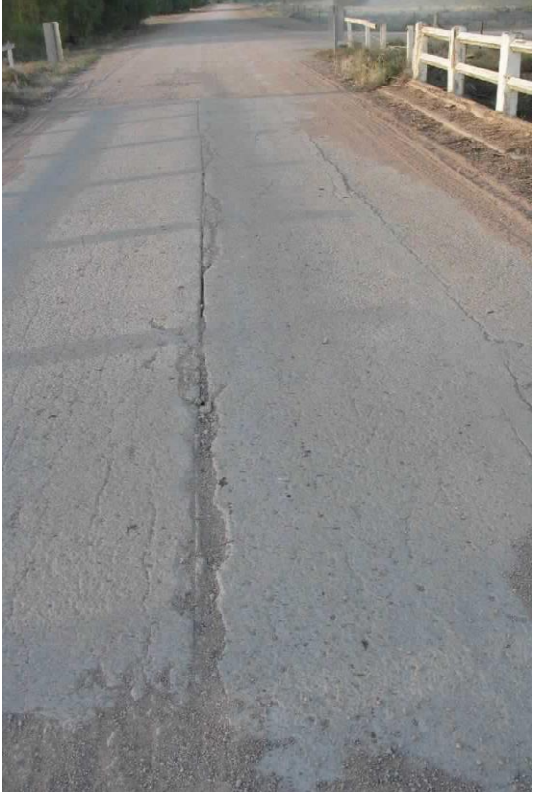
Condition state 3 -Description	Photo
<ul style="list-style-type: none"> • Moderate shrinkage or plastic settlement cracks and there may be moderate cracking and spalling due to corrosion of reinforcement. • Wear or polishing of aggregate is evident and there may be moderate loss of surface texture and skid resistance. • There may be surface irregularities which hold surface water and the ability to shed and drain surface water has been somewhat impaired. • Some blocked scuppers may be having a minor effect on deck drainage and isolated patches of weed are growing at the kerbs.

<p data-bbox="791 987 1382 1048">Cracking and spalling of concrete traffic surface, along with gravel build up blocking scuppers</p>
Condition state 4 -Description	Photo
<ul style="list-style-type: none"> • Shrinkage and plastic settlement cracks are moderate to severe and the deck has a crazed appearance but there is no differential movement between honeycomb sections. • Patches of cover concrete less than 0.5 m² have delaminated, exposing reinforcement which may have moderate loss of its sectional area. • The surface matrix is worn. • Aggregate may be polished, with surface mortar being continually scaled over irregular areas. There may be significant depressions or other surface irregularities which are impairing the surface drainage; that is, lack of crossfall or gradient. • Deck drainage is not functioning efficiently as a result of obstructions at or in kerbs and/or scuppers or inadequate provision for drainage. 	<p data-bbox="791 1115 938 1144">Not available</p>

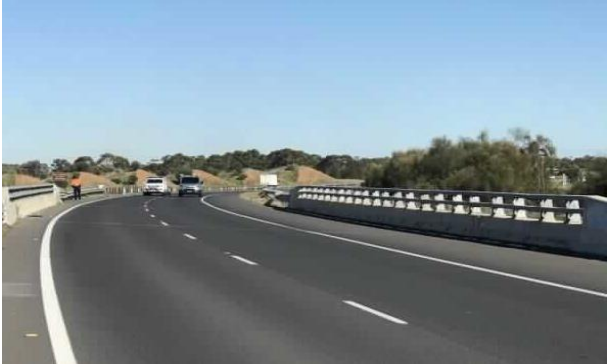
<p>340 - Traffic surface – other</p> <p>This component includes those structures with a fill, gravel, asphalt or spray seal over the deck. This component includes asphalt overlays which have been reinforced with fibreglass mesh or polypropylene geogrid mesh. Also included is the pavement on masonry arch bridges in which the fill forms the road surface.</p> <p>This component should not be used in conjunction with culverts. Generally, the road pavement is not directly supported on the culvert rather a layer of fill. If the road pavement is in poor condition over the culvert or stock underpass, describe the problem using component number 10.</p>		<p>Units</p> <p>m² of exposed surface area</p>
<p>Condition state 1 -Description</p> <ul style="list-style-type: none"> • The asphalt surface is in good condition with no cracking, potholes, rutting, bumps or depressions. • The surface has adequate crossfall or gradeline to efficiently drain surface water from it. • A fine transverse crack may have opened in the asphalt over fixed or buried expansion joints. 	<p>Photo</p>

<p>Road pavement in good condition</p>

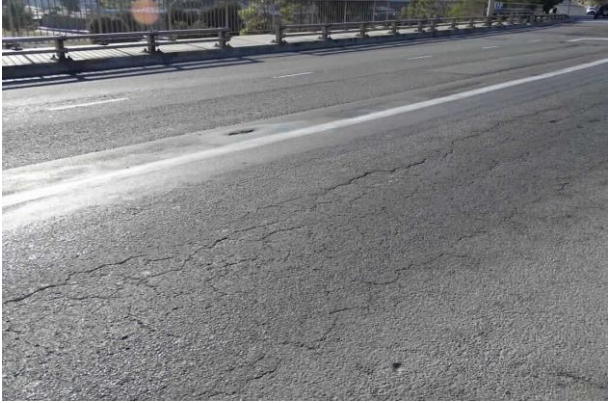
<p>Condition state 2 -Description</p> <ul style="list-style-type: none"> • There may be minor cracking, rutting, small bumps or depressions. These irregularities cause a minor hindrance to drainage of the deck. • Small potholes may be beginning to form in cracked areas. • Ride qualities are beginning to be affected. • A minor crack may have opened in the asphalt over fixed or buried expansion joints. 	<p>Photo</p>

<p>Minor cracking and rutting on pavement</p>

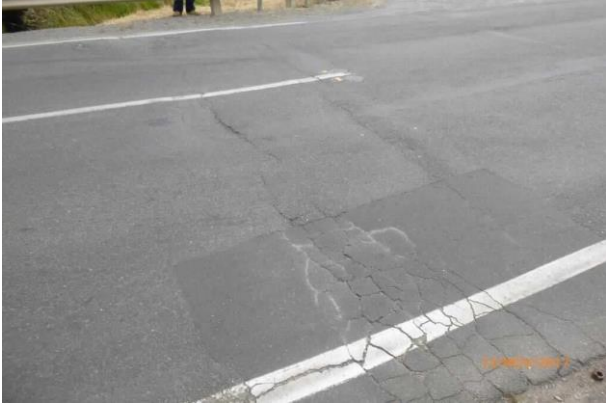
Condition state 3 -Description	Photo
<ul style="list-style-type: none"> • There may be moderate cracking, rutting, small bumps or depressions. These irregularities cause a moderate hindrance to drainage of the deck. • Potholes may have formed in cracked areas. • Ride qualities are beginning to be affected to a minor extent. • A moderate sized crack may have opened in the asphalt over fixed or buried expansion joints.

<p data-bbox="791 595 1399 658">Depressions and cracking in pavement (previous repair failing)</p>
Condition state 4 -Description	Photo
<ul style="list-style-type: none"> • Potholes, cracking, rutting, bumps or depressions are holding moisture on the deck and allowing it to penetrate the fill. • Ride qualities have been affected to a moderate extent. • Deck drainage systems may be poor or inadequate. • Severe cracks may have opened in the asphalt over fixed or buried expansion joints.

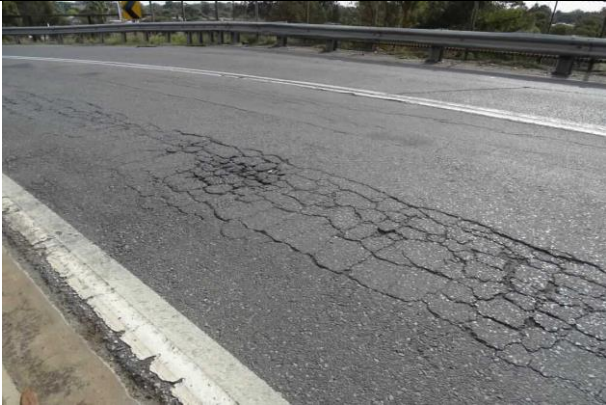
<p data-bbox="791 1095 1399 1128">Traffic surface failing</p>

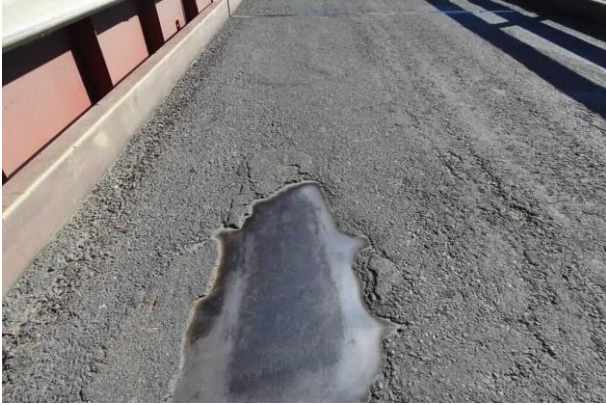
Condition state 5 -Description	Photo
<ul style="list-style-type: none"> • Potholing, cracking, rutting, bumps or depressions are having a marked effect on the drainage and rideability of the asphalt surface. • The asphalt surface may not extend full width of the bridge and may have excessive weed or grass growth, or no deck drainage has been catered for. • The asphalt surfacing over fixed joints, buried expansion joints or joints between ply deck sheets may be cracked and crazed and sections are acting independently and have debonded from the deck

<p data-bbox="791 1565 1399 1662">Traffic surface stripped in wheel path</p>

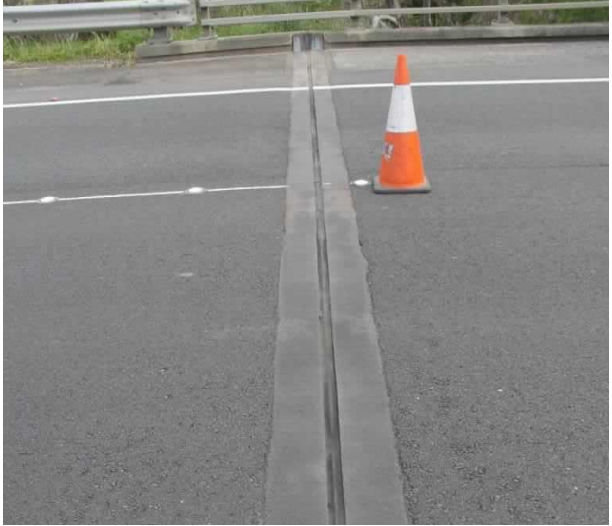
Joint in good condition

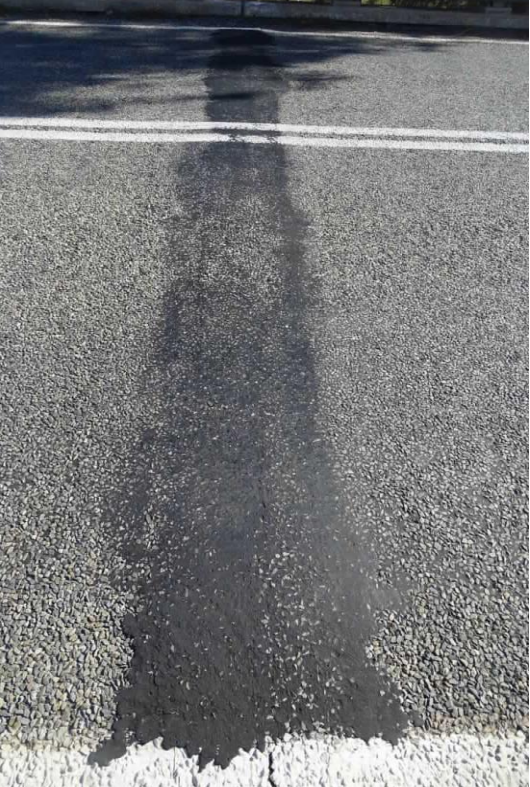
Condition state 2 -Description	Photo
<ul style="list-style-type: none"> • There may be fine adhesion and/or cohesion cracks allowing minor leakage of the joint. • The deck or asphalt adjacent to the joint may have minor spalling. • Overfilled sealer may be flowing out of the joint or may be impacted by traffic. • Thin asphalt surfacing over the joint may be cracked. • There may be some debris in the joint.

<p data-bbox="794 987 1054 1014">Minor crack in pier joint</p>
Condition state 3 -Description	Photo
<ul style="list-style-type: none"> • There may be minor adhesion and/or cohesion cracks allowing moderate leakage of the joint. • The deck or asphalt adjacent to the joint may have moderate spalling. • Overfilled sealer may be moderately impacted by traffic. • Thin asphalt surfacing over the joint may be cracked in areas. • There may be a moderate amount of debris in the joint.

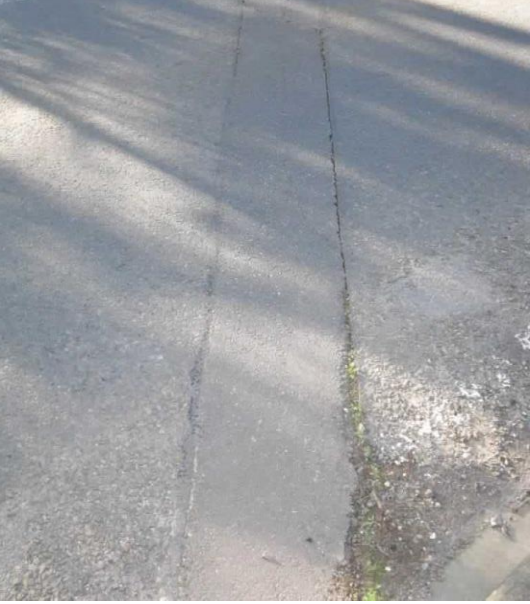
<p data-bbox="794 1659 1394 1711">Joint in satisfactory condition although minor adhesion cracking and vegetation growth and debris in crack</p>

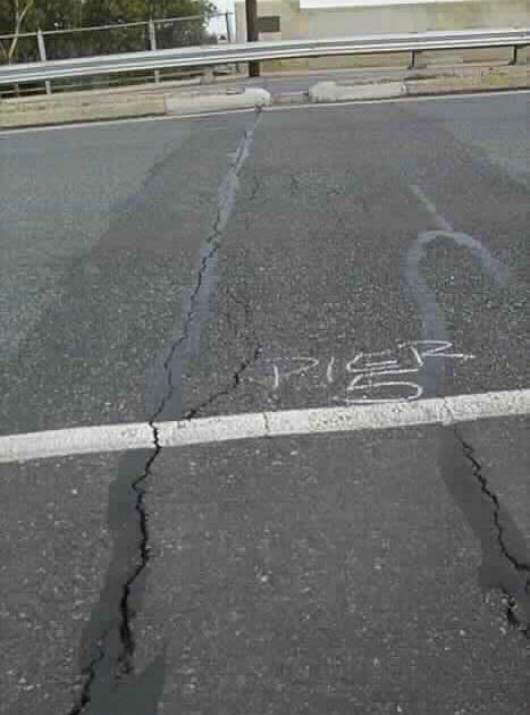
Condition state 4 -Description	Photo
<ul style="list-style-type: none"> • Adhesion and/or cohesion cracking may be moderate allowing reasonable leakage of moisture through the joint. • The adjacent deck or asphalt may have medium spalling. • Overfilled sealer may be heavily impacted by traffic and tending to rip the sealer out. • Thin asphalt surface over the joint may be breaking up with minor areas lost.

<p data-bbox="791 909 1286 969">Badly cracked joint allowing water leakage to undersides</p>
Condition state 5 -Description	Photo
<ul style="list-style-type: none"> • The joints have completely failed allowing extensive moisture penetration. • Pourable joint sealant may be almost completely lost. • Bitumen/cork filler may be broken up and being ripped out in chunks by traffic.

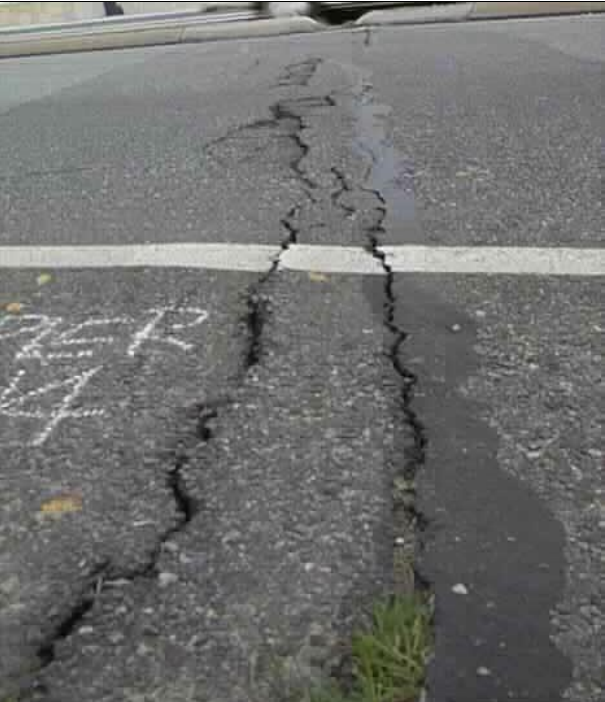
<p data-bbox="791 1706 1398 1796">Major cracking with some material loss allowing water leakage, and bulging and vegetation growth in the kerb areas</p>

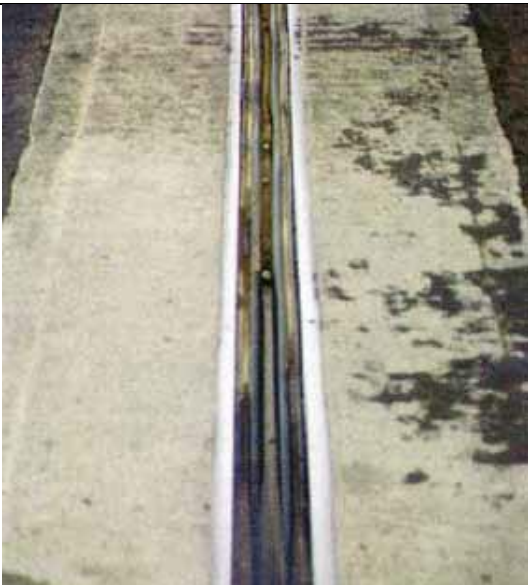
Condition state 1 -Description	Photo
<ul style="list-style-type: none"> The joint seal and its armouring (if any) are in good condition with no movement of the armouring visible, and no adhesion or sealing problems with the compression seal.

<p data-bbox="791 1003 1321 1066">Hercules joint seal and concrete nosings in good condition (VicRoads)</p>
Condition state 2 -Description	Photo
<ul style="list-style-type: none"> The joint may have lost adhesion with the deck or armouring in small areas allowing minor leakage of moisture. The adjacent deck may have minor spalls or the armouring may be moving slightly with cracks developing between the asphalt surface and the steel. There may be some debris in the joint.

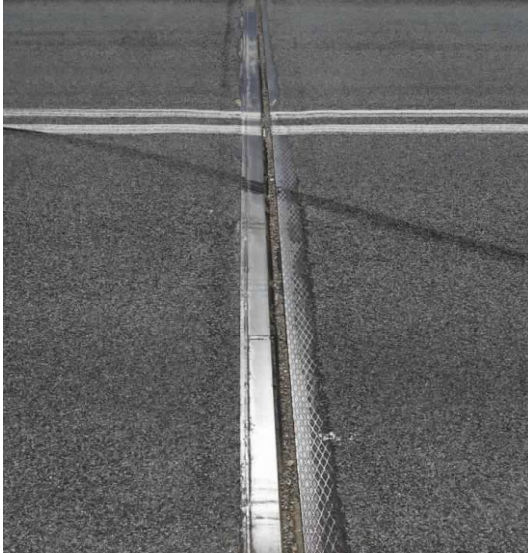
<p data-bbox="791 1653 1321 1686">Compression seal joint filled with gravel</p>

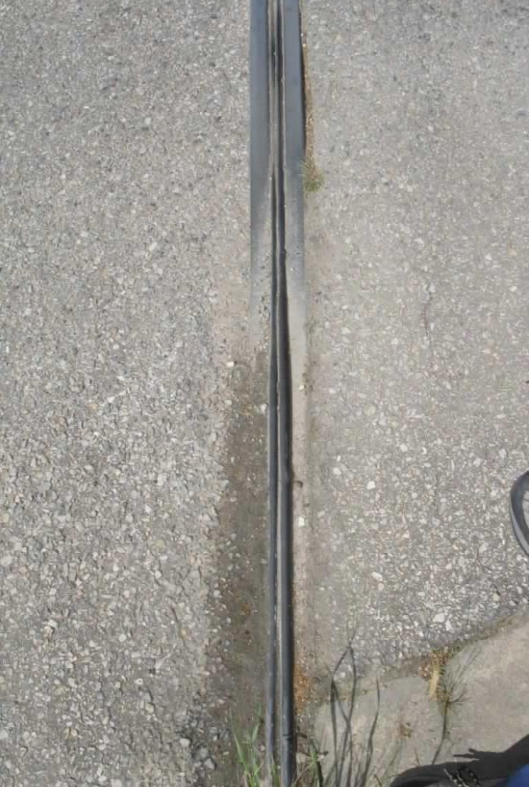
Condition state 3 -Description	Photo
<ul style="list-style-type: none">• The joint may have lost adhesion with the deck or armouring in a number of areas allowing moderate leakage of moisture.• The seal may be working to the road surface and potentially suffering damage due to traffic impact.• The adjacent deck may have moderate spalls or the armouring may be moving with cracks developing between the asphalt surface and the steel.• There may be a moderate amount of debris in the joint.

<p data-bbox="794 987 1394 1043">Compression seal has partially ejected, joint is allowing minor leakage</p>

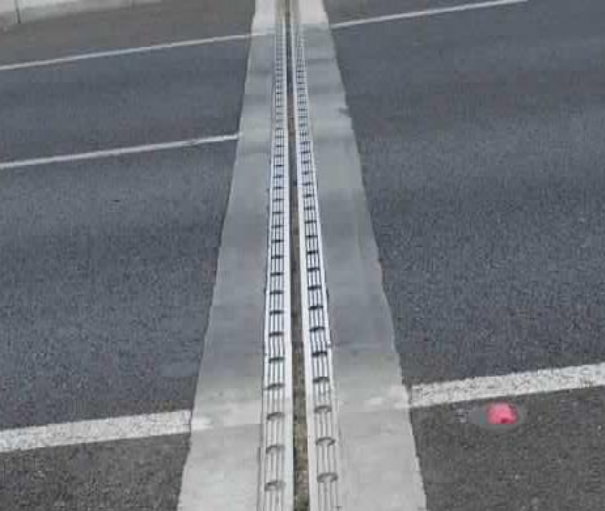
<h3 style="margin: 0;">370 - Assembly joint seal – other</h3> <p style="margin: 0;">This component defines those joints, which have an assembly mechanism consisting of end dams bolted down to the deck with a gland or gland type seal between. Common joints, which are included in this component, are products such as Transflex, Felspan, Wabo Maurer gland seals, Cipec and Firmsec (small) joints.</p> <th data-bbox="1252 159 1423 224">Units</th>		Units
	<p>Linear metres</p>	
Condition state 1 -Description	Photo	
<ul style="list-style-type: none"> • The seal and anchorages are in good condition and there is no cracking of the surrounding deck, concrete nosings or asphalt.

<p style="margin: 0;">Seal and nosing in good condition</p>	
Condition state 2 -Description	Photo	
<ul style="list-style-type: none"> • There may be minor splits of the seal or gland. Some rubber may be peeling from the end dams. • Anchorages may be slightly loose and surrounding deck or concrete nosings may be cracked. • Asphalt nosings may be breaking away from the end dams, which may also be slightly higher than the approach asphalt due to slight rutting in the wheel lines. • Glands may be pulling out of their housing due to traffic impacting or poor installation. • There may be some debris in the joint.

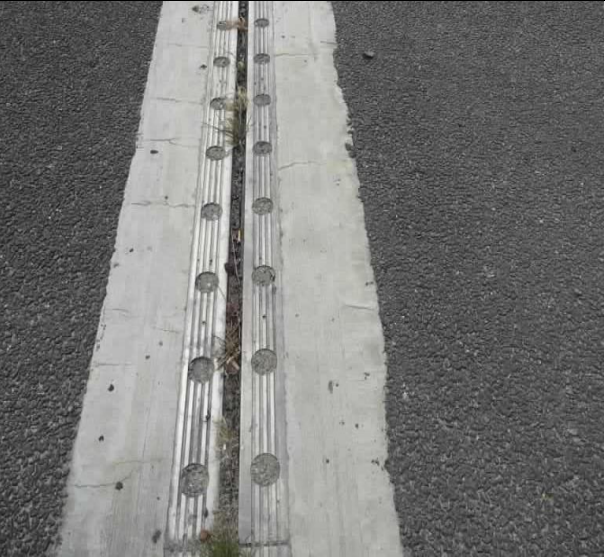
<p style="margin: 0;">Minor cracking in concrete nosing, and debris in joint</p>
