Road Structures Inspection Manual

Part 4A: Condition State Guidelines and Photographs

Bridges

RAS Document No: RAMA-ST-PRC-048
Knet Document No: 14888945
Document version: 1.3 (08/05/2020)

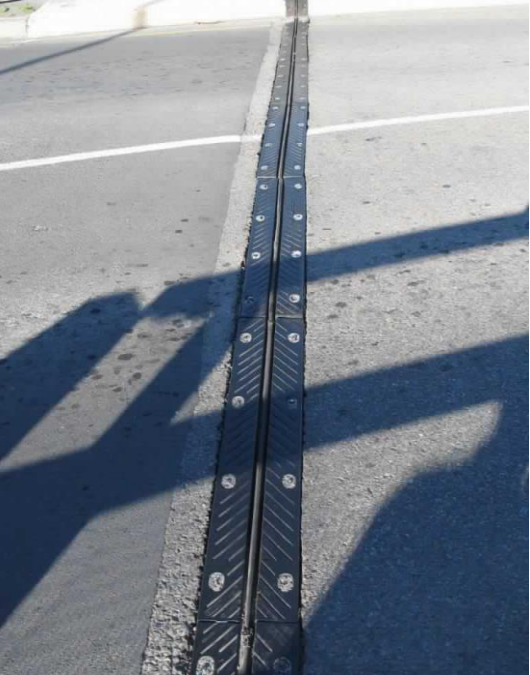
Condition state 3 -Description	Photo
<ul style="list-style-type: none"> • There may be moderate splits of the seal or gland, which may be pulling out of their housing. Some rubber may have peeled from the end dams. • Anchorages may be loose and surrounding deck or concrete nosings may have moderate cracking. • Asphalt nosings may be breaking away from the end dams, which may also be higher than the approach asphalt due to moderate rutting in the wheel lines. • There may be a moderate amount of debris in the joint.

<p data-bbox="794 875 1353 902">Felspan joint units loose, cracked and leaking badly</p>
Condition state 4 -Description	Photo
<ul style="list-style-type: none"> • The glands may be severely split or pulled out of their housings allowing moisture and road grit to penetrate. • Rubber may have peeled from the end dams exposing steel shims, which may be damaged by traffic. • Some anchorages may be quite loose allowing excessive movement of the end dams. • Surrounding concrete or concrete nosings may be badly cracked. Asphalt nosings may be badly rutted or cracked.

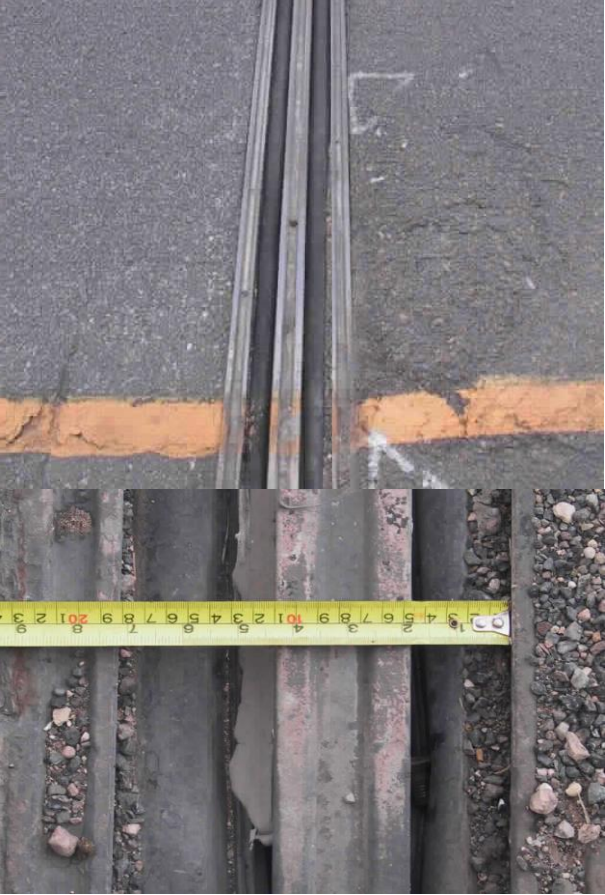
<p data-bbox="794 1839 1305 1865">Joint noisy due to loose and worn components</p>

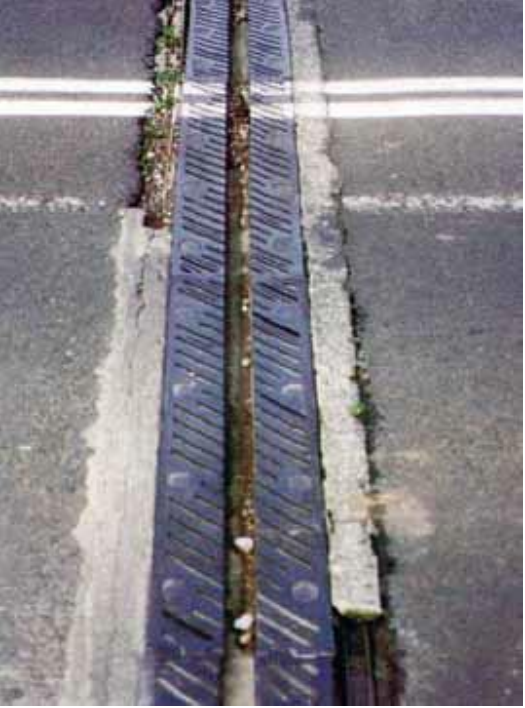
Condition state 5 -Description	Photo
<ul style="list-style-type: none">• Glands may be severely damaged or completely out of their housings.• End dams may be severely damaged by traffic, or have broken loose due to anchorage failure.• Concrete nosings may be completely broken up or asphalt nosings are potholing next to the joint.

<p data-bbox="794 907 1385 985">Reinforced concrete nosing completely broken up and impact loads are occurring directly on the Felspan (VicRoads)</p>

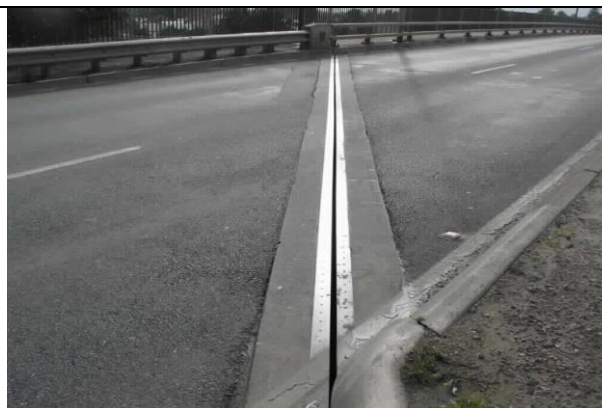
- The component shows no deterioration with the steel armouring firmly in place.
- There is no cracking of the concrete block around the steel armouring.
- The joint width is sufficiently wide to pass any road grit without it jamming in the joint.

Armoured joint in good condition

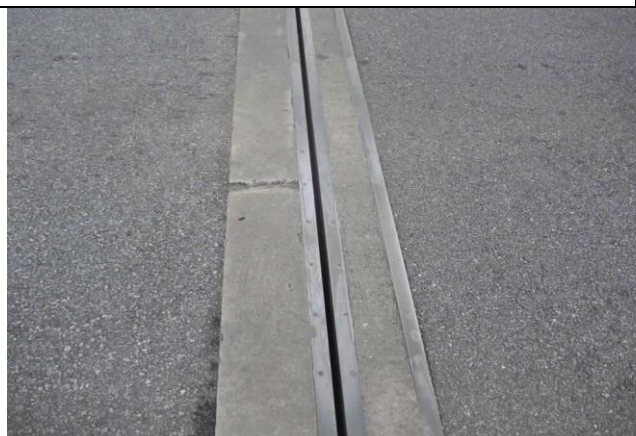
- The steel armouring may have rust staining and/or minor corrosion but it is firmly in place.
- The deck may have very fine cracking in the vicinity of the joint. Width of the joint is sufficient.

Spalled nosing

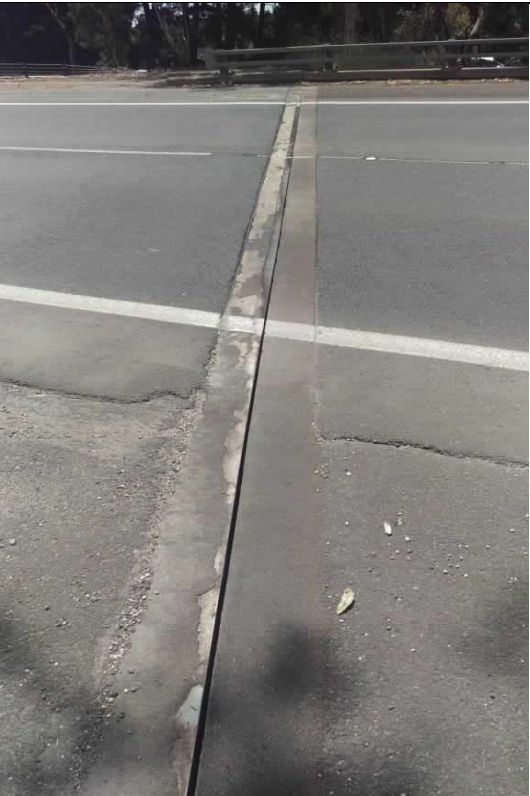
Condition state 3 -Description	Photo
<ul style="list-style-type: none">• The steel armouring may have rust staining and/or moderate corrosion but it is still firmly in place.• The deck may have minor cracking in the vicinity of the joint. Width of the joint may have reduced but is still sufficient.

<p data-bbox="794 987 1401 1048">Wear of material and minor surface corrosion of nosing plates</p>

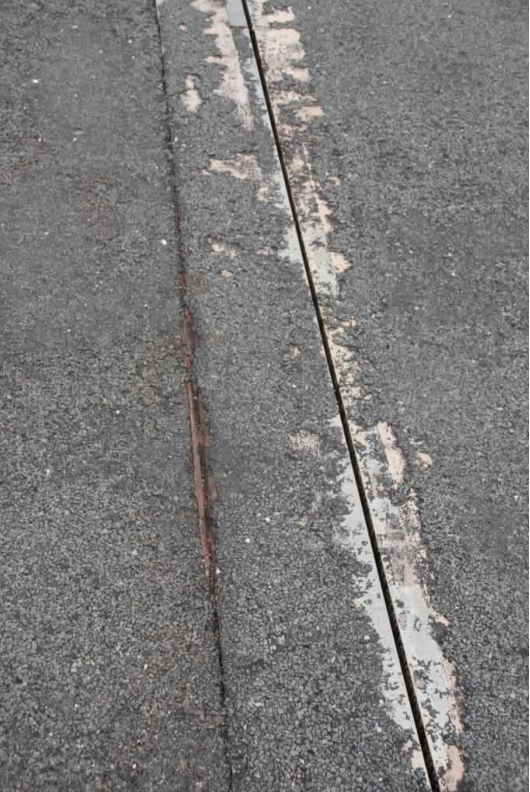
Condition state 4 -Description	Photo
<ul style="list-style-type: none">• The steel armouring is showing advanced corrosion and there may be medium cracking in the deck around the joint indicating the armouring is loose due to traffic impact.• Width of joint may be small allowing road grit to jam in the joint, or joint width may be excessive allowing high traffic impact forces onto the armouring.

<p data-bbox="794 987 1353 1043">Corrosion of armour plate with adjacent cracking in deck, and wearing of surface</p>
Condition state 5 -Description	Photo
<ul style="list-style-type: none">• The steel armouring may be loose due to excessive traffic impact. The deck may be heavily cracked and spalled due to the loose or broken anchorages of the armouring.• The deck joint may have closed up allowing dirt and grit to be trapped in the joint.	Not available.

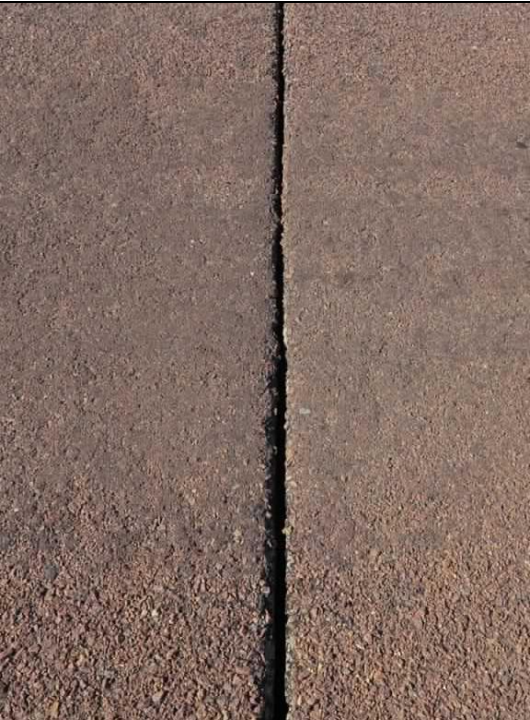
Condition state 1 -Description	Photo
<ul style="list-style-type: none"> The ends of the deck slab are intact and the joint width is sufficiently wide to pass any road grit without it jamming the joint.

<p data-bbox="794 1234 1102 1267">Open joint in good condition</p>
<ul style="list-style-type: none"> There may be minor cracking of the deck slab adjacent to the joint. Width of the deck joint gap is adequate.

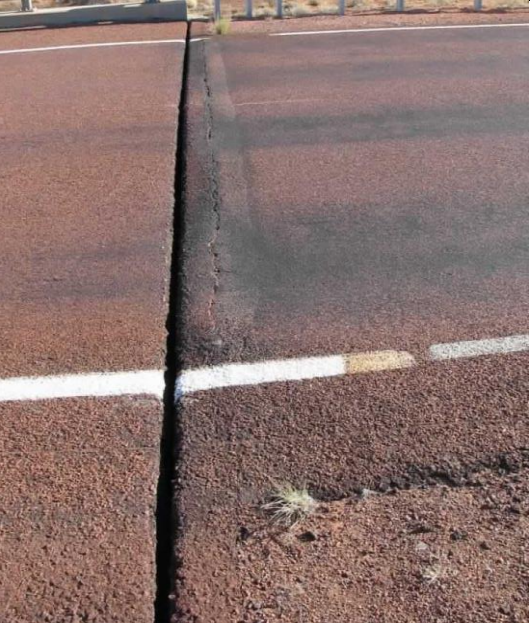
<p data-bbox="794 1921 1362 1951">Adequate joint gap, minor cracking adjacent to joint</p>

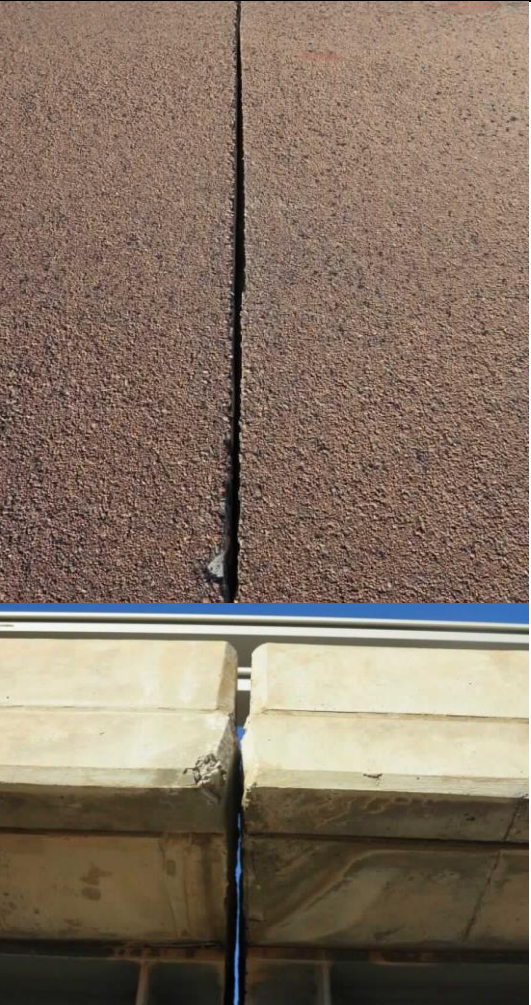
Condition state 3 -Description	Photo
<ul style="list-style-type: none">• There may be moderate cracking of the deck slab adjacent to the joint, and/or minor spalling due to traffic impact• Width of the deck joint gap may have small amounts of dirt and grit but is still adequate.

<p data-bbox="794 1191 1327 1227">Joint does not have even width within depth of joint</p>

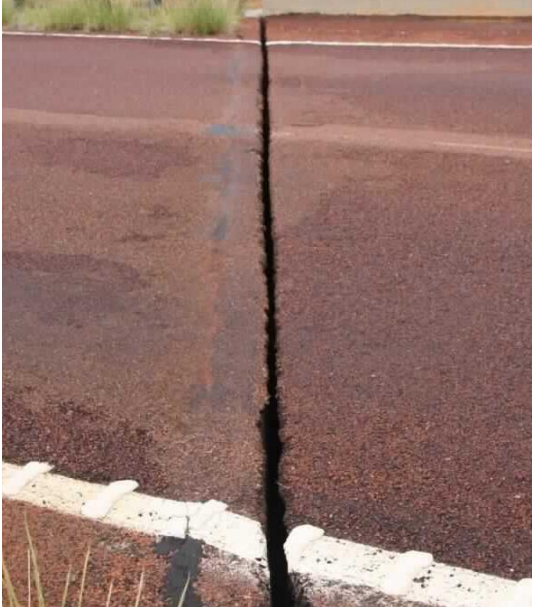
<p>Condition state 4 -Description</p>	<p>Photo</p>
<ul style="list-style-type: none"> • The ends of the deck slab adjacent to the joint may show medium cracking and/or moderate spalling due to traffic impact. • The width of the deck joint gap may be small, allowing grit to jam in the joint, or joint width may be excessive, allowing high traffic impact forces onto the ends of the deck slabs.

<p>Gap is widening as concrete edges are chipped by traffic</p>
<p>Condition state 5 -Description</p>	<p>Photo</p>
<ul style="list-style-type: none"> • The ends of the deck slabs may be severely cracked and spalled as a result of excessive traffic impact loading caused by an excessively wide gap or uneven deck slabs. • Alternatively, the deck joint may have closed up or the gap has been blocked with dirt and grit, and the consequential restraint of movement has generated the cracking and spalling. 	<p>Not available</p>

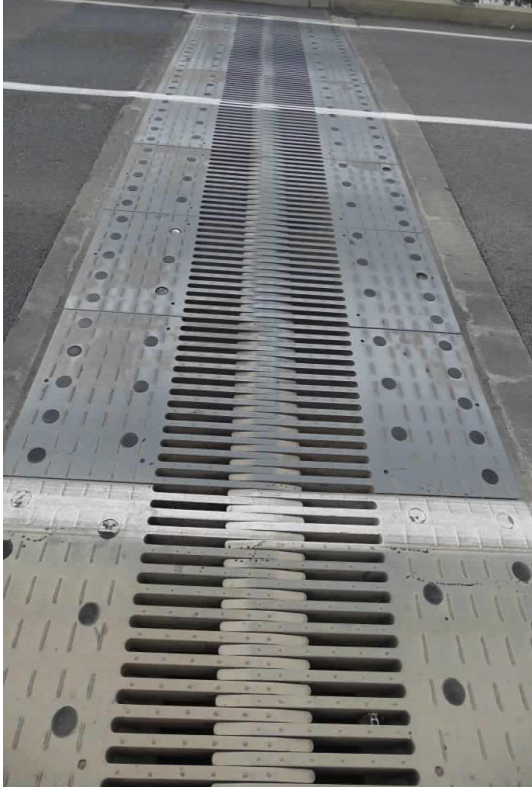
<p>39S - Sliding joint – steel</p> <p>This component describes those joints constructed mainly of steel which move or slide over or within a mating component on the other side. The joints may have a compression seal, gland, membrane or catch drain beneath, which should be considered as part of the joint component.</p> <p>Joints included in this component are steel sliding plates, steel finger joints, PSC FT joints, CIPEC and FIRMSEC (large) joints.</p>		<p>Units</p> <p>Linear metres</p>
<p>Condition state 1 -Description</p> <ul style="list-style-type: none"> • The component is in good condition with only minor rusting. • All hold down bolts are in good condition with no movement of the anchorages. • The joint shows no moisture penetration. 	<p>Photo</p>

<p>Finger joint in good condition with only minor faint cracking in the concrete nosing</p>

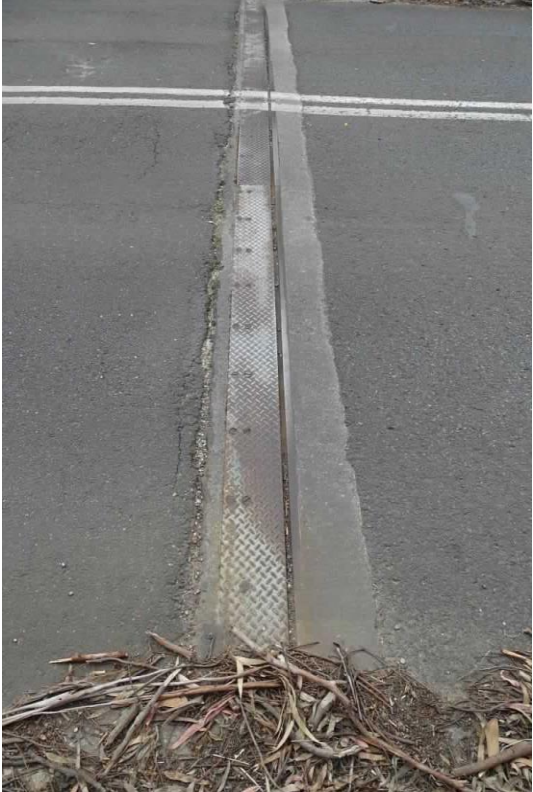
Condition state 2 -Description	Photo
<ul style="list-style-type: none"> • Minor corrosion may be showing on the steel and there may be some slight loosening of the anchorage bolts. • The adjacent asphalt may have minor cracking at the joint. • The joint may show signs of light moisture penetration. • There may be some debris in the joint.

<p data-bbox="791 987 1209 1014">Bitumen broken up and debris in joint</p>
Condition state 3 -Description	Photo
<ul style="list-style-type: none"> • Moderate corrosion may be showing on the steel and there may be some minor loosening of the anchorage bolts. • The adjacent asphalt may have moderate cracking at the joint. • The joint may show signs of medium moisture penetration. • There may be a moderate amount of debris in the joint.

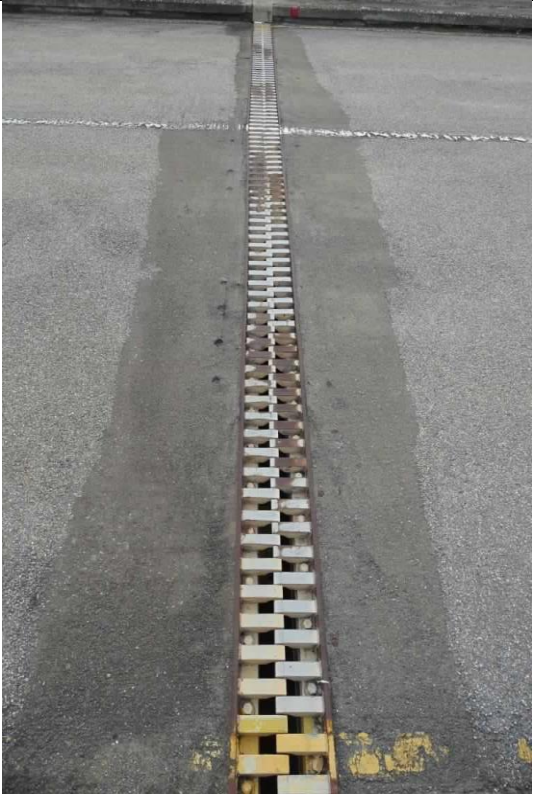
<p data-bbox="791 1845 1072 1870">Corrosion on steel fingers</p>

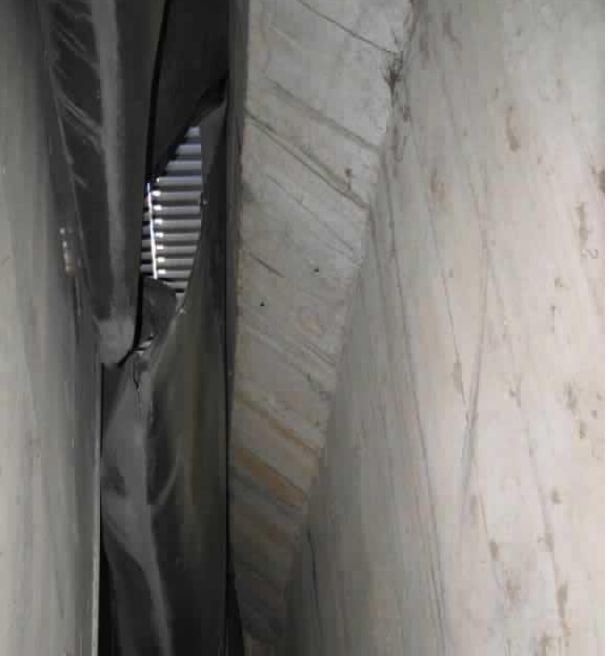
Condition state 4 -Description	Photo
<ul style="list-style-type: none"> • Heavy corrosion of the steel plates may be present, and some bolts may have failed allowing the anchorages to move. • Cracking and minor broken up asphalt may be occurring. • The joint may show signs of heavy moisture penetration. • Catch drains may be full of grit etc. and may not be functioning or catch membranes may have badly deteriorated. • Steel fingers may be rubbing due to side movement or fingers may be raised well above the mating fingers, or widening of the gap may only have the ends of the fingers in line.

<p data-bbox="794 857 1031 882">Drain membrane torn</p>
Condition state 5 -Description	Photo
<ul style="list-style-type: none"> • Advanced corrosion of the steel may be present and a number of bolts may have failed allowing excessive movement of the anchorages. • The asphalt around the joint may be badly cracked and pieces breaking out. • Steel fingers may be broken or completely apart due to excessive movement, or rotations. • Catch drains or membranes may have completely failed or are missing.

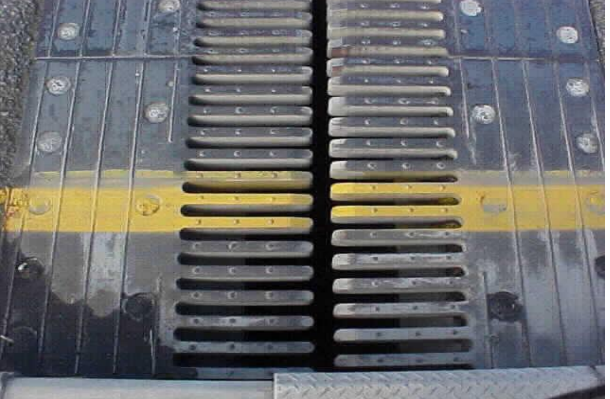
<p data-bbox="794 1321 1106 1348">Finger joint completely open</p>

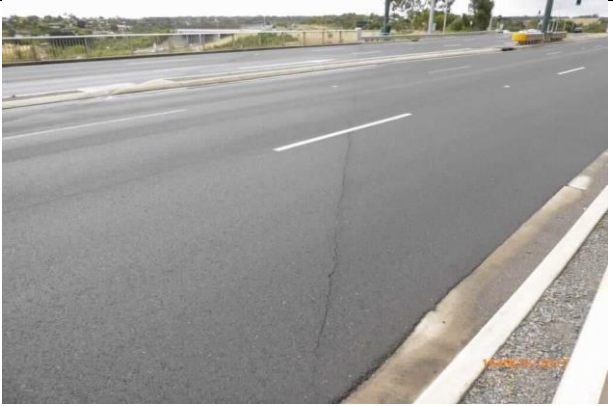
<p>400 - Fixed joint – other</p> <p>This component describes those joints, which are basically fixed but may allow very small movement of 1 or 2 mm. Transversely tensioned prestressed slabs are separated at the piers by malthoid strips and a cast-in-situ concrete infill and this joint can be considered in this component.</p> <p>Longitudinal deck joints, with or without a sprayed seal on top, where the decks are cast against each other or with a thin separator such as cork, bitumen impregnated fibreboard, styrene sheets or malthoid sheets are included in this component. If fill has been placed over the longitudinal joints, any defect in the road surface resulting from the joint should be considered under the item for Traffic Surface.</p> <p>Moisture leakage through the joint should be considered as a defect of the joint.</p>		<p>Units</p> <p>Linear metres</p>
<p>Condition state 1 -Description</p> <ul style="list-style-type: none"> • The component shows no deterioration and the joint material is held firmly in place by the surrounding concrete. • There is no moisture penetration of the joint. 	<p>Photo</p>

<p>Fine crack along abutment backwall joint, crack could be sealed by hot poured PMB</p>

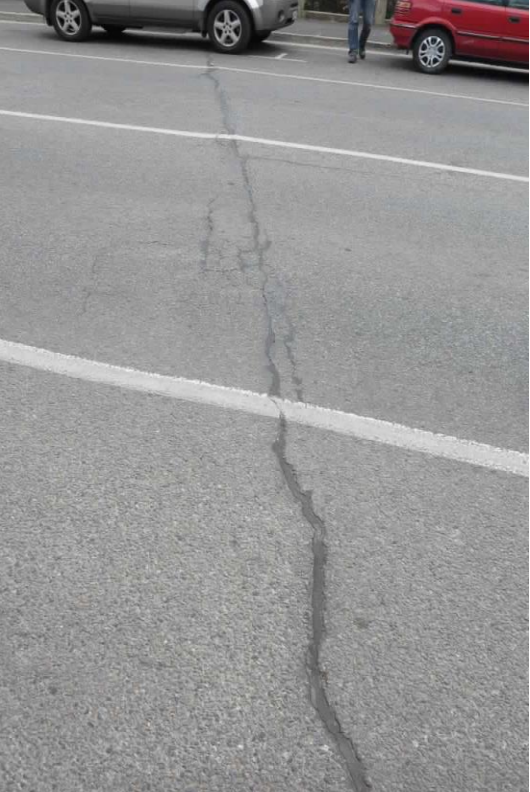
Condition state 2 -Description	Photo
<ul style="list-style-type: none">Minor deterioration of the material may have occurred or the units have moved slightly allowing minor moisture leakage of the joint through the fine crack.

<p data-bbox="794 987 1326 1048">Cracking over pier joint allowing minor moisture penetration</p>
Condition state 3 -Description	Photo
<ul style="list-style-type: none">Moderate deterioration of the material may have occurred or the units have moved allowing moderate moisture leakage of the joint through the crack.

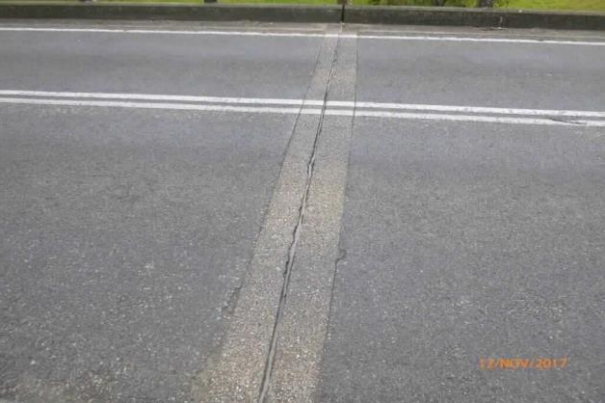
<p data-bbox="794 1489 1401 1505">Debonded joint sealant over pier joint</p>

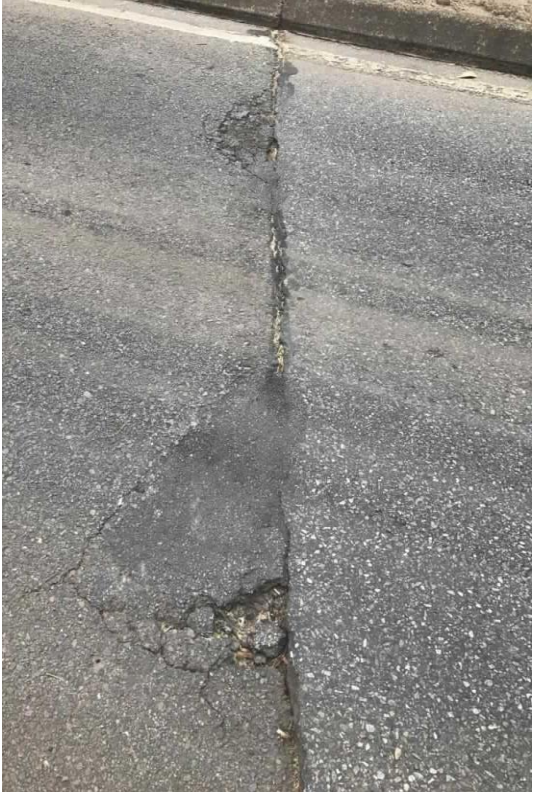
Condition state 4 -Description	Photo
<ul style="list-style-type: none"> • Medium deterioration of the material has occurred due to weathering, pressure or movement of the surrounding concrete. • Significant leakage is occurring as the joint material pulls away from the surrounding concrete.

<p data-bbox="791 987 1326 1014">Cracking and spalling at abutment sill-girder joint</p>
Condition state 5 -Description	Photo
<ul style="list-style-type: none"> • Severe deterioration has occurred and the joint material has pulled well apart from the surrounding concrete, or the joint material has badly weathered or been lost. • Heavy leakage is occurring through the joint and may be affecting the surrounding concrete or the mortar bearings below.

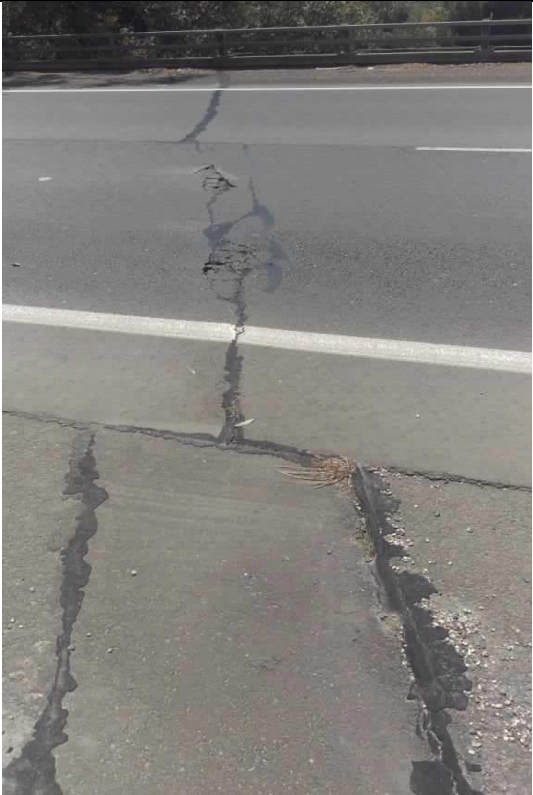
<p data-bbox="791 1845 1326 1897">Major cracking and spalling of pavement at pier joint allowing excessive moisture penetration</p>

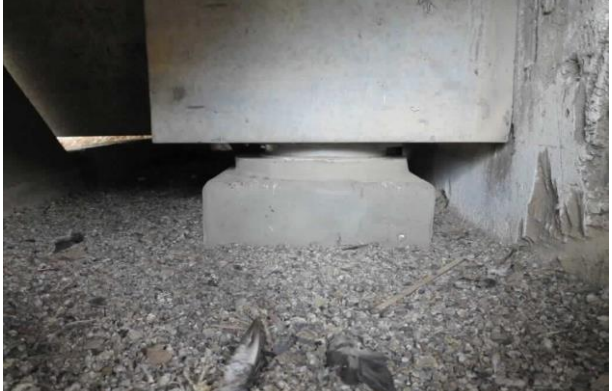
410 - Fixed bearings – other		Units
<p>This component defines those bearings that may provide for deflection or rotation and includes steel plates bearing on concrete with or without locating pins or lugs, concrete bearing on malthoid, lead sheet or a bond breaking layer of colourless grease.</p>		<p>Each</p>
Condition state 1 -Description	Photo	
<ul style="list-style-type: none"> The component shows minimal deterioration with the paint system in good condition protecting the steel plates and any material allowing minor movements is in good condition and functioning properly.

<p>Fixed steel plate bearing in good condition</p>	
Condition state 2 -Description	Photo	
<ul style="list-style-type: none"> Minor movement may have caused faint cracking in the ends of the beams due to pressure on the locating dowels. Protective paint systems may be failing allowing light rusting of the metal plates. Malthoid or lead sheets may be deteriorating or beginning to be squeezed out from beneath the beams. Bearing support may be cracked but still sound.

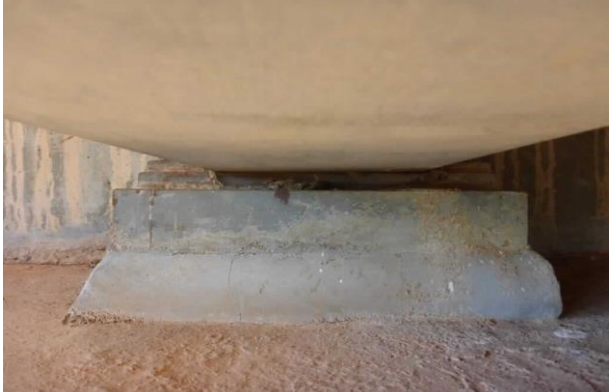
<p>Some corrosion starting on steel plates, fine cracking of mortar pad</p>

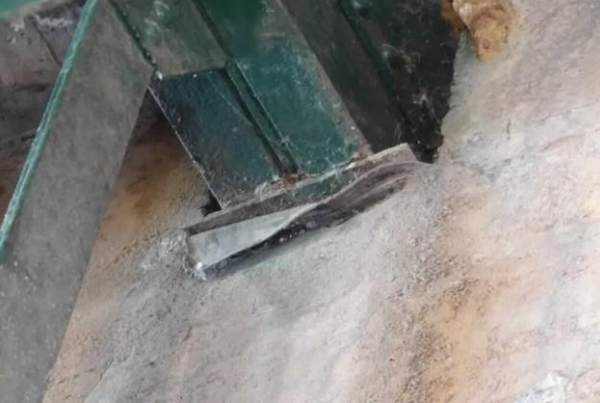
Condition state 3 -Description	Photo
<ul style="list-style-type: none"> Moderate movement may have caused minor cracking in the ends of the beams due to pressure on the locating dowels. Protective paint systems may have failed allowing minor rusting of the metal plates. Malthoid or lead sheets may have deteriorated or being squeezed out from beneath the beams. Bearing supports may have moderate cracks but are still basically sound.

<p>Lead extruding from bearing</p>
<ul style="list-style-type: none"> Medium movement may have caused medium cracking or moderate spalling of the ends of the beams. Protective paint systems may have failed causing medium corrosion of the metal plates. Malthoid or lead sheets may well be deteriorated or up to 50% extruded from beneath the beams. Bearing supports may show heavy cracking, crumbling of mortar or have sizeable spalling with some reduction of bearing support area.

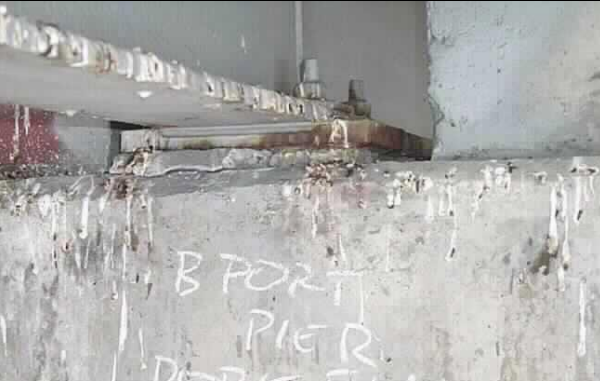
<p>Bearing plates are corroding and bearing pedestal is cracked</p>

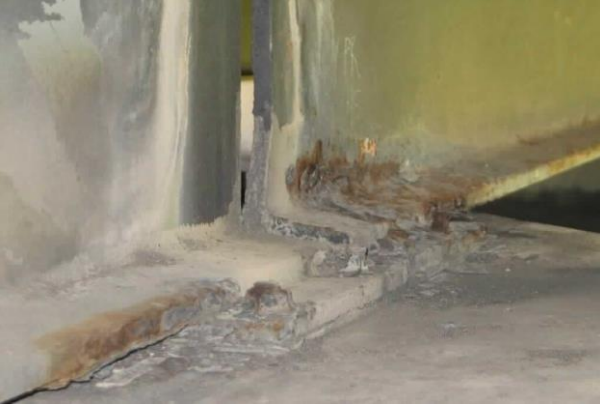
<ul style="list-style-type: none"> Large movements may have caused heavy spalling of the ends of the beams. Steel plates may be heavily corroded due to complete loss of protective paint. Malthoid or lead sheets may be totally deteriorated or almost completely extruded beneath the beams. Bearing supports may have badly crumbled mortar or heavily spalled concrete with extensive reduction in bearing support area with possible cracking having occurred.

<p>Steel bearing plate badly corroded on pier</p>

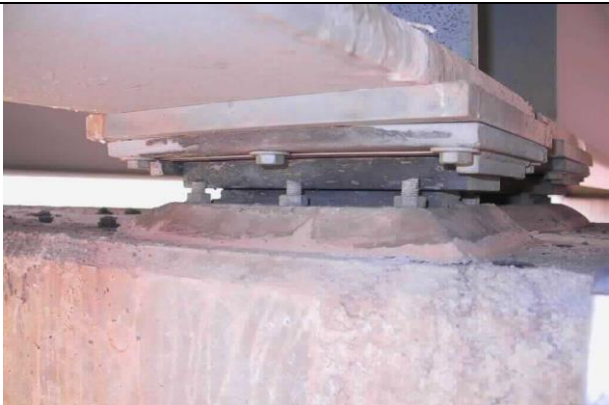
420 - Sliding bearings – other		Units
<p>This component defines those bearings that provide for movement by the use of a sliding mechanism. They also may have thin elastomer strips which will allow for some deflection and rotation, but the main mechanism is to allow for sliding of one surface over another with the use of copper or phosphor bronze plates, Teflon (PTFE) discs or coated sliding plates. The bearing may simply be greased surfaces with the sliding plate moving between guides in a steel base plate.</p>		Each
Condition state 1 -Description	Photo	
<ul style="list-style-type: none"> The component is in good condition with minimal deterioration. The paint system is in good condition and sliding components are in their correct positions and appear to be working as normal. There is minimal debris in the bearing. Bearing support is sound with mortar or concrete uncracked and in good condition.

<p>Sliding bearing in good condition (excess hold down bolt thread to be removed)</p>

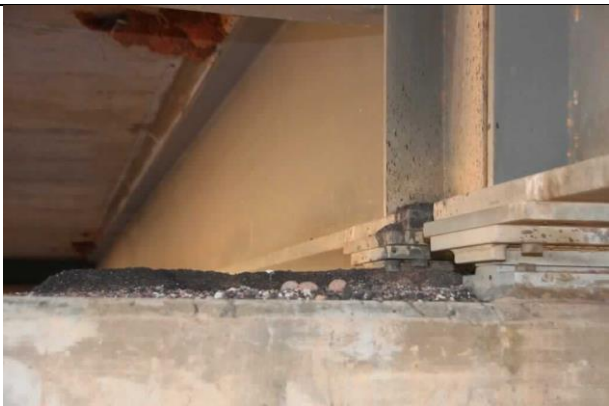
Condition state 2 -Description	Photo	
<ul style="list-style-type: none"> Protective paint systems may be failing, allowing rusting of the metal plates. Sliding components may have moved excessively but the joint is still moving correctly. Debris in the bearing or corrosion may be having a minor effect on the movement capabilities of the bearing. Bearing support may be lightly cracked but still sound.

<p>Debris build up at bearings</p>	
Condition state 3 -Description	Photo	
<ul style="list-style-type: none"> Protective paint systems may have failed causing light corrosion of the metal plates. Sliding components may have moved excessively and beginning to be extruded between the steel plates. Debris in the bearing or corrosion may be having a moderate effect on the movement capabilities of the bearing. Bearing support may show moderate cracking or light crumbling of mortar but still basically sound.

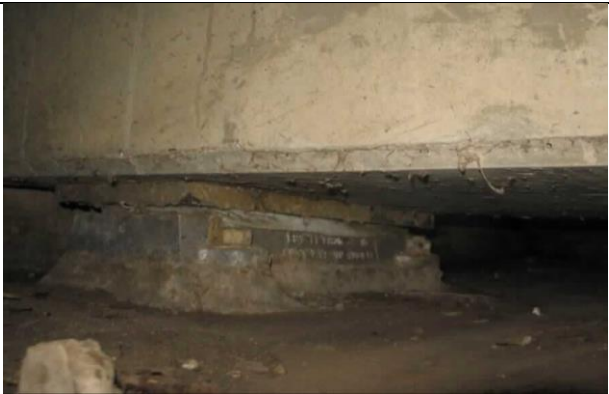
<p>Extrusion of PTFE from bearing</p>

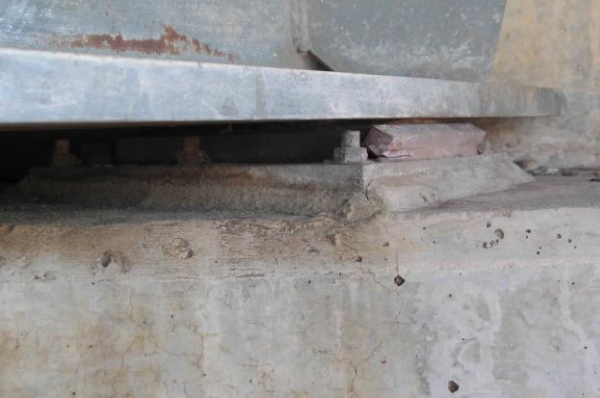
Condition state 4 -Description	Photo
<ul style="list-style-type: none"> • Protective paint systems may have failed causing medium corrosion of the metal plates. • Sliding components may have moved excessively and are being extruded between the steel plates. • The PTFE coating is delaminating from its base plate and is buckled and being destroyed. The lubricating system may have failed and the joint is failing to operate normally. • Bearing support may show heavy cracking, crumbling of mortar or sizeable spalling with some reduction of bearing support area.

<p data-bbox="794 600 1396 660">Side restraint has broken off bearing due to transverse movement when joint closes up</p>
Condition state 5 -Description	Photo
<ul style="list-style-type: none"> • Steel plates may be heavily corroded due to complete loss of protective paint. • Sliding components may have slipped out and are no longer functional or the PTFE coating has completely delaminated, buckled and destroyed. • The lubricating system may have failed and the joint has seized and is no longer functional. • Bearing support may have badly crumbled mortar or heavily spalled concrete with extensive reduction in bearing support area, with possible crushing having occurred.

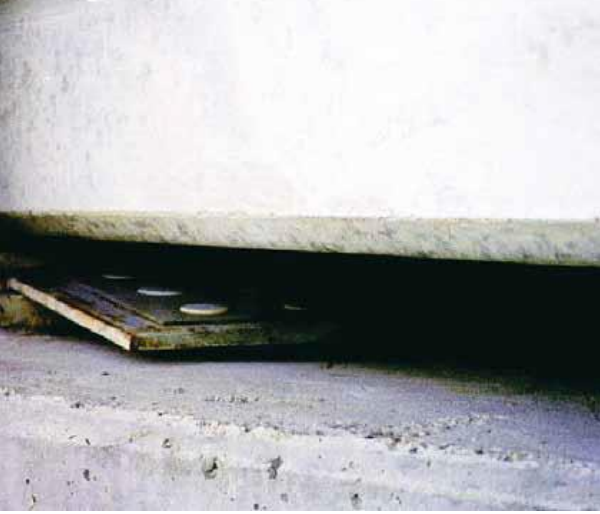
<p data-bbox="794 1294 1396 1346">Sliding plate with Teflon disks completely slipped out of bearing arrangement (VicRoads)</p>

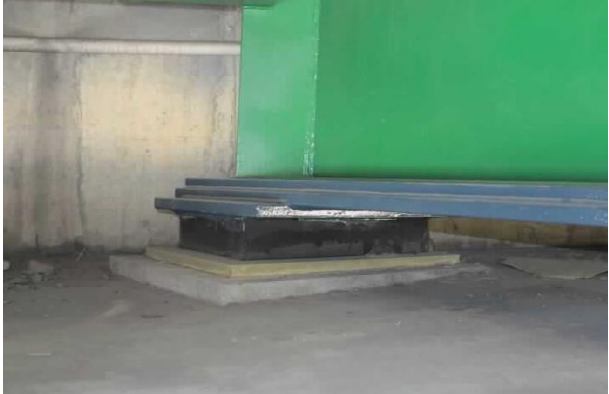
<p>430 - Elastomeric / pot bearings – other</p> <p>This component defines those bridge bearings constructed primarily of elastomers, with or without metal shims reinforcing the elastomer. The bearings may be free to move or have anti-sliding containment or be fully contained in pot bearings.</p> <p>This component also includes thrust/buffer bearings, which are situated between the ends of girders and abutment back walls.</p>		<p>Units</p> <p>Each</p>
<p>Condition state 1 -Description</p> <ul style="list-style-type: none"> • The bearing shows minimal deterioration. • Shear deformations are correct for the temperatures and structural movements. • Bearing support surfaces are flat and sound with no cracking of the mortar or concrete. 	<p>Photo</p>

<p>Elastomeric bearing in good condition</p>	
<p>Condition state 2 -Description</p> <ul style="list-style-type: none"> • The bearing may have faint cracking, splitting or signs of weathering. • Shear deformations may be moderate and the bearing is functioning normally. • Bearing support surfaces may not be flat with only partial support to the bearings, or the bearing support may be cracked but still basically sound. 	<p>Photo</p>

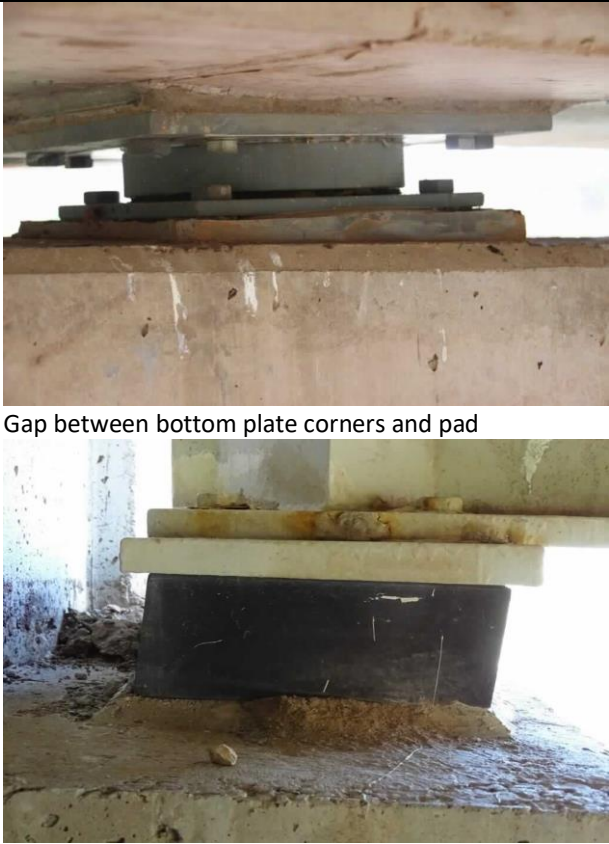
<p>Gap between bottom plate corners and pad</p> <p>Moderate bearing shear</p>

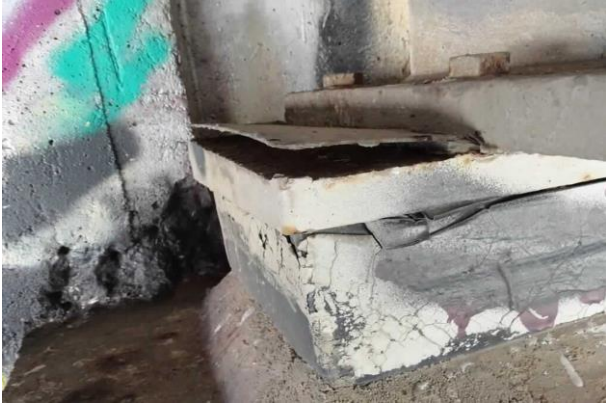
Condition state 3 -Description	Photo
<ul style="list-style-type: none"> • The bearing may have minor cracking, splitting or signs of weathering. • Shear deformations may be large but not excessive, and the bearing is still functioning normally. • Bearing support may have irregularities or minor spalling but with only minimal loss of bearing support area.

<p data-bbox="791 595 1399 622">Steel bearing shim plates corroding and lifting</p>
Condition state 4 -Description	Photo
<ul style="list-style-type: none"> • The bearing may have slight bulges between the shims and the elastomer may have fine cracking or splitting. • Rotation or shear deformations may be excessive with rollover of the edges of the bearing. • Bearing is still functioning but is being overstressed. • Bearing support may have sizeable irregularities or spalling with loss of bearing support area. • Pot bearing may have faint cracking of the container. • Bearing may have large rotation or sliding components are showing large movements. Elastomer may be beginning to be extruded from the top of the container.

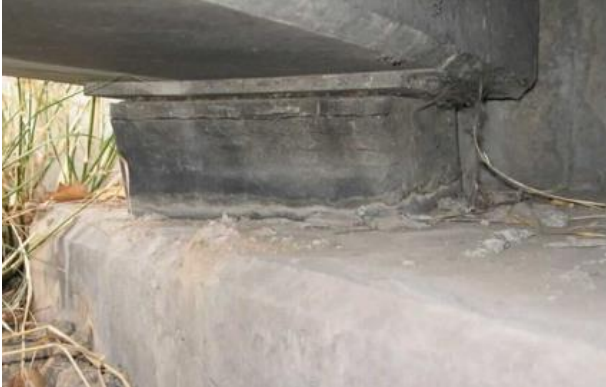
<p data-bbox="791 1048 1399 1075">Horizontal cracking near top of bearing pad</p>

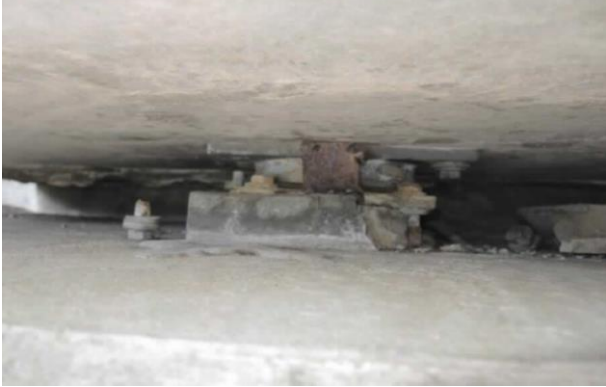
Condition state 5 -Description	Photo
<ul style="list-style-type: none"> • The bearing may have large bulging with cracking or splitting at the shims which have delaminated from the elastomer. • Shear or rotation deformations may be excessive with a sizeable reduction in the bearing area in contact with the surfaces and transferring load. • Bearing support may have heavily spalled concrete with some crushing possible. • Pot bearing container may be cracked with elastomer being extruded from the crack or through the top of the container. • Bearing may show excessive rotation or sliding components may have excessive movement and no longer functioning correctly.

<p data-bbox="791 1742 1399 1805">Bolt securing fixed pot bearing broken, and mortar pad severely cracked and broken</p>

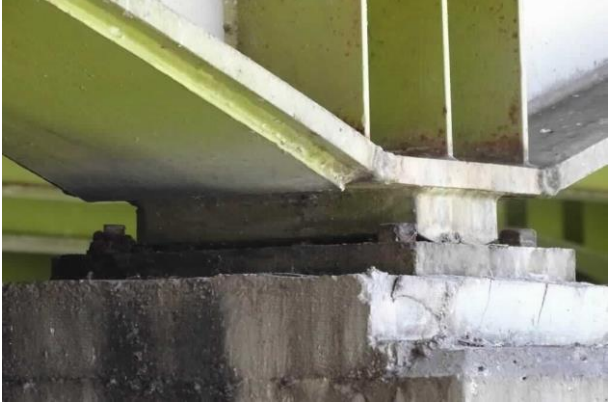
<p>44S - Rockers / rollers – steel</p> <p>This component defines those bearings that may provide for rotation and movement by means of steel rollers or rocker mechanisms. This includes knuckle / leaf type bearings.</p>		<p>Units</p> <p>Each</p>
<p>Condition state 1 -Description</p>	<p>Photo</p>	
<ul style="list-style-type: none"> • The component shows minimal deterioration. • The paint system is in good condition with the bearing well lubricated and functioning correctly. • Bearing support is sound with no cracking of the mortar or concrete.

<p>Steel rocker bearing in good condition</p>	
<p>Condition state 2 -Description</p>	<p>Photo</p>	
<ul style="list-style-type: none"> • Protective paint systems may be failing allowing minor rusting to the surface area of the metal. • Debris has lodged in the bearing hampering the movement or rotation of the bearing. • Rocker has rotated correctly, but not excessively, for the temperature and movements of the bridge. • Bearing support may be lightly cracked but still sound.

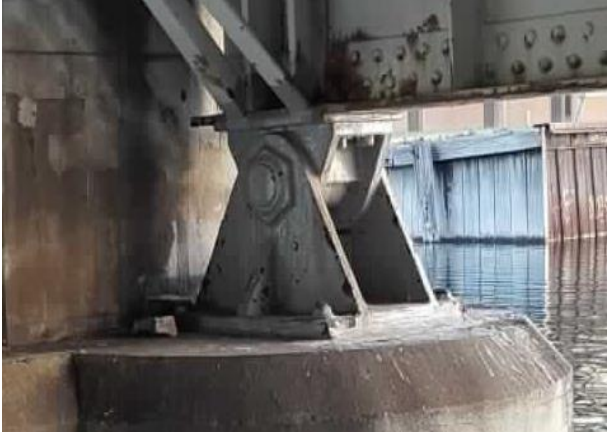
<p>Minor corrosion to bearing</p>

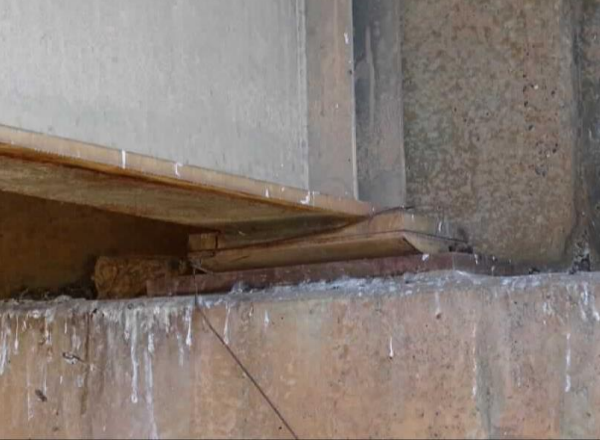
Condition state 3 -Description	Photo
<ul style="list-style-type: none"> • Protective paint systems may have failed causing moderate surface rust to the area and moderate corrosion of the metal. • Debris is hampering the movement or rotation of the bearing and its correct operation. • Rocker has rotated correctly, but not excessively, for the temperature and movements of the bridge. • Bearing support may show moderate cracking but is still basically sound.

<p data-bbox="794 640 1145 667">Moderate rusting of steel rocker</p>
Condition state 4 -Description	Photo
<ul style="list-style-type: none"> • Protective paint systems may have failed causing medium surface rust to the area and medium corrosion of the metal. • Debris is preventing the movement of the bearing and its correct operation. • Rockers may have rotated to their tolerance limits. • Bearing support may show heavy cracking, crumbling of mortar or sizeable spalling with some reduction of the bearing support area.

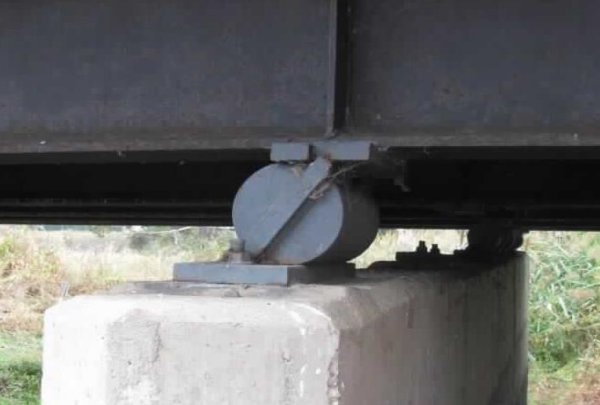
<p data-bbox="794 1120 1364 1182">Roller bearing at maximum travel, displaced approx. 75mm</p>

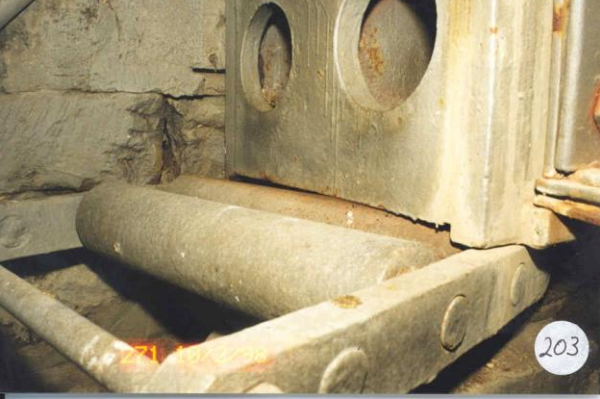
Condition state 5 -Description	Photo
<ul style="list-style-type: none"> • The steel may be heavily corroded due to complete loss of protective paint. • Lubrication systems have completely failed and excessive debris has seized the bearing. • Rockers may have rotated to their tolerance limit and the shear key may have cracked off. • Bearing support may show badly crumbled or heavily spalled concrete with extensive rotation in bearing support areas with possible crushing having occurred.

<p data-bbox="794 1628 1385 1718">Front roller missing and roller race skewed and almost completely ejected, with only a third of roller length providing support to the truss</p>

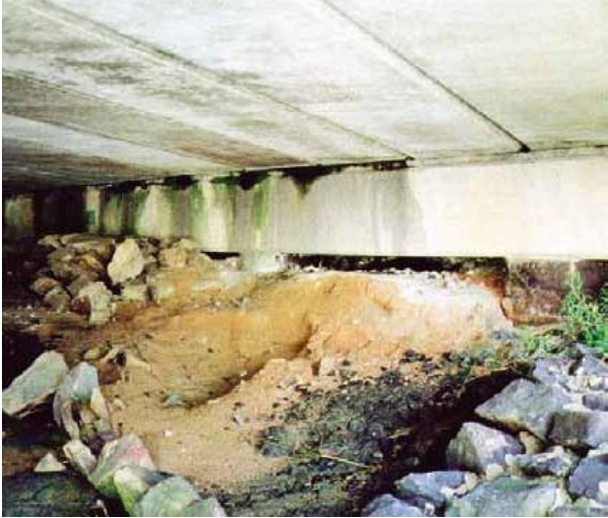
<p>Mortar pad bearings beneath prestressed slabs in good condition though moist and stained (VicRoads)</p>	
Condition state 2 -Description	Photo	
<ul style="list-style-type: none"> The mortar pads may show signs of minor dampness and leaching. The pedestals may have some fine cracking due to bearing movement or edge loading, but the strength of the bearing has not been affected.

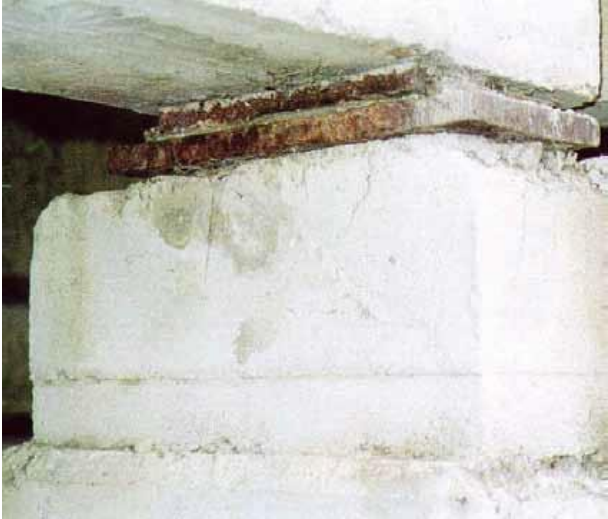
<p>High bearing pedestal with cracking in front face due to edge loading from bearing plate overhanging the pedestal (VicRoads)</p>

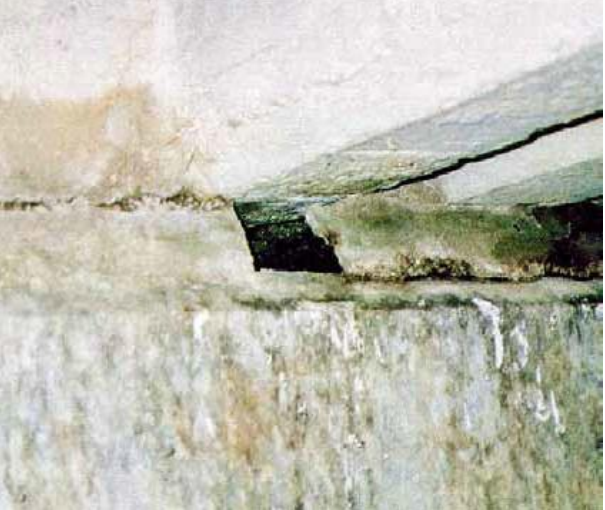
<p>Mortar bearing pad breaking up beneath beam (VicRoads)</p>
Condition state 5 -Description	Photo
<ul style="list-style-type: none"> The mortar is crushing or has been lost with large subsequent loss of bearing area. The high concrete pedestals may have heavy cracking with large spalls and subsequent loss of bearing area.

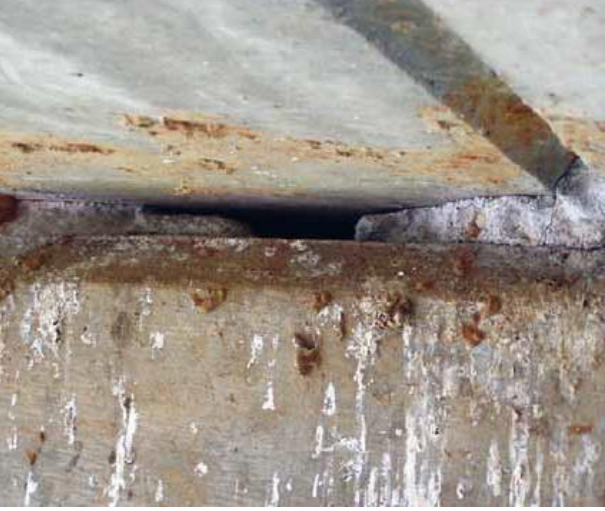
<p>Mortar pad lost and edge pad cracked (VicRoads)</p>

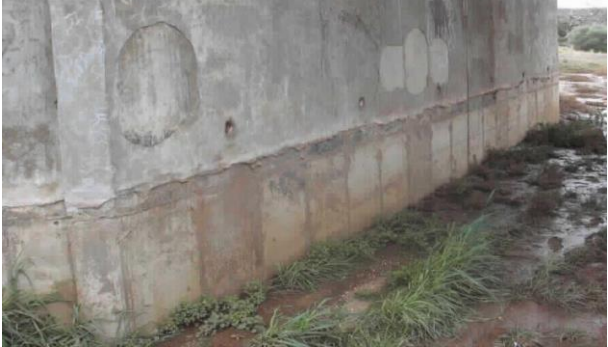
<p>Minor scour</p>
<p><u>Vegetation Growth</u></p> <ul style="list-style-type: none"> Any vegetation growth beneath the bridge is minor and having no effect on the performance of the waterway.

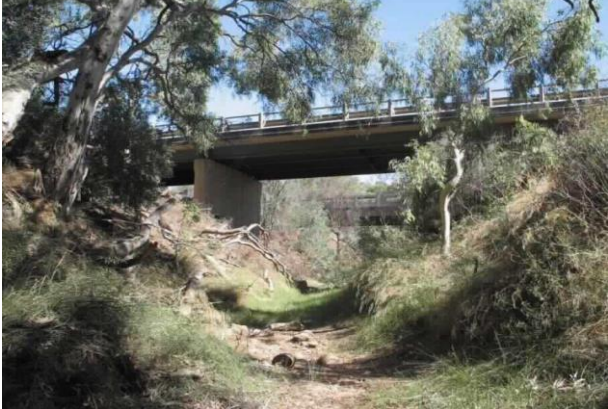
<p>Vegetation growth is having no effect on the waterway</p>
<p><u>Soil and Gravel Deposits</u></p> <ul style="list-style-type: none"> Minor soil or gravel build up is present under the bridge, but having no effect on the waterway. Light silting to ¼ depth in culverts.

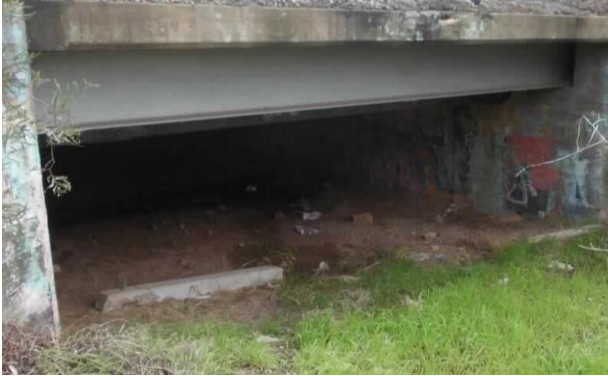
<p>Minor soil and gravel deposits</p>
<p><u>Other Debris</u></p> <p>Small amounts of accumulated debris are present in the waterway.</p>

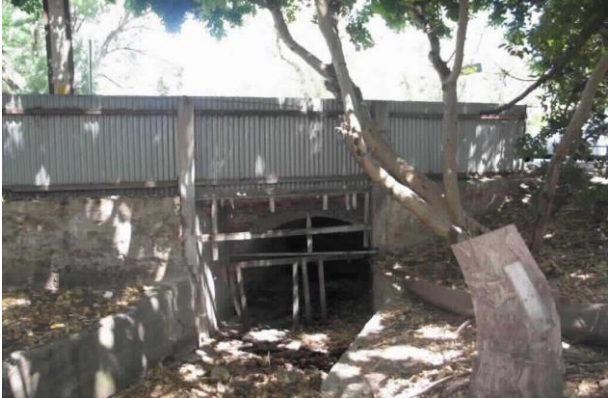
<p>Old broken fence across waterway</p>

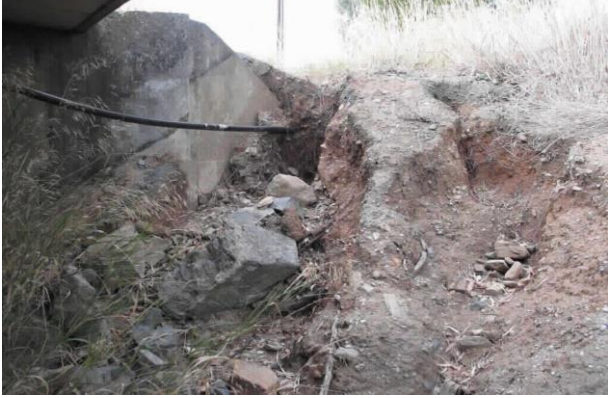
<p>Moderate scour</p>
<p><u>Vegetation growth</u></p> <ul style="list-style-type: none"> • Growth underneath or at both upstream and downstream sides, but only minimal effect on the waterway. • Removal should be considered.
