Road Structures Inspection Manual

Part 4A: Condition State Guidelines and Photographs

Bridges

RAS Document No: RAMA-ST-PRC-048
Knet Document No: 14888945
Document version: 1.3 (08/05/2020)

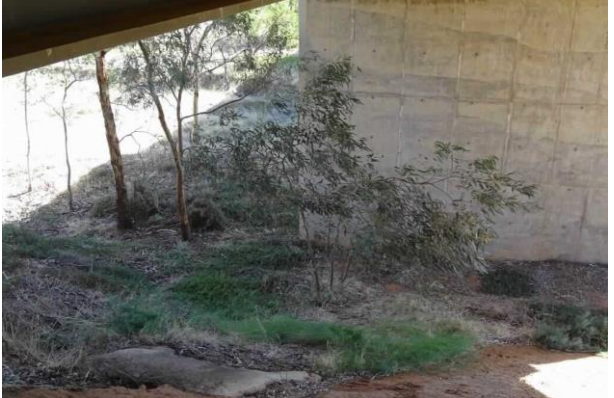
<p>Trees growing under bridge but having minimal effect on waterway</p>
<p><u>Soil and gravel deposits</u></p> <ul style="list-style-type: none"> • Moderate soil or gravel build up is present under the bridge, but only having minor effect on the waterway. • Minor ponding of water may result. • Silting from ¼ to ½ depth in culverts

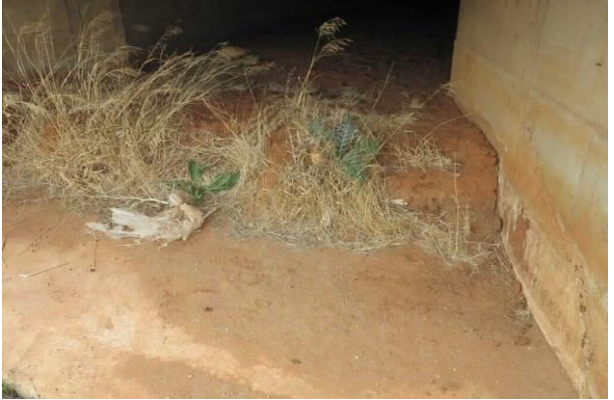
<p>Silt build up in culvert</p>
<p><u>Other debris</u></p> <ul style="list-style-type: none"> • Accumulated debris is present and is building up around the bridge supports or in the culvert cells, and should be removed. • No major impact on the waterway at this stage.

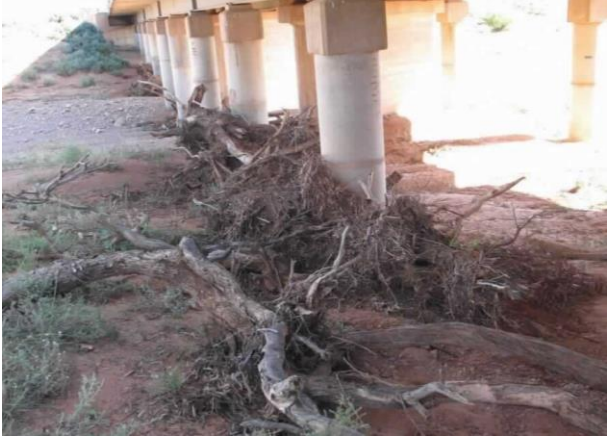
<p>Built up debris around piers</p>

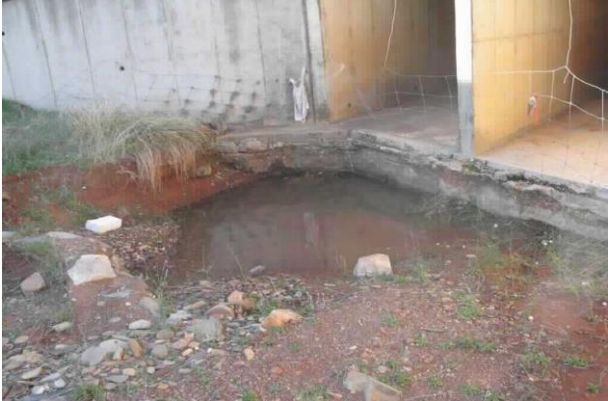
<p>Advanced scour</p>
<p><u>Vegetation growth</u></p> <ul style="list-style-type: none"> • Overgrowth of vegetation (blackberries, rushes, reeds etc.) under or at ends of bridge is affecting the waterway, and should be removed.

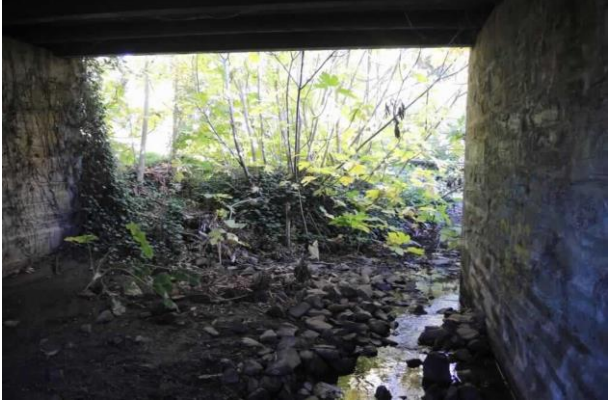
<p>Tree growing at downstream end of bridge</p>
<p><u>Soil and gravel deposits</u></p> <ul style="list-style-type: none"> • Significant accumulation of soil or gravel build up has altered the stream shape and is restricting the waterway. • Ponding of water under the bridge may be a feature. • Heavy silting in the stream such that the culvert is silted to ½ depth.

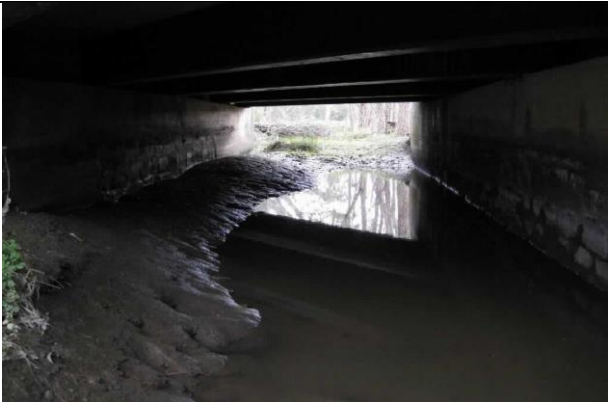
<p>Substantial silt build up reducing water flow under the bridge</p>

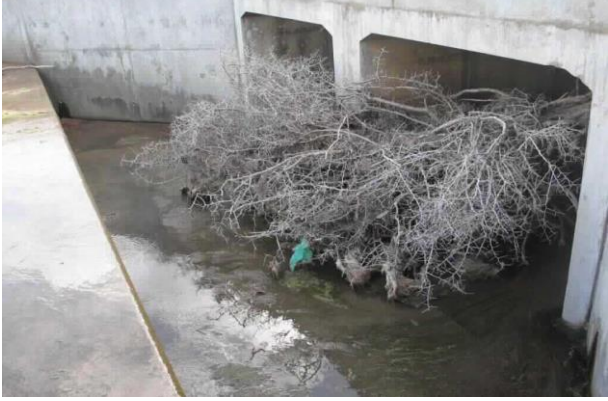
<p>Debris blocking the end of culvert cells</p>

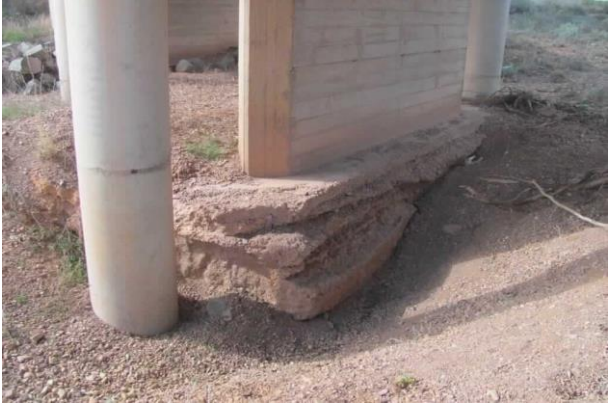
<p>Significant scour at pier</p>
<p><u>Vegetation growth</u></p> <ul style="list-style-type: none"> • Excessive overgrowth of vegetation (blackberries, rushes, reeds etc.) has severely restricted the waterway and should be removed in the short term.

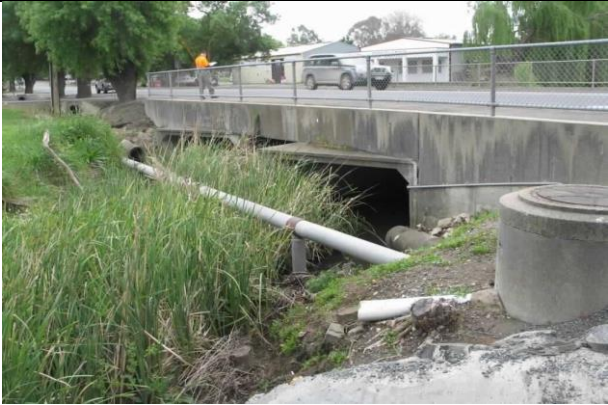
<p>Reeds and small trees blocking waterway</p>
<p><u>Soil and gravel deposits</u></p> <ul style="list-style-type: none"> • Excessive accumulation of soil or gravel build up has rendered the waterway ineffective. • Significant ponding of water under and around the bridge. • Excessive silting has severely restricted the waterway with more than 2/3 of the culvert depth silted.

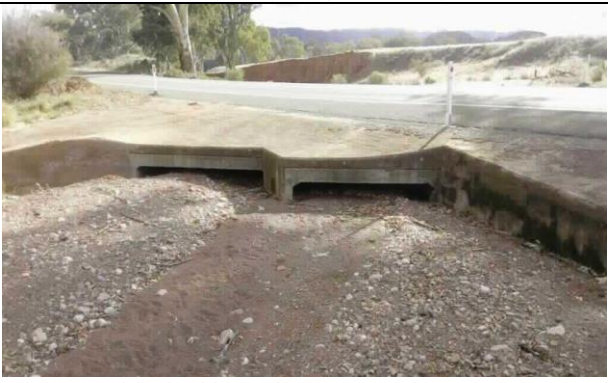
<p>Waterway blocked by sediment</p>

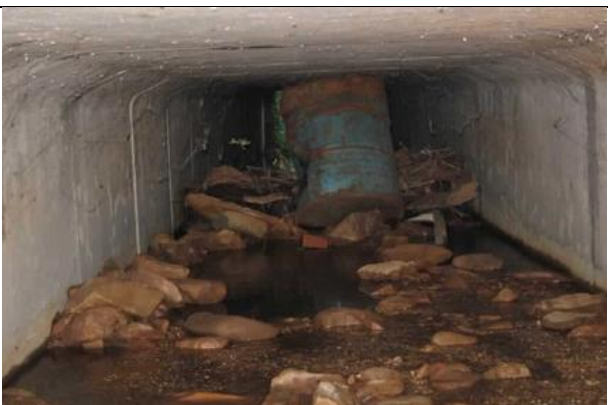
<p>Built up debris blocking waterway</p>

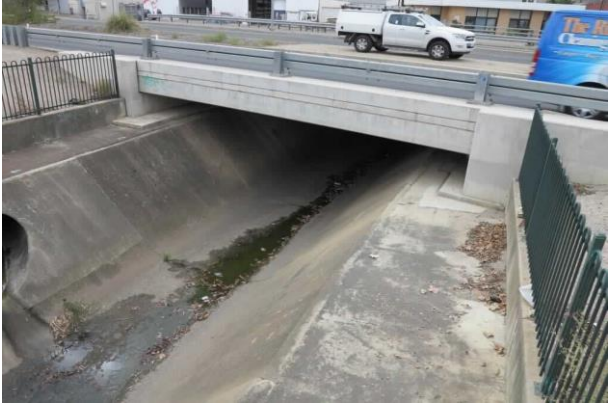
<p data-bbox="791 909 1401 943">Concrete lined channel in good condition</p>	
Condition state 2 -Description	Photo	
<ul style="list-style-type: none"> • Channel shape and bed level is unchanged but there may be cracking of the concrete or minor differential movement between the slabs. • There may be accumulated debris or bed deposits representing up to 10% of the designed waterway area in any span.

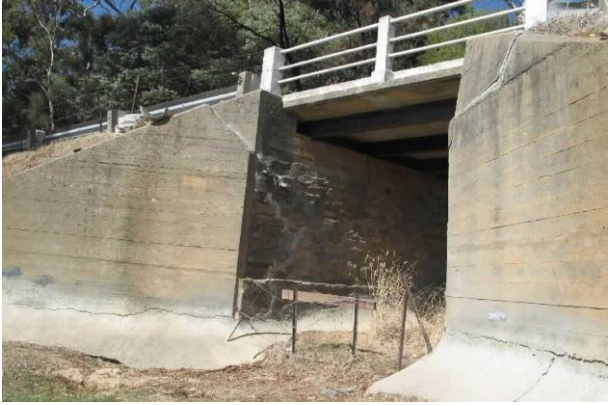
<p data-bbox="791 1379 1401 1438">Concrete protection at base of wingwall and abutment, with some cracking and minor movement</p>

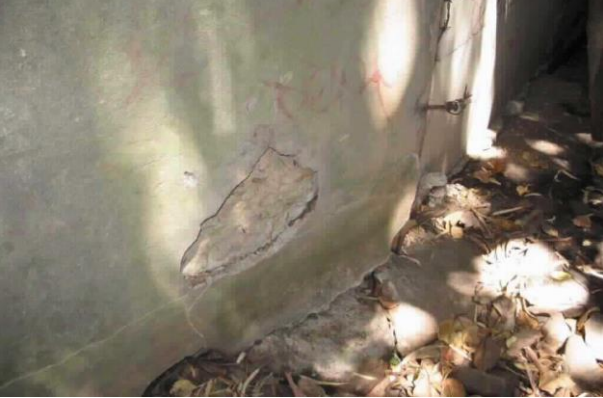
<p>Channel protection cracked and spalled</p>
Condition state 4 -Description	Photo
<ul style="list-style-type: none"> • Differential settlement or movements have caused concrete edges to break away allowing water behind the concrete. • Moderate loss of fill material may have occurred. • There may be accumulated debris or bed deposits representing up to 30% of the designed waterway area in any span.

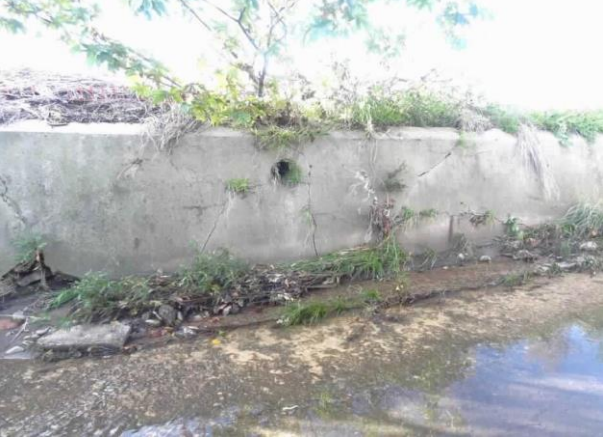
<p>Concrete channel wall and lining cracked in many places</p>

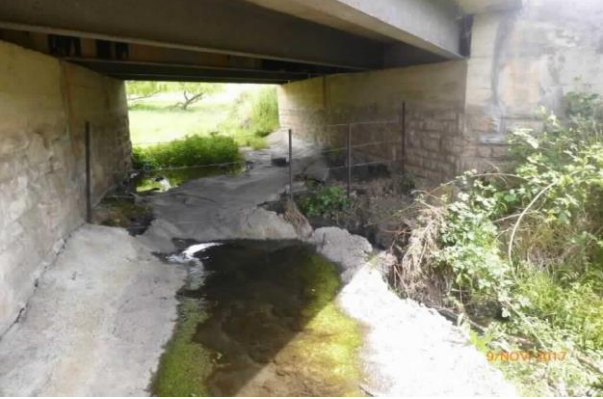
<p>Poorly formed concrete channel has water flowing underneath causing minor scour</p>

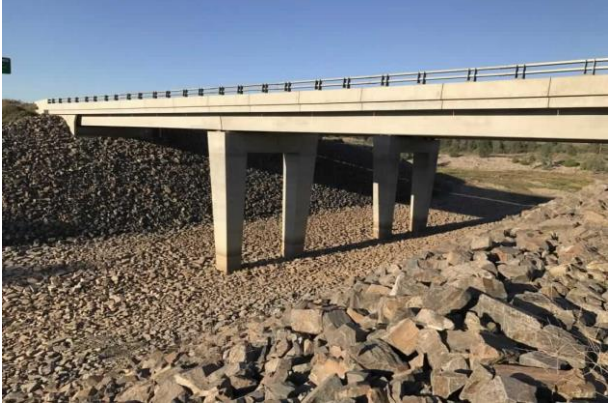
<p>Rock channel protection in very good condition</p>	
<p>Condition state 2 -Description</p> <ul style="list-style-type: none"> • Slight settlement may have occurred or there may be minor cracking of the mortar between stones. • Rock gabions or mattresses may have lost their shape slightly but only minor loss of rock fill may have occurred. 	<p>Photo</p>

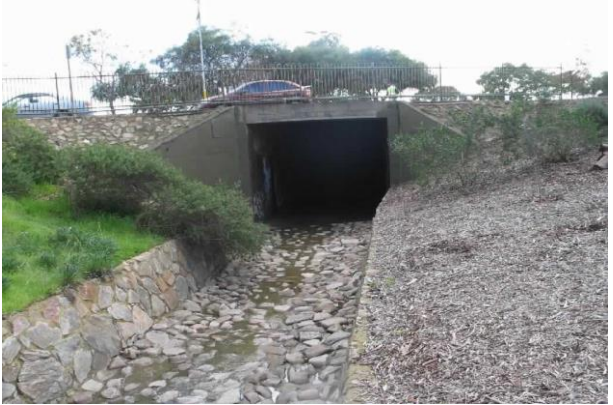
<p>Channel protection in good condition, minor vegetation growth</p>

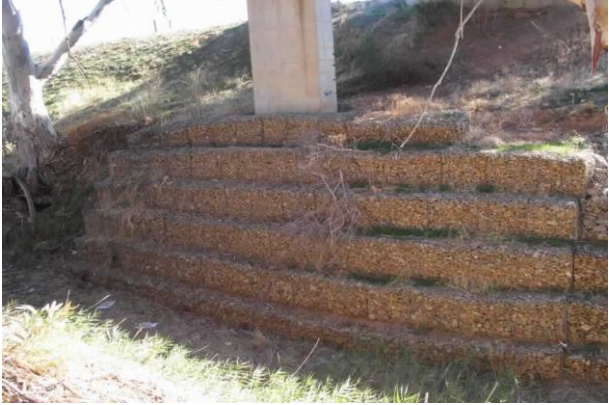
<p>Gabions have moved since placement</p>
<p>Condition state 4 -Description</p> <ul style="list-style-type: none"> • Scour of the banks has altered the stream shape or the bed beneath the bridge is scouring due to inadequate waterway. • Settlement may have badly cracked mortar between blocks and a few blocks may be missing with possible loss of fill material. • Gabions or mattresses may be badly distorted with some wires broken and a moderate loss of rock filling may have occurred. 	<p>Photo</p>

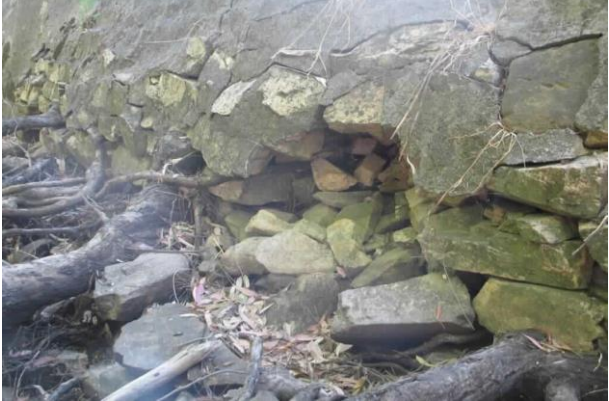
<p>Channel wall has been undermined with loss of material</p>

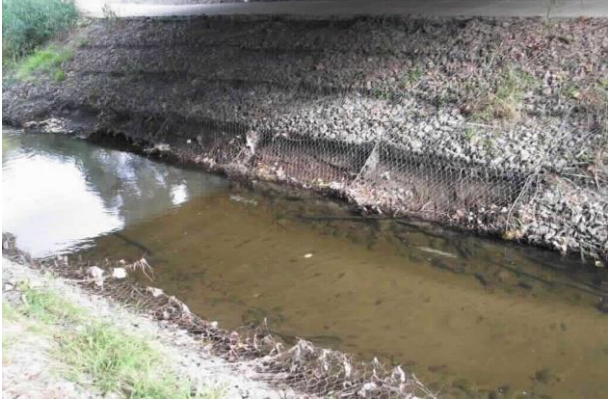
<p>Stones missing from reno mattresses</p>

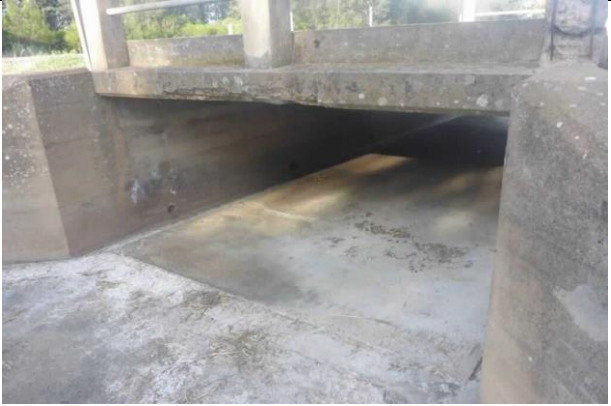
<p>Concrete base slab in good condition</p>	
Condition state 2 -Description	Photo	
<ul style="list-style-type: none"> • Minor cracking and spalling may be present with small areas of corroding reinforcement visible. • Dampness patches and efflorescence powder may be visible with evidence of minor ponding. • Shrinkage cracking is fine and dry.

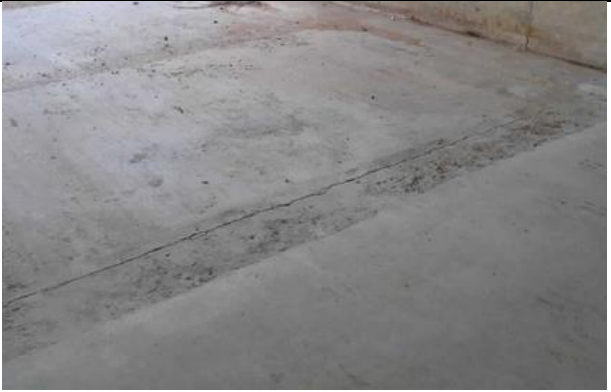
<p>Base slab with minor cracking</p>

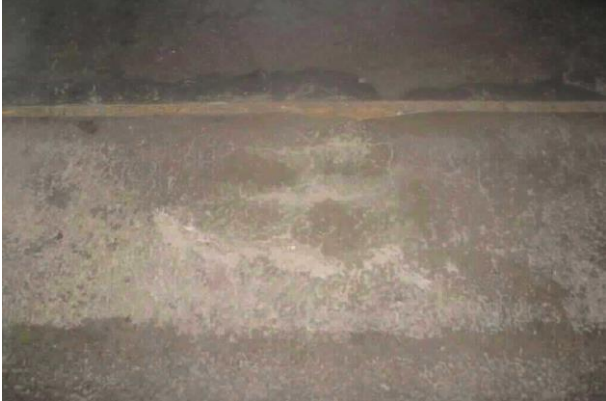
<p>Concrete spalling</p>
<p>Condition state 4 -Description</p> <ul style="list-style-type: none"> • There may be moderate to severe cracking and spalling with moderate loss of section due to corroding reinforcement. • The slab has extensive crazed cracking. 	<p>Photo</p> <p>Not available</p>
<p>Condition state 5 -Description</p> <ul style="list-style-type: none"> • There may be severe cracking/spalling or advanced corrosion of reinforcement over large areas with more severe loss of section of reinforcement. 	<p>Photo</p>

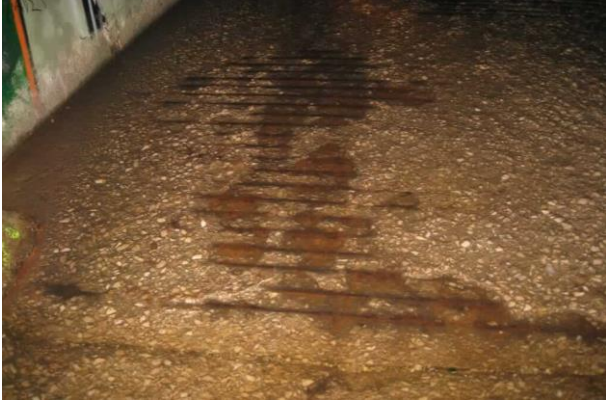
<p>Exposed reinforcement in base slab</p>

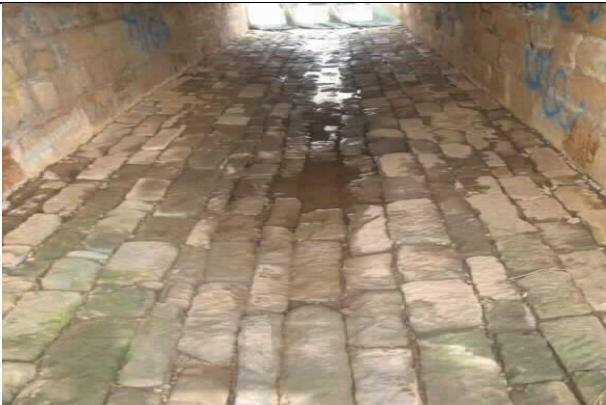
<p>Condition state 3 -Description</p> <ul style="list-style-type: none"> • There may be moderate cracking in the mortar between the stones or in the unreinforced concrete due to minor settlement. • There may be minor loss of mortar of no concern. • Water may be ponding on the slab. • The floor may have separated from concrete abutments/pier walls in a few locations and there may be minor settlement or movement occurring. 	<p>Photo</p>

<p>Water ponding in centre of base slab</p>
<p>Condition state 4 -Description</p> <ul style="list-style-type: none"> • Moderate cracking has occurred in the mortar between the stones or in the unreinforced concrete and stones may be missing. • The floor may have separated from the abutments/pier walls, providing access for moisture and there may be moderate settlement or movement occurring. 	<p>Photo</p>

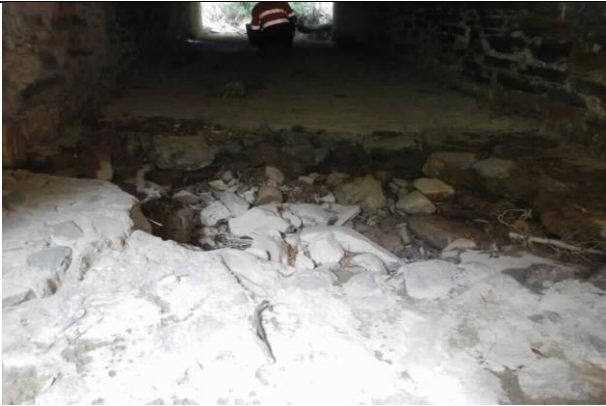
<p>Large scour hole in base slab</p>
<p>Condition state 5 -Description</p> <ul style="list-style-type: none"> • Severe cracking has occurred in the mortar between the stones and large areas of stones may be missing. • The unreinforced concrete may be severely cracked and broken in numerous areas. • The floor may have separated from the abutments/pier walls in many places, providing access for moisture and significant settlement or movement is occurring. 	<p>Photo</p> <p>Not available</p>

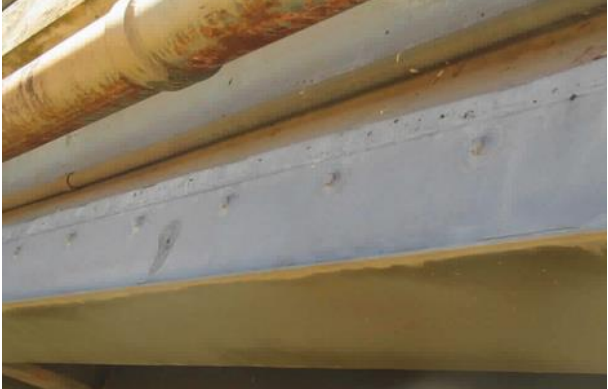
<p>Condition state 1 -Description</p>	<p>Photo</p>	
<ul style="list-style-type: none"> • There is no evidence of rust and any protective coating system is in good condition. • There are no signs of distress at anchors or associated supports.

<p>Steel plate and anchors in good condition</p>

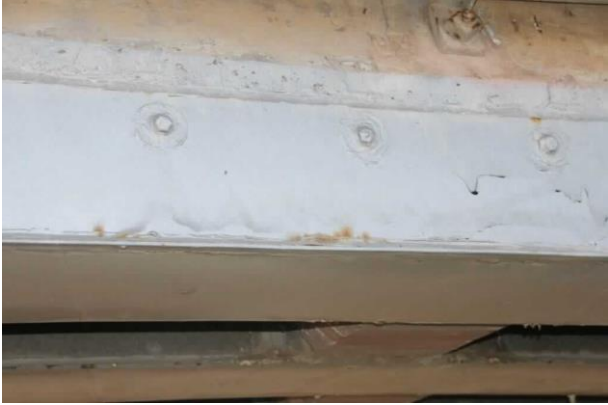
<p>Condition state 2 -Description</p> <ul style="list-style-type: none"> • The bars or tendons may show signs of rust or the protective coating system may only be in fair condition. • There are no signs of distress at anchors but the supports may be lightly corroded and in need of lubrication. 	<p>Photo</p>

<p>Paint blistering on steel strengthening plate attached to girder</p>
<p>Condition state 3 -Description</p> <ul style="list-style-type: none"> • The bars or tendons may have minor rusting or the protective coating system may be broken or in poor condition. • There are no signs of distress at anchors but the supports may have minor corrosion and be in need of lubrication. 	<p>Photo</p>

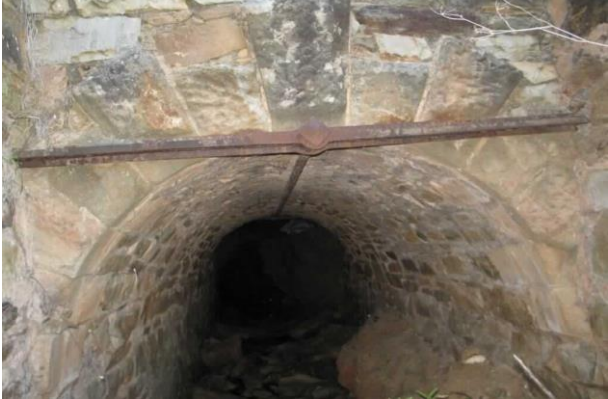
<p>Tie bars (preventing spread of arch spandrel walls) with rusting but no signs of distress</p>

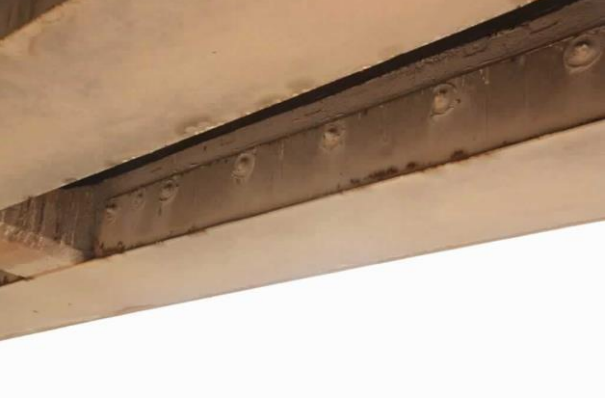
Condition state 4 -Description	Photo
<ul style="list-style-type: none"> • The bars or tendons may exhibit minor corrosion. Any protective coating system has been lost or is in very poor condition. • The conduit is in poor condition, grout may be visible through the damaged conduit and may be exhibiting signs of distress. • Anchors and associated supports may have moderate deformations. • Tendons may be beginning to abrade but there are no wire breakages. • Bars may be beginning to abrade but there is no loss of section.

<p data-bbox="794 600 1225 631">Corrosion on girder strengthening plate</p>
Condition state 5 -Description	Photo
<ul style="list-style-type: none"> • The bars or tendons are badly corroded, or have slackened noticeably. • Anchorages may have severe deformations or anchorages have moved or slipped. Associated supports are badly damaged. • Tendons may be severely abraded with a number of broken wires. • Bars may be severely abraded with loss of section. 	<p data-bbox="794 770 938 801">Not available</p>

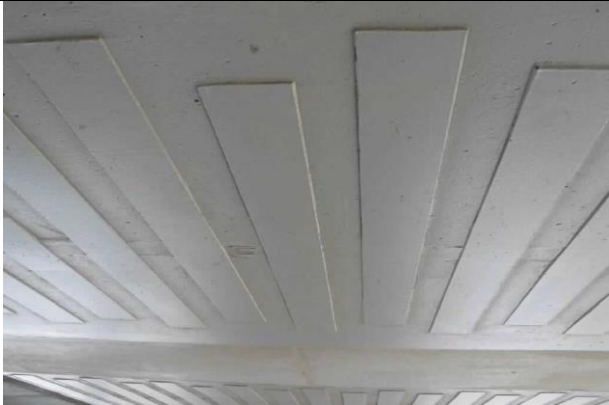
Condition state 1 -Description	Photo	
<ul style="list-style-type: none"> • The system is in good condition, with no signs of distress in either the substrate, the bonding resin or the strengthening material.

<p>Carbon fibre strips on soffit of reinforced concrete box girder in sound condition with no evidence of bubbles or peeling at ends or along edges</p>	
Condition state 2 -Description	Photo	
<ul style="list-style-type: none"> • There may be small areas of delamination (< 5% of the laminate area). • There may be evidence of minor initial breakdown of the system (that is, a fine crack across the end of the laminate or fine cracks in the resin or substrate). 	<p>Not available</p>

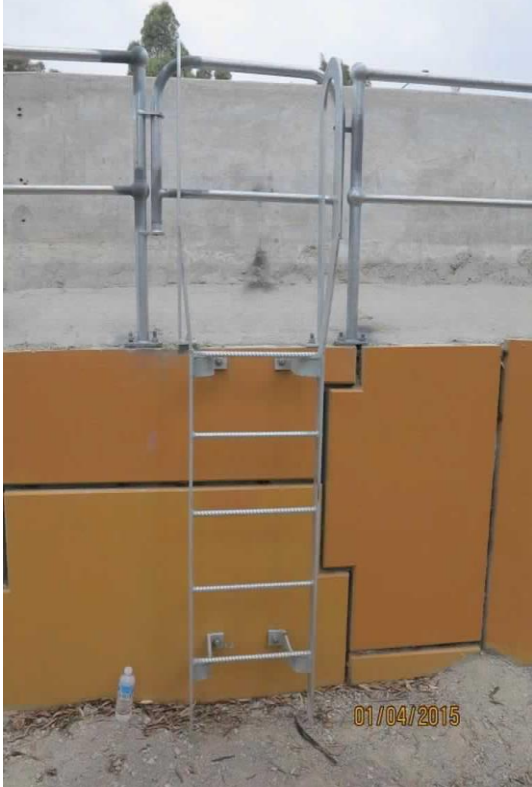
<p data-bbox="790 1332 1324 1366">Ladder attached to RE wall in good condition</p>

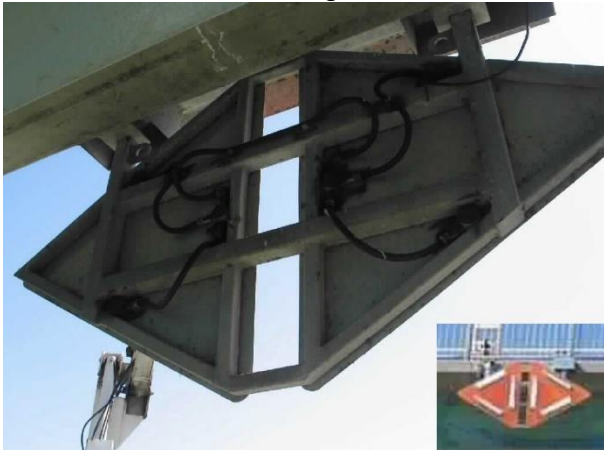
<p data-bbox="790 1814 1396 1848">Navigation sign in good condition</p> </div>

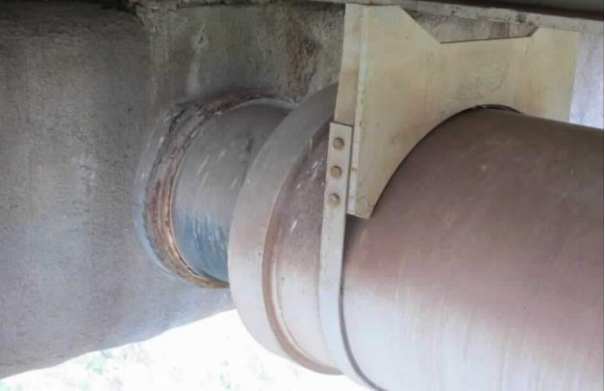
<p data-bbox="794 591 1347 618">Light corrosion of metal superstructure strut collar</p>

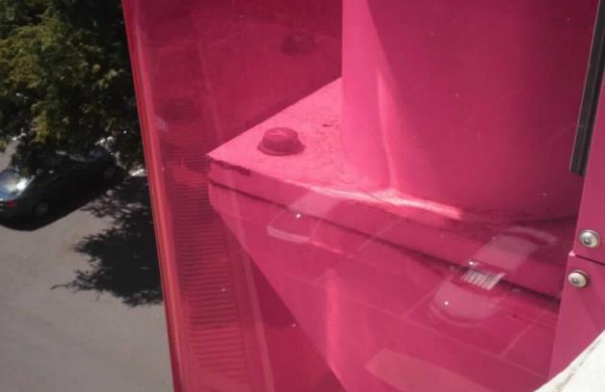
<p data-bbox="794 1016 1369 1043">Damage to protective coating of pink urban art posts</p>

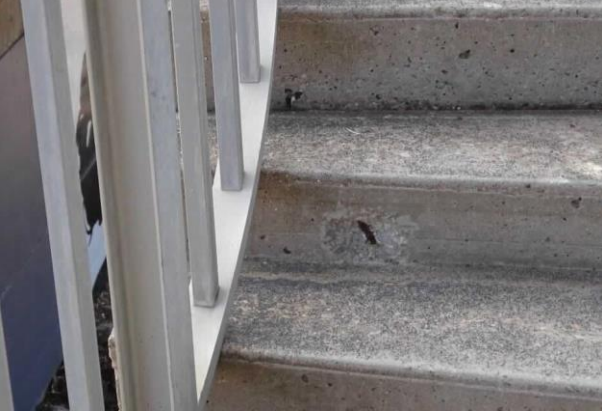
<p data-bbox="794 611 1118 640">Spall in step of spiral staircase</p>

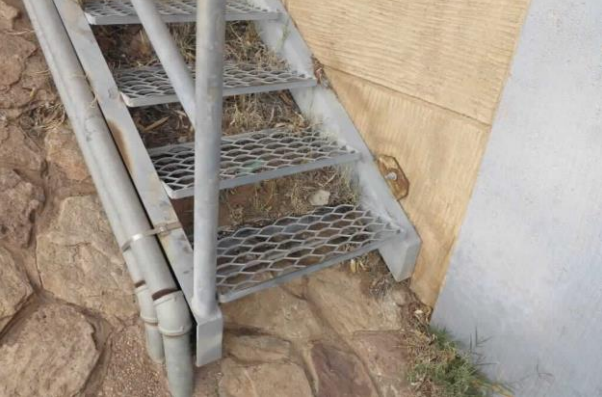
<p data-bbox="794 1043 1070 1072">Corrosion of access stairs</p>

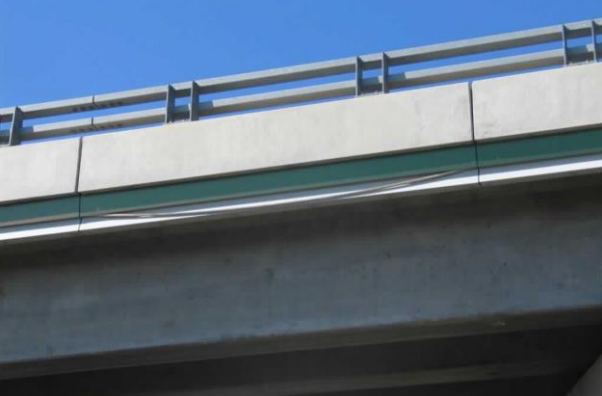
<p data-bbox="794 1476 1155 1505">LED lighting not properly secured</p>

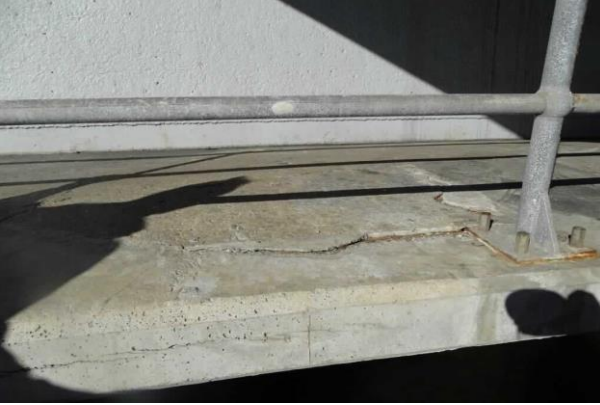
<p data-bbox="794 595 1396 629">Spalled footpath at abutment</p>
Condition state 5 -Description	Photo
<ul style="list-style-type: none"> • Concrete: Advanced deterioration or corrosion of reinforcement. • Metal: Corrosion is advanced. Section loss is significant. • Deterioration of concrete or section loss of metal is sufficient to warrant analysis to ascertain the impact on the strength and/or serviceability of the element. • There is doubt about the integrity of the connection(s). There may be advanced corrosion or cracking of the connectors and/or the supporting bridge element. • Ladders, gantries or access ways have significant defects and are unsafe to use.

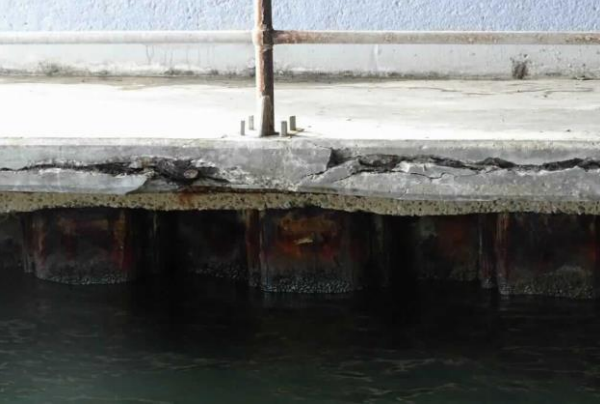
<p data-bbox="794 1207 1396 1240">Badly spalled footpath at abutment</p>

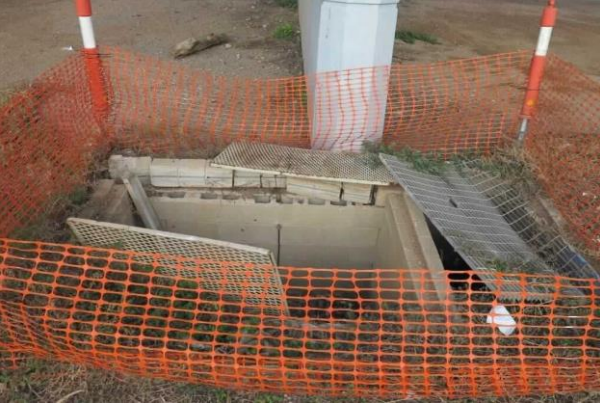
<p data-bbox="794 1644 1396 1677">Service pit lids dislodged and damaged</p>

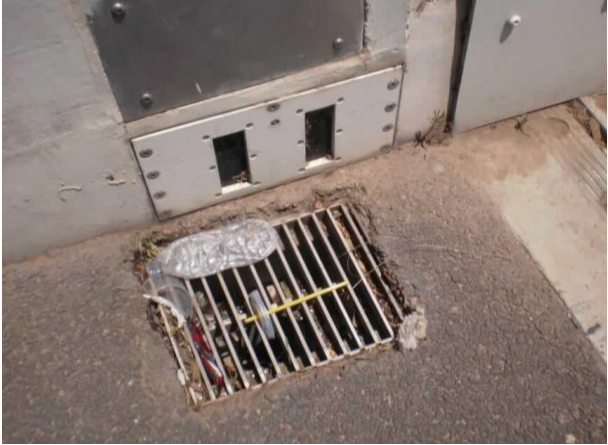
Minor debris in deck drainage pit

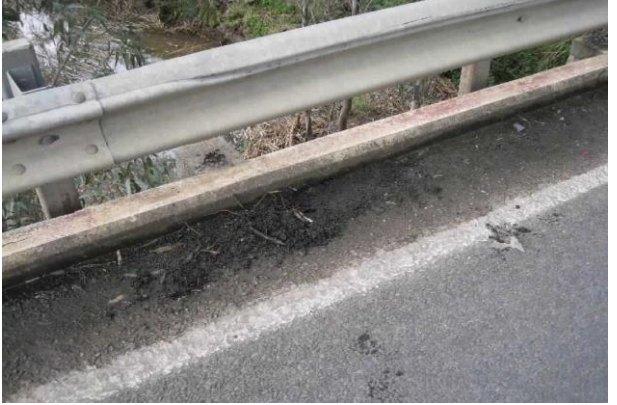
<p>Condition state 3 -Description</p> <ul style="list-style-type: none"> • Some scuppers are blocked but drainage of deck is still adequate. • Drainage system is functional possibly with some moderate leakage from joints and/or some brackets may be broken. 	<p>Photo</p>

<p>Blocked scupper</p>
<p>Condition state 4 -Description</p> <ul style="list-style-type: none"> • Drainage pipes may have broken sections and/or large number of leaks. • Scuppers / grates may be damaged. There may be large number of scuppers blocked affecting drainage of the deck. • There may be some loose or missing hangers. 	<p>Photo</p>

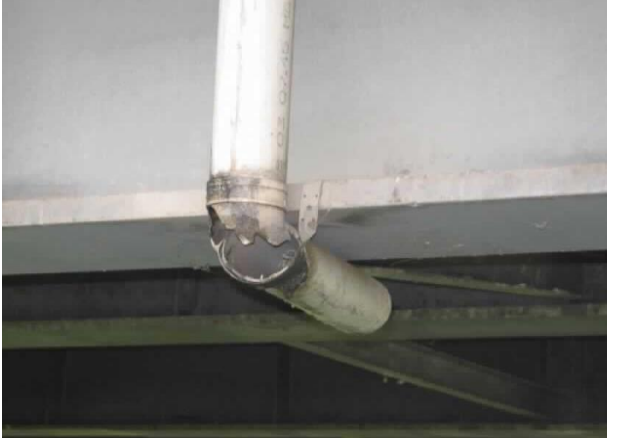
<p>Scupper downpipe broken</p>
<p>Condition state 5 -Description</p> <ul style="list-style-type: none"> • Blocked scuppers prevent or threaten to prevent satisfactory drainage of deck. • Drainage system may be blocked or damaged and not functioning satisfactorily. • There may be many loose or missing hangers. 	<p>Photo</p>

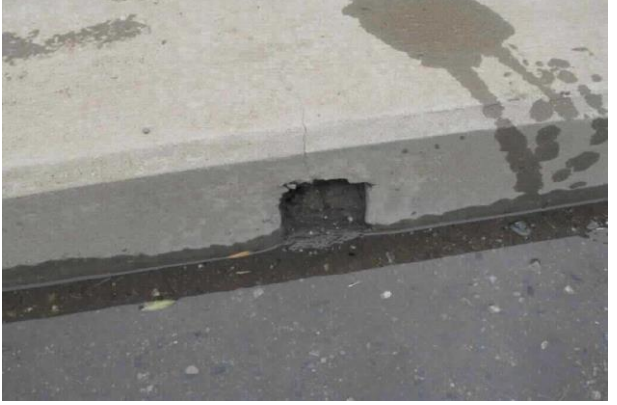
<p>Blocked scupper affecting drainage of deck</p>
