# SAFETY ALERT

Quick Cut Saw Kickback – Notifiable

September 2016

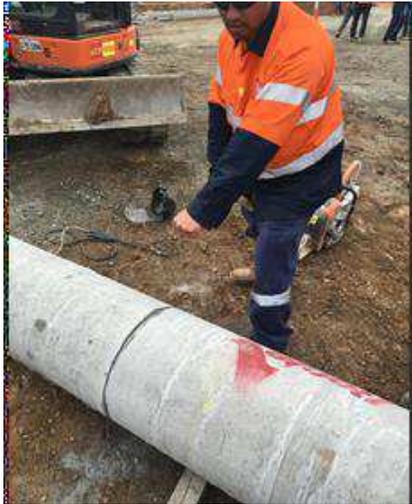
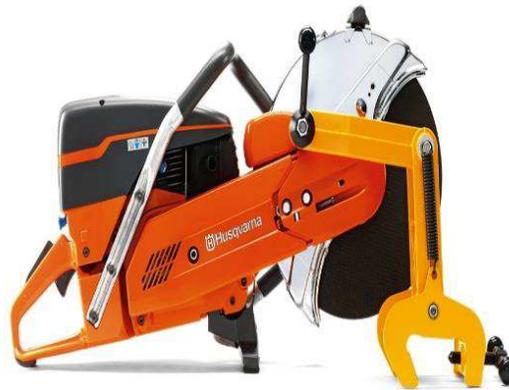
A worker was injured using a quick cut saw whilst cutting a reinforced concrete stormwater pipe to length. The pipe was placed on a single timber bearer on the ground while the worker was standing square to the pipe in line with the cut. During the operation of the saw, it kicked upwards towards his upper body and face resulting in a laceration of the neck.

Workers using the quick cut saw must be adequately trained. All materials being cut must be secured to prevent movement and correct PPE must be used.

The contractor will review current setup and methodology of cutting materials using quick cut saw to secure against unintended movements.

The contractor is investigating the use of clamps to secure against unintended movements of quick cut saw and is ensuring appropriate equipment is securely clamped. Plus ensuring the pipe is suitably restrained before cutting.
