# SAFETY ALERT

Crane Arm incident

January 2017

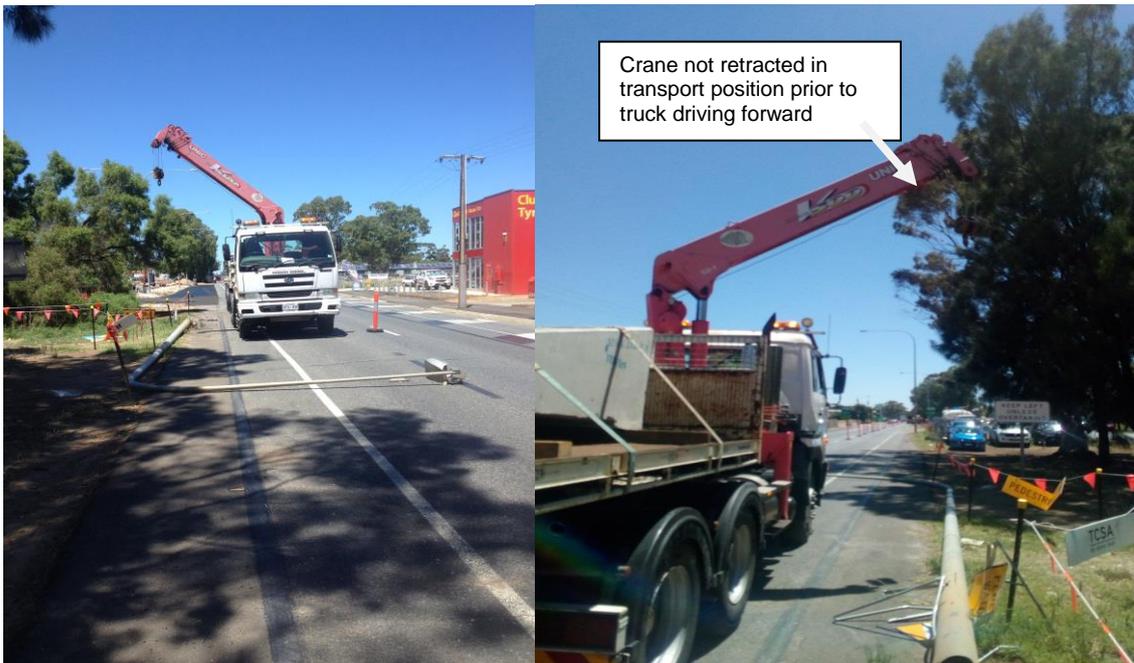
A contractor's operator failed to fully retract the crane arm after offloading pre-cast walls at a site location. The operator drove forward to a second site position with the boom still protruding from the side of the truck. The crane arm hit a light pole causing it to fall in front of the truck and onto the closed lane of a main road.

- The contractor should have retracted the boom of the crane fully and placed it into the standby/transport mode. The fitting of a warning device is being investigated.
- The contractor's Safe Work Method Statement (SWMS) did not risk assess what could happen if the crane was not fully retracted.
- A spotter was not supplied to the driver at the time to assist in giving directions.

- Ensure risk assessment is undertaken for the task before proceeding and that the SWMS reflects this.
- Where there is a need for plant and equipment such as a crane, assess if spotters should be used to lower the risk.
