ISSUE DATE: 13 Aug 18

SAFETY ALERT

ROCK GRAB FALLS FROM TRAILER

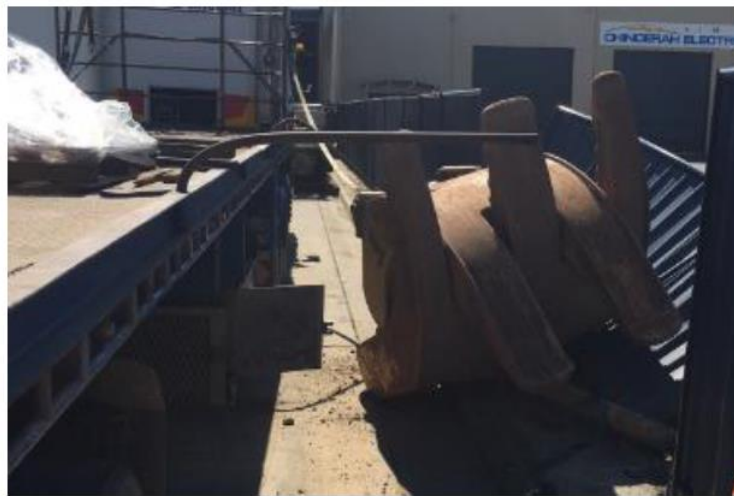
Using a 4t rated forklift with slipper tines fitted, a workshop fitter was in the process of moving the grab from the centre of the trailer to a position closer to the forklift ready for it being lifted off the trailer. At the first attempt to move it, the grab was inadvertently tipped by a forklift tine, rocked off its dunnage and subsequently rolled off the opposite side of the semi-trailer, demolishing a neighbour's fence and landing "half in" their property.

Other important facts are, the delivery semi-trailer was parked closer to the Workshop's boundary fence than normal because of a congested unloading area, the workshop yard (where the semi was parked) has a substantial cross fall towards the boundary fence and the forklift operator's *Licence to Perform High Risk Work* (LF) had expired on the 17 July 2018. There were no injuries resulting from this incident.

- 🏠 Ensure loading/unloading areas are designated and identified on your site's Vehicle/Traffic Management Plan, sufficient space is provided to enable the safe conduct of unloading/loading tasks, areas are delineated, and access controlled.

- 🏠 Ensure work equipment and unloading methodology is appropriate for the task. For example, the task above should have been completed using a mobile crane (FRANNA, etc) or the workshop's own gantry crane.

- 🏠 Conduct a Toolbox Talk with workers:
 - Remind forklift operators of the derating effect of slipper tines – they should refer to the forklifts load chart, if no information is provided for slipper tine use then they must not be fitted.
